# Llyn Tegid Reservoir Safety Project

## Access Audit

Version: 3.0

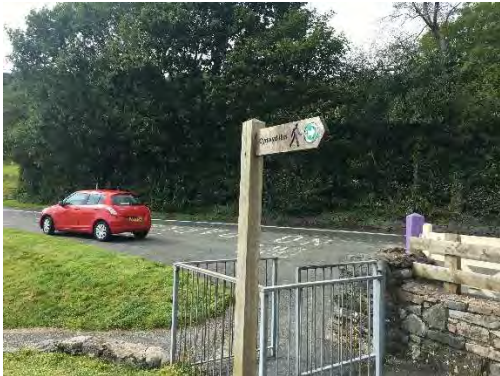
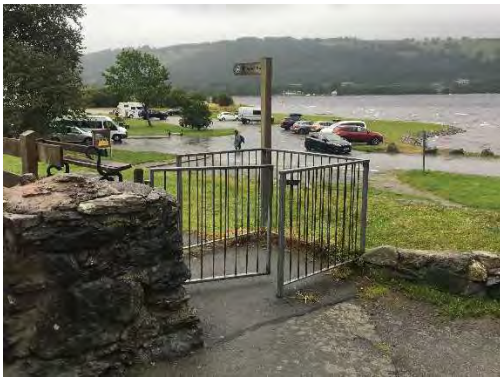
<p>Access onto Y Bala Rhif 4 from Pensarn Road</p> <p>Access control barrier: Steel chicane approx. 1200mm x 1200mm, two-way opening, not self-closing. It is possible to avoid this gate and join Y Bala Rhif 4 in several other locations along this footpath, the closest being approx. 60m further east via the ramp (adjacent watersports building / public toilets).</p> <p>Path gradient: c. 1:20 (length c. 8m; rise c. 0.4m; width c. 1.5m – 2.5m).</p> <p>Surface material: tarmac, 1.5-2.5m wide. Worn in some parts making the surface uneven, no step level &gt;15mm noted.</p> <p>Seating provided (first of three resting places on Y Bala Rhif 4 between Pensarn Road entrance and Watersports Centre). All on raised stone paving within grass, therefore not fully accessible.</p> <p>Litter bin provided.</p> <p>Timber PRow fingerpost sign on Pensarn Road footpath, directing users onto Y Bala Rhif 4 footpath.</p>	<p>Access barrier not compliant with recommendations of BS 8300 (i.e. 2-way self-closing gates may be used, but not revolving gates, turnstiles, kissing gates or A-frame barriers), or BARM (no steps, or stiles or other physical barriers restricting access).</p> <p>BS 8300: any gradient of 1:20 or steeper is a ramp, requiring a handrail on each side and landings at the head and foot of the ramp. Min recommended width is 1.5m. Max gradient for this rise is 1:16, so the gradient is acceptable.</p> <p>BS 8300: appropriate accessible space should be allowed for wheelchair users, integrated within the general seating provision, and a choice of seating options should be provided for a variety of users.</p> <p>BARM: regular seating provides resting points, particularly to reduce impact of gradients and distances.</p>	<p>Llyn Tegid Reservoir Safety project to replace access barrier with a two-way opening, self-closing gate that complies with recommendations of BS 8300. (Note this footpath can be accessed without restriction in four other locations nearby).</p> <p>Any opportunities to reduce the gradient of this ramp or improve access standards with handrails etc is beyond the working area, and therefore outside the scope of the Llyn Tegid Reservoir Safety project.</p> <p>Any opportunities to improve access standards (e.g. provision of accessible seating) would be beyond the working area, and therefore outside the scope of the Llyn Tegid Reservoir Safety project.</p>

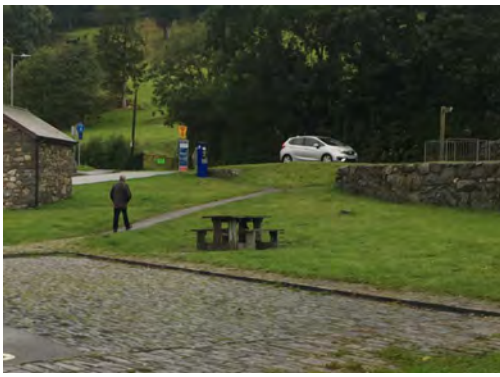
R4/02

<p>Access to Y Bala Rhif 4 from lakeside car park at western side (includes access to parking payment machine)</p> <p>Access control barrier: see above, R4/01</p> <p>Path gradient: At steepest c. 1:8 (gradient varies along ramp, steepest at top nr gate). Other gradients generally c. 1:23 – 1:28 (total length c. 30m; total rise c. 2.4m; width c. 0.6m – 1.0m). No handrails. No level landings.</p>	<p>The ramp is not compliant with BS 8300, which recommends that path gradients should be the lowest practicable gradient within the range of 1:20 to 1:12 (although maximum recommended gradient for this rise is 1:20), requiring level landings for every 500mm rise / 10m going, and requiring handrails. BARM recommended maximum ramp gradient should be 1:10.</p>	<p>Opportunities to improve access standards (e.g. by reducing gradients, widening paths etc) would be beyond the working area, and therefore outside the scope of the Llyn Tegid Reservoir Safety project.</p>

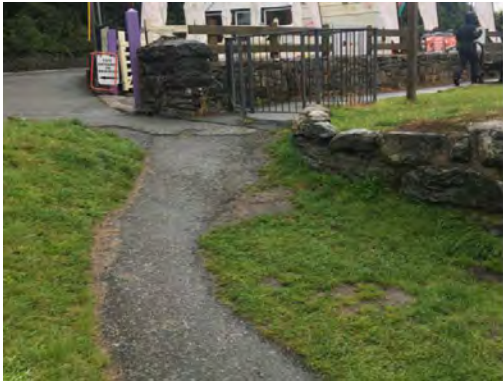
<p>Surface material: Tarmac and some stone paving (around pay machine and at base of ramp). Inconsistent tarmac surfacing at top of ramp, and uneven transition between tarmac and stone paving surfaces creates step levels &gt;15mm along route.</p> <p>Parking payment machine along route (before steep section of ramp) accessible from the foreshore car park via tarmac footpath.</p> <p>See above (R1/04) for seating, litter bins and signage information.</p>		<p>Llyn Tegid Reservoir Safety project to provide the localised improvement of addressing the uneven transition between tarmac and stone paving surfaces.</p>
R4/03

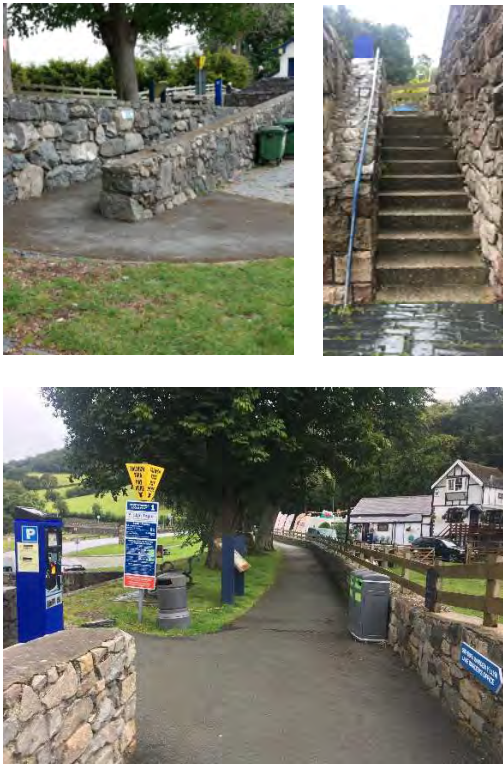
<p>Ramp and stepped access from Y Bala Rhif 4 to lakeside car park at western side of Bala Adventure &amp; Watersports building / public toilets (provides access from the lakeside car park to another parking payment machine)</p> <p>No access control barriers</p> <p>Ramp gradient: c. 1:15 (length c. 24m; Rise c. 1.7m; Width 1.4m – 1.6m). No handrails. No level landings.</p> <p>Step dimensions: Total rise c. 1.8m, width c. 1m. (individual step rise c. 180mm; tread c. 300mm). One handrail provided. Steps leading up to public toilets do not have any handrails.</p> <p>Seating provided (final of a set of three resting places along this stretch of Y Bala Rhif 4 between Pensarn Road entrance and Watersports Centre). All on raised stone paving within grass, not accessible. This is the last bench for app. 150m along Y Bala Rhif 4 (heading west to east) – next is located within leisure centre outdoor area.</p> <p>Litter bin and recycling bins provided. All accessible, recycling bins are within boundary of access route.</p> <p>Interpretation signage provided.</p>	<p>The ramp does not comply with recommendations of BS 8300 as the maximum recommended gradient for this rise is 1:20. Ramps require a handrail at either side, and level landings for every 500mm rise / 10m going. BARM guidance recommends a maximum ramp gradient of 1:10.</p> <p>Steps not compliant with recommendations of BS 8300, lacking corduroy tactile paving top and bottom and contrasting nosings. Dimensional ranges for the steps should be between 150-180mm for the rise and between 300-450mm for the going, steps fall within these dimensions. A handrail should be provided on each side of the ramp or stair, stairs only have one handrail, some have none.</p> <p>BS 8300 recommends litter bins, amongst other street furniture, should wherever possible be located at or beyond the boundaries of an access route.</p>	<p>Re-grading the ramp and adding in level landings here is likely to be costly and disruptive, and is outside the scope of the Llyn Tegid Reservoir Safety project.</p> <p>Llyn Tegid Reservoir Safety project to provide a handrail to one side of the ramp and additional signage from the lakeshore car park, to improve compliance with BARM guidance.</p> <p>Opportunities to improve access standards here would be beyond the working area, and therefore outside the scope of the Llyn Tegid Reservoir Safety project.</p> <p>The Llyn Tegid Reservoir Safety project will move the recycling bins so that they do not sit within the boundary of the access route, which will improve compliance with BS 8300 (there is plenty of room not within the footpath that they can be located).</p>

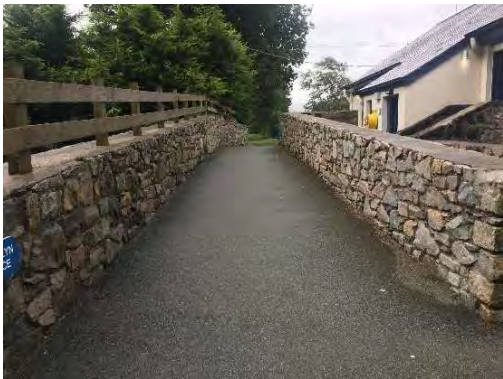
<p>Ramp on Y Bala Rhif 4 (west of Bala Adventure &amp; Watersports building).</p> <p>Ramp gradient: c.1:15 (length c. 10m; rise c. 0.6m; width c.2.0m – 2.5m). No handrails. No level landings.</p> <p>Surface material: Tarmac. Even surfaced, no notable step levels.</p>	The ramp does not comply with recommendations of BS 8300, as maximum recommended gradient for this rise is 1:20. Ramps require level landings for every 500mm rise / 10m going, and two handrails. BARM recommended maximum gradient is 1:10.	Reconstructing for compliant ramp dimensions here could be costly and disruptive. Opportunities to improve access standards here would be beyond the working area, and therefore outside the scope of the Llyn Tegid Reservoir Safety project.
R4/05

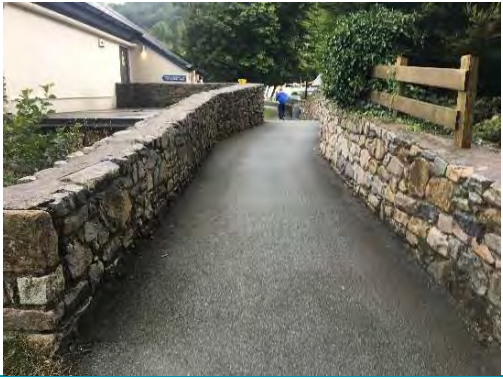
<p>Ramp on Y Bala Rhif 4 (east of Bala Adventure &amp; Watersports building).</p> <p>Ramp gradient: c.1:15 (length c. 10m; rise c. 0.6m; width c. 2.0m – 2.5m). No handrails. No level landings.</p> <p>Surface material: Tarmac. Even surface, no notable step levels.</p>	The ramp does not comply with recommendations of BS 8300, as maximum recommended gradient for this rise is 1:20. Ramps require level landings for every 500mm rise / 10m going, and two handrails. BARM recommended maximum gradient is 1:10.	Reconstructing for compliant ramp dimensions here could be costly and disruptive. Opportunities to improve access standards here would be beyond the working area, and therefore outside the scope of the Llyn Tegid Reservoir Safety project.

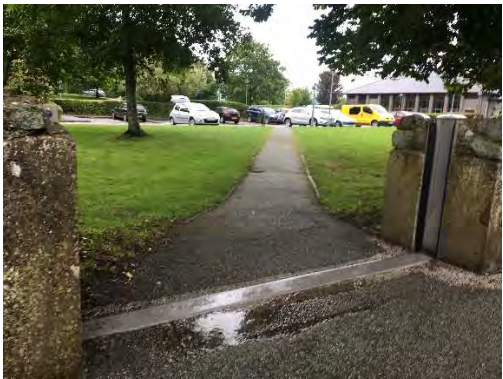
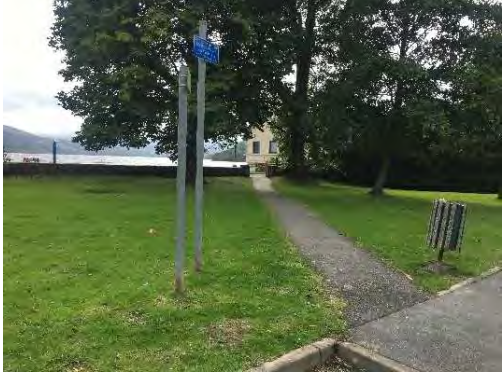
R4/06

<p>Path connecting leisure centre car park to Y Bala Rhif 4</p> <p>Access control barrier: None</p> <p>Path gradient: Varies, path is lowest at toe of embankment line. c. 1:36 (embankment toe to Y Bala Rhif 4) and 1:140 (embankment toe to car park)</p> <p>Path width: 1.5-2.0m</p> <p>Surface material: Tarmac. Uneven where tarmac has worn at toe of embankment, other than this surface is relatively smooth. Step level where tarmac meets frame of demountable defence, this doesn't appear to be &gt;15mm.</p> <p>No seating.</p> <p>Litter bin provided. Accessible, not within boundary of access route.</p> <p>No directional signage. Signpost at the end of the footpath from the car park could be adapted to</p>	<p>This is one of the access points onto Y Bala Rhif 4 that is uncontrolled, being directly connected to one of the well-used car parks in the area. Currently there is no known issue with unauthorised access from this connection.</p> <p>NRW aim to remove demountable defence / fill gap in wall as it creates operational risk.</p>	<p>Retain the open access between Leisure Centre Car Park and Y Bala Rhif 4, but at new location nearer Leisure Centre where a demountable defence would not be required. Block up this demountable defence to reduce flood risk.</p> <p>Opportunity to re-create connecting path at a location within Reservoir Safety Scheme, where it can lead directly on to ramp down to foreshore as part of open spaces enhancements proposed.</p> <p>Consider additional signage within development of detailed plans for enhancements around leisure Centre.</p>

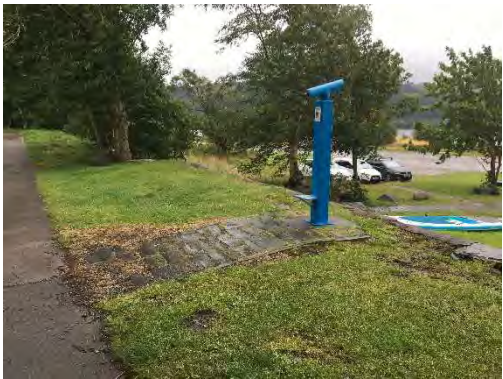
<p>Ramped access to telescope from Y Bala Rhif 4</p> <p>Gradient: c.1:15. No handrail. No level landing.</p> <p>Width: c. 1.2m.</p> <p>Surface material: Stone paving. Uneven surface, no step level &gt;15mm noted.</p> <p>Note: Telescope unlikely to be useable for wheelchair users due to height.</p>	<p>Access is not compliant with BS 8300, 'where joints are filled but recessed below the surface, the difference in level between adjacent units should not be greater than 2mm, with joints not wider than 10mm and recess not deeper than 5mm'. BARM recommends path surfaces be 'hard and firm with very few loose stones' and that 'the ideal is non-slip, well-drained, level path'.</p>	<p>Filling recessed joints and smoothing of any protruding stone paving slabs would improve compliance with both guidance recommendations. 'Where joints are filled to the surface, the difference in level between adjacent units should be not more than twice the joint width, subject to a maximum difference in level of 5mm' (BS 8300). Making the paths as level as possible will improve compliance with BARM guidance.</p> <p>Opportunities to improve access standards here would however be beyond the scope of the Llyn Tegid Reservoir Safety project.</p>

<p>The ramp does not comply with recommendations of BS 8300, maximum recommended gradient for this rise is 1:20. Ramps require level landings for every 500mm rise / 10m going, two handrails, and a minimum width of 1.5m. BARM recommends a maximum ramp gradient of 1:10, no preferred width is given, but minimum path width is 1m.</p>	<p>Opportunities to improve access standards here would be beyond the scope of the Llyn Tegid Reservoir Safety project.</p>
R4/08

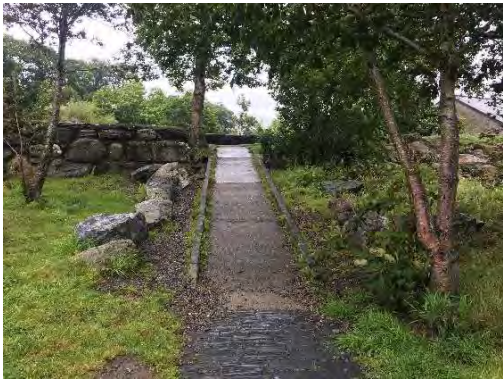
<p>Concrete ramp from Y Bala Rhif 4 to lakeside, connecting to slate paved surfaces near watersports centre.</p> <p>Ramp gradient c. 1:10 (length c. 20m, rise c. 1.9m, width 1.2m – 1.5m). No handrails. No level landings.</p> <p>Surface material: Concrete, tarmac and stone paving. Tarmac is relatively even, consistent ramp edging. No step levels &gt;15mm noted. Crossfall of pavement at top of ramp is &lt;1:50 (see R4/08). Large loose stones across path at base of ramp (&gt;10mm).</p> <p>NRW experiencing erosion issues with the rip rap at this location.</p>	<p>The ramp does not comply with recommendations of BS 8300, maximum recommended gradient for this rise is 1:20. Ramps require level landings for every 500mm rise / 10m going, two handrails, and a minimum width of 1.5m. BARM recommends a maximum ramp gradient of 1:10, no preferred width is given, but minimum path width is 1m.</p> <p>BARM recommends path surfaces be hard and firm with very few loose stones (no bigger than 10mm) and that the ideal is non-slip, well-drained, level path. BS 8300 recommends a firm, slip-resistant and reasonably smooth surface, cobbles, bare earth, sand and unbonded gravel should not be used.</p>	<p>Llyn Tegid Reservoir Safety project to deliver improved compliance with BS 8300, replacing this ramp with a reduced gradient ramp, min 1.5m wide, that connects with new path from Leisure Centre car park.</p> <p>Handrails not to be provided as not provided on nearby paths and ramps.</p>

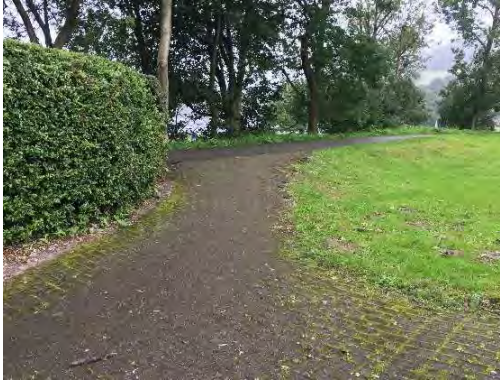
<p>Ramp between Y Bala Rhif 4 and Leisure Centre frontage</p> <p>Access control barrier: None.</p> <p>Ramp gradient: c. 1:10 (length c. 6m; rise c. 0.6m; width 1.8m – 3.0m). No handrails. No level landings.</p> <p>Surface material: Brick setts. Even and smooth surface. Not slip resistant when wet due to moss build up, likely worsened by area being heavily shaded by vegetation on embankment.</p>	<p>The ramp does not comply with recommendations of BS 8300 as maximum recommended gradient for this rise is 1:20). Ramps require level landings for every 500mm rise / 10m going, and two handrails. BARM recommends maximum gradient is 1:10 for a ramp.</p>	<p>Llyn Tegid Reservoir Safety project to provide a reduced gradient (no steeper than 1:20) access path as part of Leisure Centre enhancement works.</p>

<p>This is one of the access points onto Y Bala Rhif 4 that is uncontrolled, being directly connected to one of the well-used car parks in the area. Currently there is no known issue with unauthorised access from this connection.</p>	<p>Retain the open access at this location, no access control would be proposed along the replacement footpath.</p>

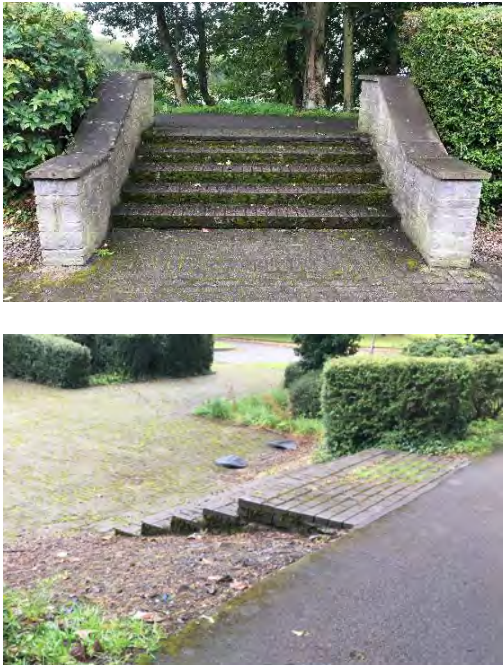
<p>Series of 3 flights of access steps between Y Bala Rhif 4 and Leisure Centre (1 no. with enclosing walls, 2 no. without)</p> <p>Step dimensions: Total rise c. 700mm - 800mm, widths differ for each flight; c. 2.7m, 2.8m and 2.9m. (Individual step rise c. 200mm; Tread c. 300mm – rise differs with each step acc, to topo). No handrails.</p> <p>Surface material: Brick setts, even surface. Not slip resistant when wet due to moss build up, likely worsened by area being heavily shaded by vegetation on embankment.</p> <p>Staircase edge without enclosing walls would be difficult to navigate for someone who is partially sighted, exposed corners of brick at stair edges also pose a danger to pedestrians as there is no handrail.</p> <p>Although south facing, Leisure Centre area appears very dark, heavily shaded and uninviting due to dense and neglected overgrown vegetation. Three flights seem excessive for size and footfall of space. One flight leads to a space where there was formerly a café but now appears redundant.</p>	<p>Steps are not compliant with BS 8300, requiring the provision of tactile paving and contrasting nosings. Where practicable, the dimensional ranges for steps and stairs should be between 150 mm and 180 mm for the rise and between 300 mm and 450 mm for the going. The rise and going of each step within a flight should be uniform. Handrails should be provided at either side of a stair.</p>	<p>As part of Leisure Centre enhancement works, Llyn Tegid Reservoir Safety project to rationalise and improve access steps and connections between Leisure Centre and Y Bala Rhif 4, including the addition of tactile paving, handrails and resurfacing. Opportunity to reduce the number of flights to two as part of enhancement proposals for this area.</p> <p>Removal of vegetation as part of Reservoir Safety Scheme should improve issue of darkness and shading in this area. If resurfacing takes place, ensure surface materials comply with requirements recommended in guidance.</p>

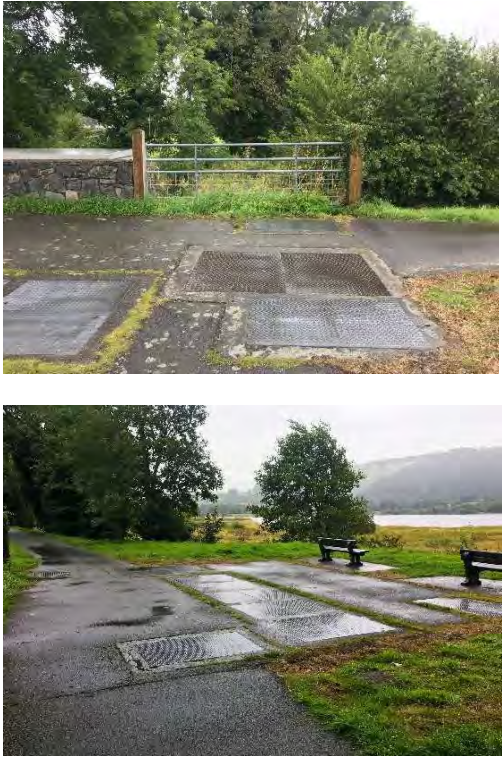
<p>Steel field gate on timber posts, providing vehicular maintenance access onto Y Bala Rhif 4 at location of pump station.</p> <p>Path gradient (up to Bala Rhif 4): c. 1:4 (length c. 3m; rise c. 0.7m; width c. 4m).</p> <p>Seating area dimensions: c 7m x 9m (63m<sup>2</sup>)</p> <p>Surface material: Path leading up to access gate on Y Bala Rhif 4 is unsurfaced grass. Footpath is tarmac, bench and inspection chamber covers are set in concrete. Volume of exposed inspection chamber covers here mean that much surfacing is also steel.</p> <p>Seating provided, two benches overlooking panoramic lake views. Several metal inspection chamber covers and breaks in tarmac surface detract from appearance and make the surface unsmooth in parts and appear untidy.</p> <p>No litter bins.</p> <p>No signage.</p>	<p><i>Ramped access and gate not considered here as not for public use</i></p> <p>BARM recommends path surfaces be hard and firm with very few loose stones (no bigger than 10mm) and the ideal is a non-slip, well-drained, level path. BS 8300 recommends an access route have a firm, slip-resistant and reasonably smooth surface. Cobbles, bare earth, sand and unbonded gravel should not be used. Current materials are not non-compliant, but overall appearance is cluttered, untidy, and arguably uneven because of so many changes in surface material.</p> <p>BS 8300 recommends that appropriate accessible space should be allowed for wheelchair users to be integrated within the general seating provision, and a choice of seating options should be provided for a variety of users. BARM acknowledges that regular seating provides resting points, particularly to reduce impact of gradients and distances.</p>	<p>Llyn Tegid Reservoir Safety project to deliver surfacing enhancements including higher quality surfacing / surface dressing (consider recessed inspection chamber covers allowing uniform surfacing - subject to agreement with the asset owner DCWW).</p> <p>Llyn Tegid Reservoir Safety project to improve seating area, within Reservoir Safety Scheme.</p> <p>Consider inclusive / accessible seating opportunities and interpretation / public art opportunities.</p>

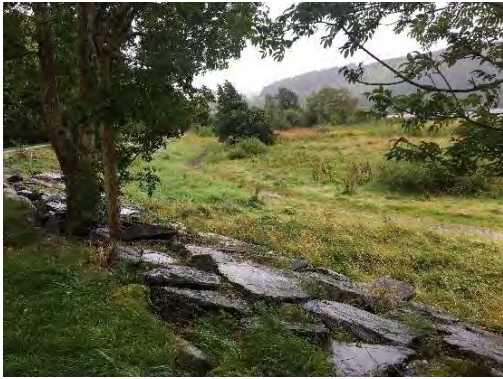
<p>Uneven in parts, several areas where water gathers during rainfall.</p> <p>No seating.</p> <p>Litter bin provided. Not accessible due to nature of footpath.</p> <p>No signage noted along route.</p>	<p>non-slip, well-drained, level path'. BS 8300 recommends 'an access route should have a firm, slip-resistant and reasonably smooth surface. Cobbles, bare earth, sand and unbonded gravel should not be used'.</p>	
			<p>BS 8300 recommends minimum path width be 1.8m (although a minimum of 2m is preferred), BARM recommends at least 1m path width.</p>	<p>Widen footpath to 1m as part of surfacing (above). If there is scope to formalise this path addition of seating and directional signage should be considered.</p>
R4/16

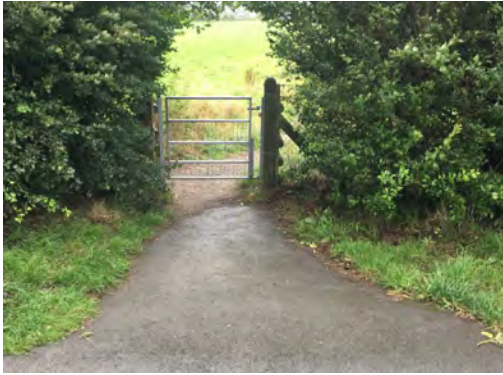
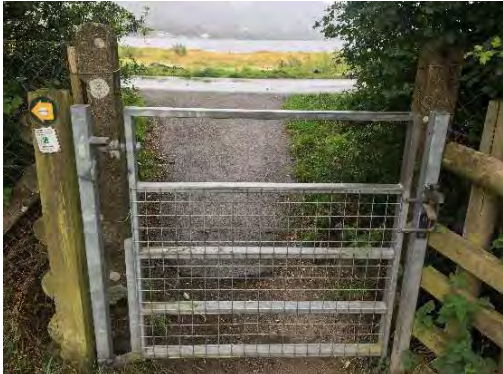
<p>Ramped footpath connection onto Y Bala Rhif 5 from Y Bala Rhif 4</p> <p>Access control barrier: Steel field gate, 1.2m wide, self-closing, opens one-way.</p> <p>Ramp gradient: c. 1:5 – 1:10 (length c. 5m; rise c. 0.5m; width: 1.1m – 1.8m). No handrails. No level landings.</p> <p>Surface material: Tarmac leading on to bare earth. Change in surface creates a step level exceeding 15mm between the ramp and unsurfaced path.</p> <p>No seating.</p> <p>No litter bins.</p> <p>No directional signage provided from Y Bala Rhif 4 (signage is provided on other side of gate from Y Bala Rhif 5 as shown).</p>	<p>Access control barrier does not comply with recommendations set out in BS 8300 (2-way self-closing gates may be used, but not revolving gates, turnstiles, kissing gates or A-frame barriers) or BARM (no steps, or stiles or other physical barriers restricting access).</p>	<p>Replacing the pedestrian access gate with a curved metal 'kissing gate' with RADAR bypass (as defined in BS 5709) would make the gate more accessible and improve compliance with both sets of guidance as well as maintaining ability to function as livestock farmland if necessary.</p> <p>GCC would prefer to replace with 2-way self-closing gate. Further discussion with landowner required. If no livestock here or use changes as part of Reservoir Safety scheme, then suggest no access barrier necessary.</p>

<p>The ramp does not comply with recommendations of BS 8300 (maximum recommended gradient for this rise is 1:20), requiring level landings for every 500mm rise / 10m going, two handrails and a minimum width of 1.5m.</p>	<p>Llyn Tegid Reservoir Safety project to provide improved compliance to BS 8300 recommendations, reducing gradient and ensuring a 1.5m width (minimum) throughout. Resurface the path and remove any step levels greater than 15mm. No handrails considered necessary at this location.</p>
			<p>BS 8300 recommends that information and signage should be located where it is clearly identifiable and visible from all directions, and that signage should reaffirm directions on a route that continues over a long distance or at changes in direction.</p>	<p>Llyn Tegid Reservoir Safety project to add directional fingerpost or waymarker signage at this junction highlighting that Y Bala Rhif 5 is also a PRow (from Y Bala Rhif 4).</p>

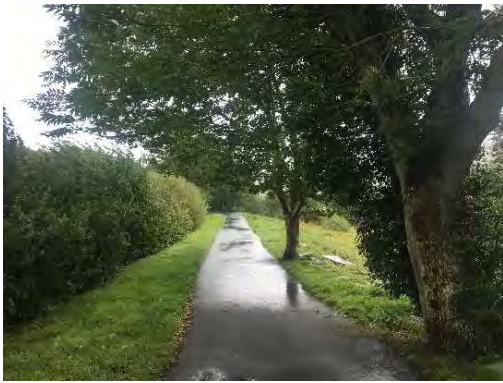
Y Bala Rhif 4 (pumping station to Tegid Street) Path Gradient: >1:60 for most, if not all the route	BARM recommends that step levels should not exceed 15mm, anything greater than this is likely to be a trip hazard.	Llyn Tegid Reservoir Safety project to remove step levels greater than 15mm during footpath reinstatement.

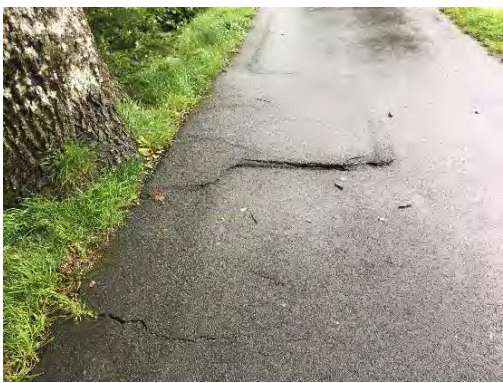
Surface material: Tarmac. Several step levels exceed 15mm along the footpath (particularly in this section) where irregular surfaces have arisen due to issues below the tarmac footpath surface. There are areas where this also affects the crossfall of this footpath.  No seating (total length of route is 500m)  No litter bins.  No directional signage.  Several trees along this section have self-seeded adjacent to the footpath and overhang so that there is less than 2.1m (height) clear walking tunnel for pedestrians.	BARM also recommends that a 'clear walking tunnel' be maintained throughout an access route of 2.1m high and 1m wide (although it does state that priority should be eye level and spikey vegetation, this is neither).  BARM recommends the maximum distance between resting spaces in 300m. BS 8300 recommends that seating should be located such that it and its users do not reduce the access route width below 1.8m when in use by a variety of people.	Opportunity to rectify issue of clear walking tunnel as part of the Reservoir Safety Scheme, removal of trees that have self-seeded on the embankment is required to enable works. Management to ensure that any self-seeded trees are not left to establish on the embankment following works will help to prevent this issue from reoccurring in the future.  Consider addition of accessible seating along this route as part of Llyn Tegid Reservoir Safety project enhancements, ensuring this doesn't reduce the access route width to below 1.8m in parts, which will in turn reduce compliance with BS 8300.

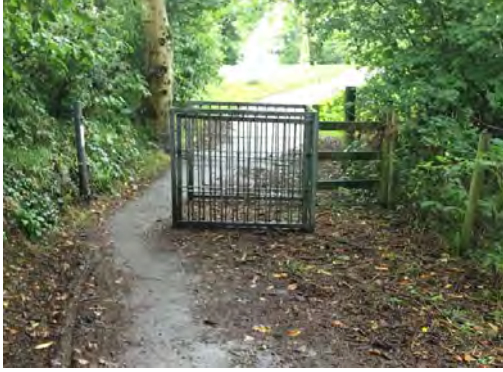
Access control and ramped connection from Y Bala Rhif 4 on to Y Bala Rhif 5 - adjacent to Rugby Club. Route of proposed Bala Railway extension.	Access control barrier does not comply with recommendations set out in BS 8300 (2-way self-closing gates may be used, but not revolving gates, turnstiles, kissing gates or A-frame barriers) or BARM (no steps, or stiles or other physical barriers restricting access).	Subject to landowner consent, Llyn Tegid Reservoir Safety project to improve accessibility. Preference would be to remove access barrier (assuming not required for stock control). Alternatively, consider replacement with a two-way opening, self-closing gate that complies with recommendations of BS 8300, (but will not prevent access of unauthorised vehicles such as motorbikes).
		Access control barrier: Steel chicane (broken, swinging gate has come off hinges and been left propped up against remaining fences). If functional it would be approx. 1200mm x 1200mm, two-way opening, not self-closing (same as in R4/01).  Ramp: gradient c. 1:13, length c. 21m, rise c. 1.6m, width c. 1.2-2.4m. No handrails. No level landings.	The ramp does not comply with recommendations of BS 8300, maximum recommended gradient for this rise is 1:20. Ramp requires level landings for every 500mm rise / 10m going, two handrails and a minimum width of 1.5m.	Llyn Tegid Reservoir Safety project to re-create ramp with improved compliance to BS 8300 recommendations, including gradient, level landings and a minimum width of 1.5m throughout.

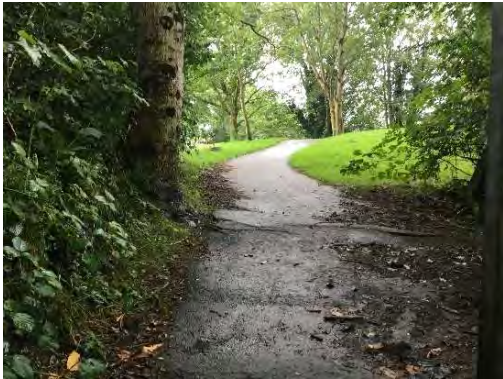
<p>Surface material: Tarmac. Exposed roots have created breaks and an uneven surface with a step level &gt;15mm. Area is shaded, lots of leaf litter and debris build up behind the gate makes the surface slippery.</p> <p>No seating.</p> <p>No litter bins.</p> <p>No directional signage indicating this route is also a public right of way. It would be useful here as there is also a gate leading down into the rugby club (not PRow).</p>	<p>BARM recommends path surfaces be level, step levels should not exceed 15mm.</p>	<p>Llyn Tegid Reservoir Safety project to ensure removal of any step levels greater than 15mm will increase compliance, as other than these areas of raised tarmac, surfacing appears compliant.</p>
R4/19

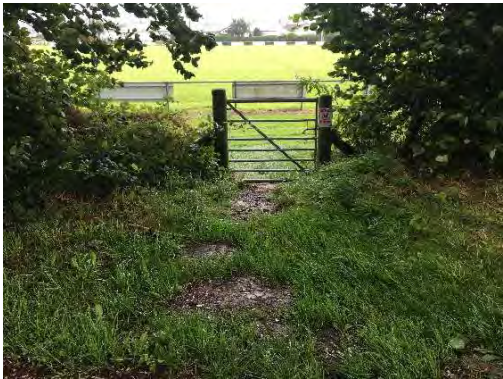
<p>Ramped connection from Y Bala Rhif 4 to the rugby club grounds (not PRow)</p> <p>Access control barrier: Steel field gate, 1.2m wide, one-way opening. Gate not normally used for public access, however is used to go and fetch balls when kicked out of Rugby ground. Also used as an access to the embankments generally when the rugby club grounds are used for parking/ camping during big events (e.g. Bala Big Bash).</p> <p>Ramp gradient: c. 1:10; length c. 4m; rise c. 0.4m; width c. 0.5m – 1.0m. No handrails. No level landings.</p> <p>Surface material: Unsurfaced, combination of grass and bare earth.</p> <p>No seating. No litter bins. No signage.</p>	<p>BARM recommends path surfaces be 'hard and firm with very few loose stones (no bigger than 10mm)' and that 'the ideal is non-slip, well-drained, level path'. BS 8300 recommends 'an access route should have a firm, slip-resistant and reasonably smooth surface. Cobbles, bare earth, sand and unbonded gravel should not be used'.</p> <p>Access control barrier does not comply with recommendations set out in BS 8300 (2-way self-closing gates may be used, but not revolving gates, turnstiles, kissing gates or A-frame barriers) or BARM (no steps, or stiles or other physical barriers restricting access).</p>	<p>Retain gate, but no access improvements proposed, as gate is rarely used and normally locked.</p>

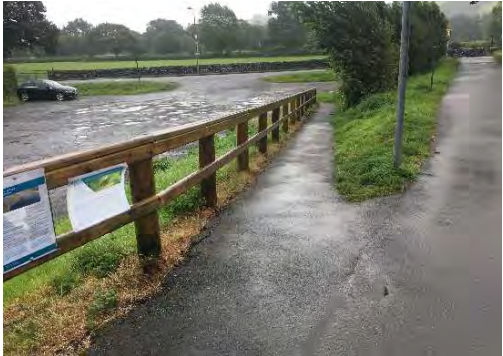
<p>Ramped footpath connection between Y Bala Rhif 4 and rugby club car park.</p> <p>No access control barrier.</p> <p>Ramp gradient: c. 1:13; length c. 25m; rise c. 1.9m; width: 1.0m – 1.1m. One handrail provided, no level landings.</p> <p>Surface material: Tarmac. No step levels &gt;15mm noted. Evidence of path edging remains in parts but has disintegrated for much of the route and is</p>	<p>Ramp does not comply with recommendations of BS 8300 (maximum recommended gradient 1:20 for this rise). Ramp requires level landings for every 500mm rise / 10m going, two handrails, and a minimum width of 1.5m.</p> <p>This is one of the access points onto Y Bala Rhif 4 that is uncontrolled, being directly connected to one of the well-used car parks in the area. Currently there is no known issue with unauthorised access from this</p>	<p>Review need for this access to car park. Either reinstate like for like or consider removal of this access.</p>

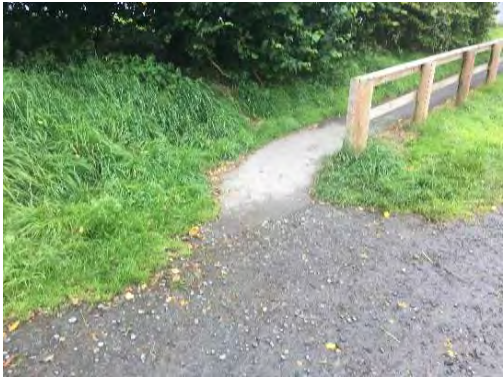
<p>therefore inconsistent. Tarmac surfacing ends at base of ramp leading onto gravel car park (with loose stones &gt; 10mm) with several large potholes.</p> <p>No seating.</p> <p>Bin provided at base of ramp in rugby club car park, not accessible from this route due to surface material of car park.</p> <p>No directional signage at this point, there is a signpost here that could be adapted to include directional information.</p>	<p>connection, access appears to generally be for vehicular loading.</p> <p>BS 8300 recommends pedestrian paths have a detectable demarcation which can be followed by people who are blind or partially sighted, for example a wall, building line, kerb edge, grass verge, barrier, or clearly detectable change in texture.</p> <p>BS 8300 recommends that information and signage should be located where it is clearly identifiable and visible from all directions, signage should reaffirm directions on a route that continues over a long distance or at changes in direction.</p>	<p>Construct all tarmac paths with consistent edging (with no upstands) to ensure robust construction; contrast between grass and tarmac is sufficient for demarcation.</p> <p>Llyn Tegid Reservoir Safety project to provide directional fingerpost signage (or adapt what is already there) confirming direction of the lake, leisure centre, Bala Town centre to aid people who may join Y Bala Rhif 4 at this point via the ramp.</p>

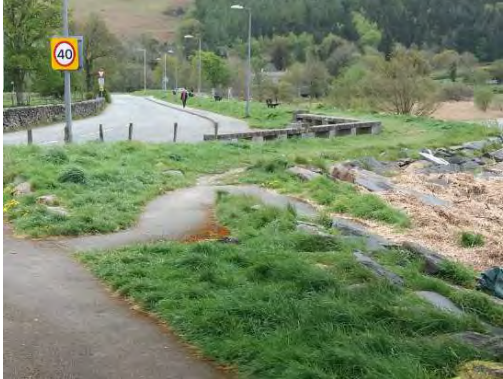
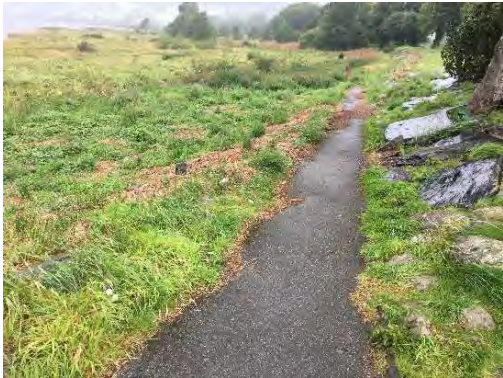
<p>Ramped footpath connection between Y Bala Rhif 4 and lake foreshore path leading back to the lakeside car park.</p> <p>Ramp gradient: At steepest c. 1:10 (gradient varies along ramp); total length c. 55m; total rise c. 2.5m; width 0.5m– 1.2m. No level landings. No handrails.</p> <p>Surface material: Tarmac. Evidence of path edging remains in parts but has disintegrated for much of the route and is therefore inconsistent. Tarmac surfacing ends at base of ramp leading onto exposed earth path. Path is undulating and uneven, no step levels &gt;15mm noted.</p> <p>No seating.</p> <p>No litter bins.</p> <p>No directional signage.</p> <p>Ramp apparently used during Bala Triathlon.</p>	<p>Ramp does not comply with recommendations of BS 8300. Ramp gradient varies over the full length but much of the fall takes place over 10m (it is approx. 1:13 here) making it steeper than the recommended gradient of 1:20 for this rise. Ramp also requires level landings for every 500mm rise / 10m going, two handrails and a minimum width of 1.5m.</p> <p>BS 8300 recommends pedestrian paths have a detectable demarcation which can be followed by people who are blind or partially sighted, for example a wall, building line, kerb edge, grass verge, barrier, or clearly detectable change in texture.</p>	<p>Llyn Tegid Reservoir Safety project to maintain / re-create access to lake foreshore but relocated slightly to the west, so that the Bala railway crosses just one path here rather than two. Aim retain or improve on ramp gradient and width if possible, but full handrailing/ landings/ slack gradients etc are not justified in context of linked paths.</p> <p>Construct all tarmac paths with consistent edging (with no upstands) to ensure robust construction; contrast between grass and tarmac is sufficient for demarcation</p>

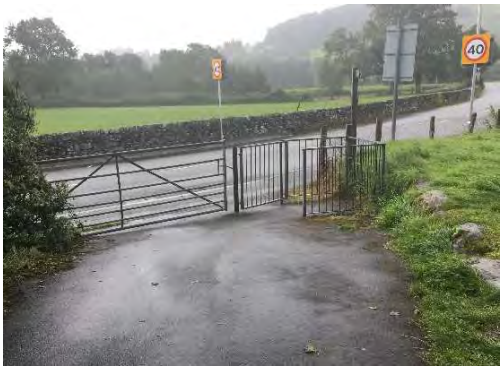
<p>Access onto Y Bala Rhif 4 from Tegid Street adjacent Rugby Club.</p> <p>Access control barrier (vehicular): Steel field gate (locking mechanism broken, being held shut with a stick), 2m wide, two-way opening.</p> <p>Access control barrier (pedestrian): Steel chicane 'kissing gate', 1.1m wide, two-way opening, not self-closing.</p> <p>Path gradient: Generally, c. 1:19 (steep section adjacent gate c. 1:8); length c. 15m; total rise c. 0.8m; width c. 2.0m – 4.5m.</p> <p>Surface material: Tarmac. Generally even surface, no step levels &gt;15mm noted. Dropped kerbs between Tegid Street to Y Bala Rhif 4. Route opens out onto busy road, no blister paving present.</p> <p>Seating / resting place 10m from here (see TS/01).</p> <p>No litter bins.</p> <p>Timber finger post sign directs users onto Y Bala Rhif 4 and towards Y Bala Rhif 1 from Tegid Street.</p>	<p>Access control barrier does not comply with recommendations set out in BS 8300 (2-way self-closing gates may be used, but not revolving gates, turnstiles, kissing gates or A-frame barriers) or BARM (no steps, or stiles or other physical barriers restricting access).</p> <p>Ramp does not comply with recommendations of BS 8300 (maximum recommended gradient for this rise is 1:20). Ramp requires level landings for every 500mm rise / 10m going, and two handrails.</p> <p>No specific requirement or recommendation found in BARM or BS 8300 about installing blister paving where there are dropped kerbs, BS 8300 states that this is where it is commonly used to warn people who are blind or partially sighted of proximity to the crossing points</p>	<p>Llyn Tegid Reservoir Safety project to reconstruct path at junction with Tegid Street. To include barrier set short distance back from (busy) road. Need to maintain controlled vehicular access at this point.</p> <p>Llyn Tegid Reservoir Safety project to regrade footpath to a gradient less steep than 1:20, so it becomes a 'gentle slope' rather than a ramp.</p> <p>Consider the addition of blister paving as the PRow opens out onto a busy road and an uncontrolled crossing point. Further discussion with GCC Highways required to agree specs.</p>

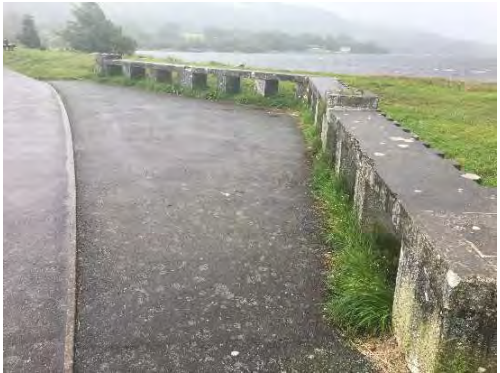
<p>Tegid Street bandstand.</p> <p>Path gradient: &gt;1:60 on main footpath, behind bandstand embankment gradient c. 1:6.</p> <p>Surface materials: Tarmac (grassed embankment behind). Surface is generally even along footpath and tarmac inlet, no step levels &gt;15mm noted.</p> <p>Seating / resting place: One long concrete structure with low-raised planters (two planters missing, there should be four). Height c. 600-800mm. Picturesque views of the Lake here, however seating is only accessible from roadside, not from lakeside due to embankment.</p>	<p>BS 8300 recommends that appropriate accessible space should be allowed for wheelchair users to be integrated within the general seating provision, and a choice of seating options should be provided for a variety of users.</p> <p>Future extension of Bala railway is likely to result in removal of this seating area as it will be too close to the proposed track alignment.</p>	<p>Llyn Tegid Reservoir Safety project to create a new more accessible space with views of the lake, slightly north of the existing bandstand area. Area to include informative signage about the area and accessible seating that allows all users to sit and enjoy views of the lake.</p> <p>Ensure any proposals still allow this to function as a passing space, as footpath falls below minimum recommended width of 1.8m.</p>

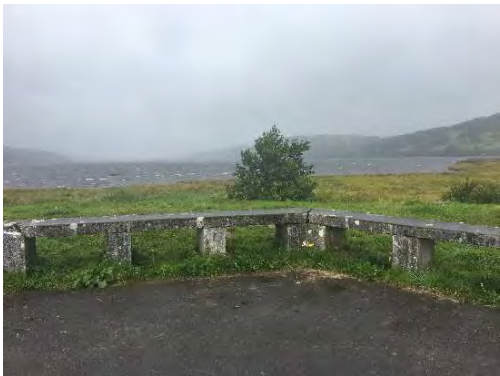
<p>No litter bins.</p> <p>No signage. Area may benefit from an information signage (history of bandstand, info about lake?) if this area was to be enhanced (ample directional signage before and after, this probably isn't needed here).</p>		
TS/02

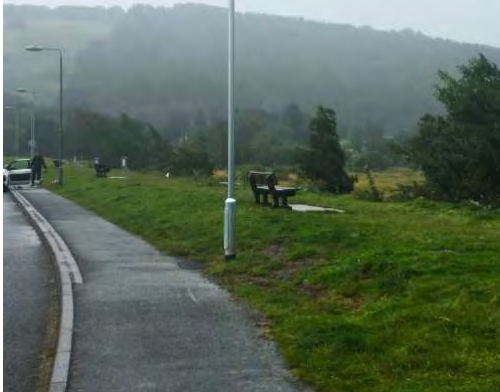
<p>Tegid street and B4391 footpath (connecting route between Y Bala Rhif 4 and Y Bala Rhif 1)</p> <p>Path gradient: &gt;1:60 for most, if not all of route.</p> <p>Path width: 1.2m – 1.5m</p> <p>Embankment gradient: c. 1:4 (no path provided to access seating located on here).</p> <p>Surface material: Tarmac footpath. Embankment is unsurfaced (grass and in some cases bare earth), uneven and inaccessible.</p> <p>Set of 4 benches on top of the embankment crest give picturesque views across Llyn Tegid but they are not accessible. Seating sits on concrete platforms within the embankment crest.</p> <p>No litter bins.</p> <p>There is directional signage at the bottom of Tegid Street, where it meets B4391, directing users to Y Bala Rhif 1 (and towards Y Bala Rhif 4 if approaching from the other direction).</p>	<p>BS 8300 recommends minimum path width be 1.8m (although a minimum of 2m is preferred). Where the surface width of an access route is less than 1.8m, passing places should be provided to allow two wheelchair users to pass each other. BARM recommends at least 1.2m path width for urban / formal landscapes.</p> <p>BS 8300 recommends that appropriate accessible space should be allowed for wheelchair users to be integrated within the general seating provision, and a choice of seating options should be provided for a variety of users.</p> <p>Future extension of Bala Railway along this embankment crest will remove opportunity for seating; the Reservoir Safety Project will install some of track bed here which will have some visual impact but not affect access.</p>	<p>Opportunity to widen the footpath to 1.8m is not a feasible option as it is located on a highway; no scope for increasing width as would impact on embankment .</p> <p>Existing benches not to be replaced here due to Bala railway project, and risk of damage to railway channel if seats needed to be removed in the future. Loss of seating here mitigated by creation of new high quality seating area (as TS/01), option to relocate these benches elsewhere within the community.</p>

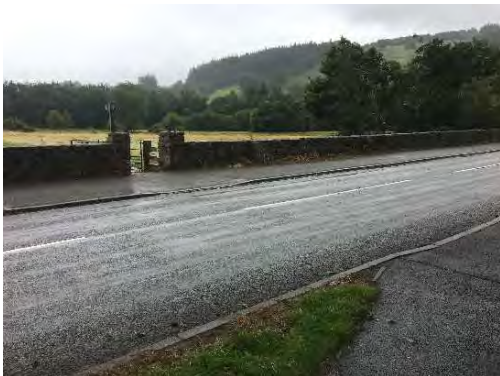
<p>Access onto Y Bala Rhif 1 from B4391</p> <p>Path gradient: &gt;1:60 for most of route. Slight gradient increase where dropped kerbs have been put in place to facilitate access to Y Bala Rhif 1 from B4391.</p> <p>Path width: c. 1.2m – 1.4m</p>	<p>No specific requirement or recommendation found in BARM or BS 8300 about installing blister paving where there are dropped kerbs, BS 83000 states that this is where it is commonly used to warn people who are blind or partially sighted of proximity to the crossing points.</p>	<p>The addition of blister paving at this uncontrolled crossing point would be good practice, as Y Bala Rhif 1 is the most accessible route within the survey area and there is no way to avoid crossing this road if accessing it from Y Bala Rhif 4.</p> <p>The Bala railway extension plan includes for a pelican crossing in this location that would almost certainly include blister paving; the Llyn Tegid Reservoir Safety project is</p>

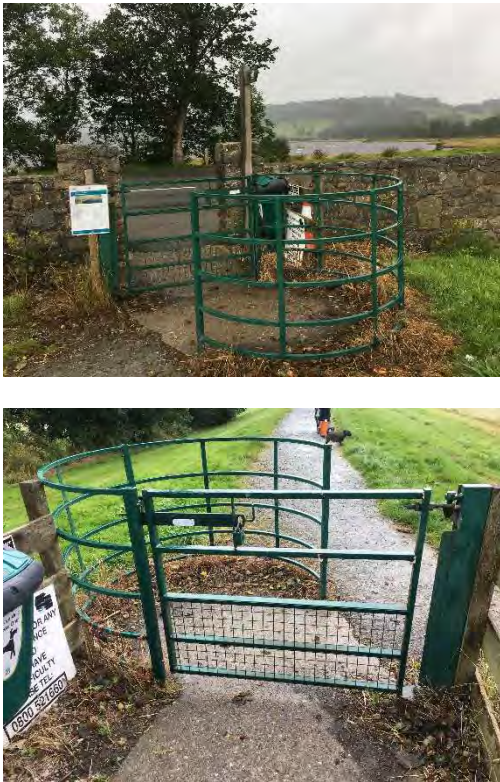
<p>Ramped access and access control (entrance from B4391).</p> <p>Access control barrier: Curved metal 'kissing gate' with RADAR bypass. Self-closing, opens both ways, has 'radar key' padlock system to allow wheelchair users to open fully outwards from either side and move straight through. c. 1.2m wide.</p> <p>Path gradient (footpath to barrier): c. 1:7; length c. 1.4m; rise c. 0.18m; width c. 1.2m.</p> <p>Surface material: Tarmac, concrete and bound stone. Tarmac footpath to concrete is a smooth, even surface, no step level. Stone path behind gate sits slightly lower than the concrete foundation for gate, step level &gt;15mm where two surfaces meet.</p> <p>No seating.</p> <p>Dog waste bin provided. Accessible, not within boundary of access route.</p> <p>Timber finger post sign and dog litter bin provided here.</p> <p>Footpath on crest of embankment was surfaced with unbound stone approx. 15 years ago (formerly grass), to improve DDA standards.</p>	<p>BARM recommends path surfaces have very few loose stones, and none bigger than 10mm. BS 8300 recommends unbonded gravel should not be used.</p> <p>BARM recommends that any changes in surface should not result in step levels greater than 15mm to avoid creating a trip hazard.</p> <p>Ramp does not comply with recommendations of BS 8300, in which the maximum recommended gradient for this rise is 1:12, requiring level landings for every 500mm rise and 10m going, two handrails, and a minimum width of 1.5m. BARM guidance recommends that the steepest gradient be 1:10, no preferred width is given, but minimum path width recommended is 1m.</p>	<p>Llyn Tegid Reservoir Safety project to resurface this footpath in tarmac.</p> <p>Also remove RADAR by-pass curved kissing gate and replace with 2-way opening self-closing gate set into the footpath sufficiently to avoid it opening across the footway of the B4391 – idea supported by GCC PROW.</p> <p>Llyn Tegid Reservoir Safety project to remove step level during resurfacing (above) by ensuring joint where surface materials meet is flush.</p> <p>Llyn Tegid Reservoir Safety project to regrade this ramp, to increase compliance with BS 8300 at this location.</p>

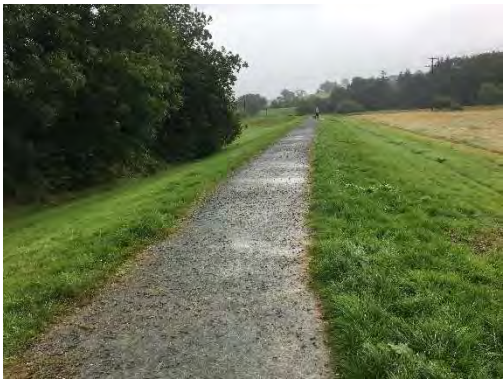
<p>Y Bala Rhif 1 (Tegid Street to Bala Industrial Estate access road, approx. 800m)</p> <p>Path gradient: less than 1:60 for most, if not all the route. Some uneven points along path in which puddles gather during rainfall. No notable step level changes, clear walking tunnel throughout.</p> <p>Path width c. 1.5m – 2.0m</p> <p>Surface material: Footpath appears to have been surfaced in bound stone material, however large loose stones (&gt;10mm) are all along the route, this is likely to be uncomfortable or cause difficulty for those with reduced mobility or wheelchair users.</p> <p>Seating provided (see below – R1/02)</p> <p>No litter bins along this route.</p> <p>No signage noted along the route (it is one straight path with no junctions, directional signage probably unnecessary). Information signage (about Tryweryn, weir, sluice gates?) may add interest.</p>	<p>BARM recommends path surfaces have very few loose stones (none bigger than 10mm). BS 8300 recommends unbonded gravel should not be used, footpath should be reasonably level.</p> <p>BS 8300 recommends minimum path width be 1.8m (although a minimum of 2m is preferred), BARM recommends at least 1m path width.</p>	<p>Llyn Tegid Reservoir Safety project to resurface this footpath in tarmac. Opportunity to level out the path during resurfacing to ensure effective drainage will improve compliance with BS 8300, as it reduces the risk of surface water forming puddles and freezing.</p> <p>Llyn Tegid Reservoir Safety project to widen this footpath as part of resurfacing works, it is likely that grass has grown over path edges and reduced width in places, plenty of scope to widen to 2m throughout.</p> <p>Provide ramped access down to riverside (for vehicular maintenance access and public interest).</p>

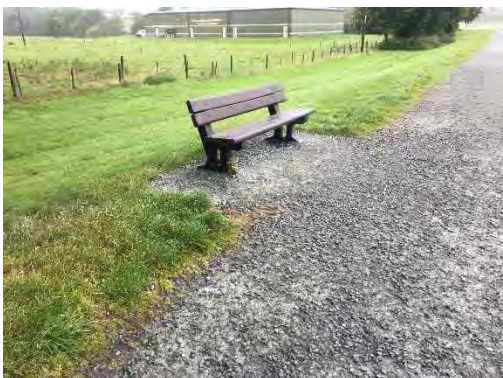
<p>Bench along Y Bala Rhif 1</p> <p>Path gradient: As above (see R1/02)</p> <p>Path width: As above (see R1/02)</p> <p>Surface material: As above (see R1/02)</p> <p>Seating provided (one bench) on hard surface extended from the footpath (no other resting places provided within 300m of this one). Significantly more large loose stones are scattered around the bench than on the footpath, creating an uneven surface, bench does not reduce the access route width.</p>	<p>BARM recommends the maximum distance between resting spaces in 300m. BS 8300 recommends that seating should be no more than 50m apart for those with limited mobility.</p> <p>Given the level of use of this footpath seating every 50m would be excessive, though the area would benefit from addition of more seating.</p>	<p>Currently there is a large stretch of path with no benches / resting spaces; suggest re-using one of the benches from Tegid Street (TS02).</p> <p>Llyn Tegid Reservoir Safety project to provide new feature bench and interpretation at triangular meadow area (also along this stretch of PRow).</p>

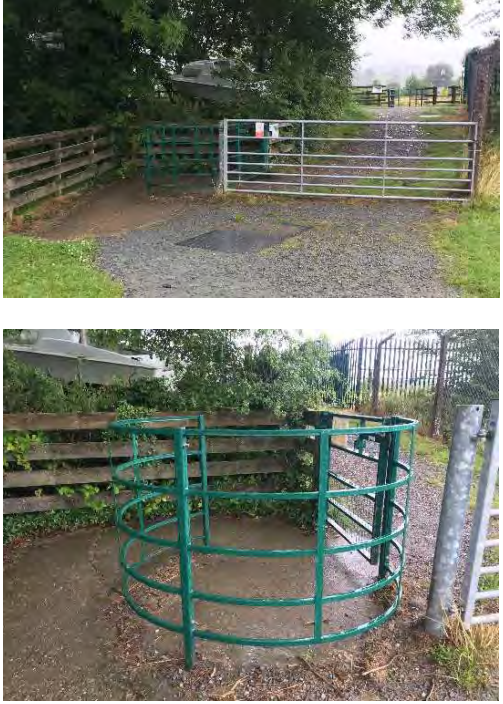
<p>Access control along Y Bala Rhif 1 (south of Bala Industrial Estate access road)</p> <p>Access control barrier (pedestrian): Curved metal 'kissing gate' with RADAR bypass. Self-closing, opens both ways, has 'radar key' padlock system to allow wheelchair users to open fully outwards from either side and move straight through. c. 1.2m wide.</p> <p>Access control barrier (vehicular): Steel field gate 2m wide. Opens one-way, presumed vehicular maintenance access gate.</p> <p>Path gradient (access road down to access control barrier): c. 1:10; length c. 10m; rise c. 1m; width c. 1.5m – 2.0m. No level landings. No handrails.</p> <p>Surface material: Gate foundations are concrete. Path is bound stone surface with loose stones &gt;10mm and exposed bare earth, some small step level changes where surface materials change and have worn but none appear to be &gt;15mm.</p> <p>Some vegetation appears to overhang below 2.1m and reduce width of path to less than 1m in parts.</p>	<p>Ramp does not comply with recommendations of BS 8300, in which the maximum recommended gradient is 1:20 for this rise. Ramps require level landings for every 500mm rise and 10m going, and two handrails. BARM guidance recommends that the steepest gradient be 1:10 for this type of access route.</p> <p>BARM recommends path surfaces be firm with very few loose stones (none bigger than 10mm). BS 8300 recommends unbonded gravel should not be used.</p> <p>BARM recommends that 'clear walking tunnel' be maintained throughout an access route of 2.1m high and 1m wide.</p>	<p>Llyn Tegid Reservoir Safety project to remove both RADAR kissing gates here for more open access; also provide surfacing and gradient improvements (no handrails and landings). Consider maintaining vehicular access with removable wooden bollards rather than a gate. This is the dead-end of an industrial estate road, with only through traffic being NRW to sluices. These vehicles stop here anyway to access through electronic barriers so very low traffic risk.</p> <p>Llyn Tegid Reservoir Safety project to re-surface the ramp in tarmac to improve compliance with guidance.</p> <p>Removal of overhanging branches outside of scope of project, however NRW operations team to be mindful of this when developing maintenance plans.</p>

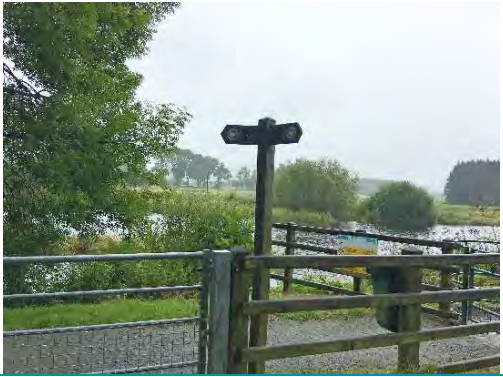
<p>No seating.</p> <p>Dog waste bin provided. Accessible, not within boundary of adjacent access route.</p> <p>Directional fingerpost signage visible to all users (inc. those joining Y Bala Rhif 4 at this point)</p>		
R1/06

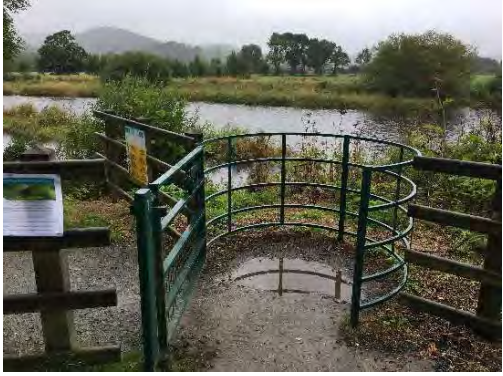
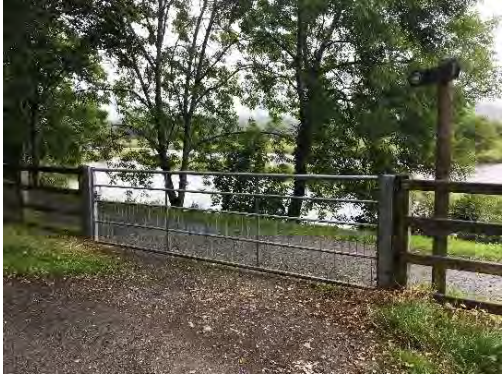
<p>Access onto Y Bala Rhif 1 (north of Bala Industrial Estate access road)</p> <p>Access control barrier (pedestrian): Curved metal 'kissing gate' with RADAR bypass. Self-closing, opens both ways, has 'radar key' padlock system to allow wheelchair users to open fully outwards from either side and move straight through. c. 1.2m wide.</p> <p>Access control barrier (vehicular): Steel field gate, 2m wide, two-way opening.</p> <p>Path gradient (from access road down to control barriers): c. 1:15; length c. 3m; rise c. 0.2m. No level landings. No handrails.</p> <p>Surface material: Gate foundation is concrete, slight gradient means that rainwater collects here, other than this the surface is even. Concrete ties in to bound stone footpath behind. Path to vehicular access gate is unsurfaced (bare earth / grass in parts). No step level &gt;15mm noted here.</p> <p>No seating.</p> <p>Dog waste bin provided (see R1/04).</p> <p>Directional signage provided (see R1/04).</p>	<p>Maximum recommended gradient for rise of 0.2m is 1:12.7 over 2.5m distance, gradient is compliant, but as it is a ramp it requires level landings for every 500mm rise and 10m going and two handrails. BARM guidance recommends that the steepest gradient be 1:10 for this type of access route and acknowledges that regular seating provides resting points, particularly to reduce impact of gradients and distances.</p> <p>BARM recommends path surfaces be hard and firm with very few loose stones (no bigger than 10mm). BS 8300 recommends unbonded gravel should not be used. Path surface should be level.</p>	<p>Addition of handrails at this location is outside scope of Llyn Tegid Reservoir Safety project.</p> <p>Llyn Tegid Reservoir Safety project to remove this gate altogether for more open access along with surfacing and gradient improvements. Consider maintaining vehicular access through provision of removable bollards rather than a gate.</p>

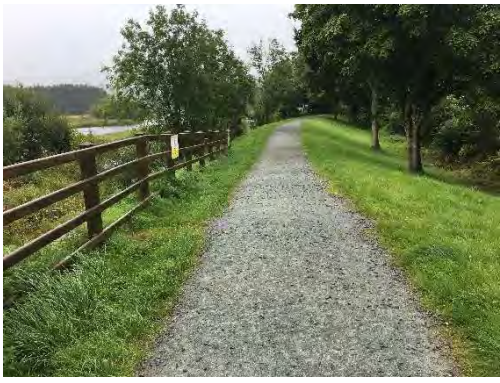
Y Bala Rhif 1 (500m, from Bala Industrial Estate access road to Station Road)  Path gradient: less than 1:60 for most of route. One ramp present along route (see R1/07).  Path width c. 1.5m – 2.0m	BARM recommends path surfaces be hard and firm with very few loose stones (no bigger than 10mm). BS 8300 recommends unbonded gravel should not be used.	Llyn Tegid Reservoir Safety project to resurface this footpath in tarmac.
