# Llyn Tegid Reservoir Safety Project

## Access Audit

Version: 3.0

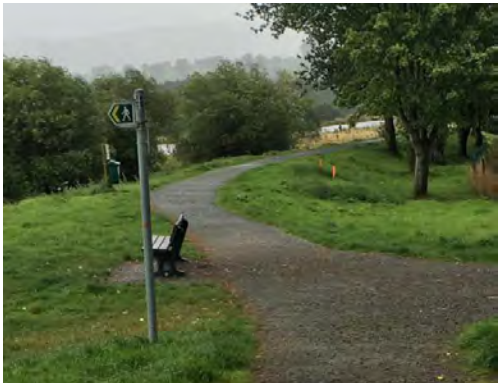
Surface material: Footpath appears to have been surfaced in bound stone material, however large loose stones (>10mm) are all along the route, this is likely to be uncomfortable or cause difficulty for those with reduced mobility or wheelchair users. No step levels >15mm noted. Clear walking tunnel throughout.  Seating provided (one bench) on hard surface extended from the footpath (no other resting places provided within 300m of this one).  Dog waste bin provided. Accessible, not within boundary of adjacent access route.  Directional signage provided near the end of the route indicating the three directions that are PRow from the four-way footpath junction (users can also join or terminate PRow through adjacent 'Green Car Park' here).	BS 8300 recommends minimum path width be 1.8m (although a minimum of 2m is preferred), BARM recommends at least 1m path width.	Widen footpath to 2m throughout route to improve compliance with BS 8300.

BARM recommends the maximum distance between resting spaces is 300m. BS 8300 recommends that seating should be located such that it and its users do not reduce the access route width below 1.8m when in use by a variety of people.	Llyn Tegid Reservoir Safety project to install recycled plastic benches at approximate location R1/07, currently there is a large stretch of path with no benches / resting spaces; suggest re-using one of the benches from Tegid Street (TS02).  Ensure addition of seating along this route does not reduce the access route width to below 1.8m or sit within the boundary of the access route (recommendations set out in BS 8300).
R1/08

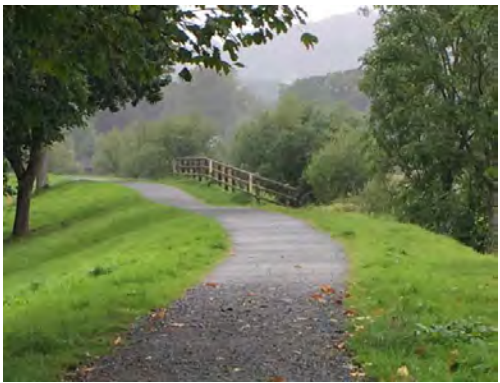
Ramp Y Bala Rhif 1  Path gradient: c. 1:25; length c. 12m; rise c. 0.5m; width c. 2.0m. No level landings.  Surface material: Bound stone with large loose stones (see R1/06). Even surface, no step levels >15mm noted.  See R1/06 for seating, litter bin and signage information.	BARM recommends path surfaces be hard and firm with very few loose stones (no bigger than 10mm). BS 8300 recommends unbonded gravel should not be used.	Llyn Tegid Reservoir Safety project to resurface this footpath in tarmac.

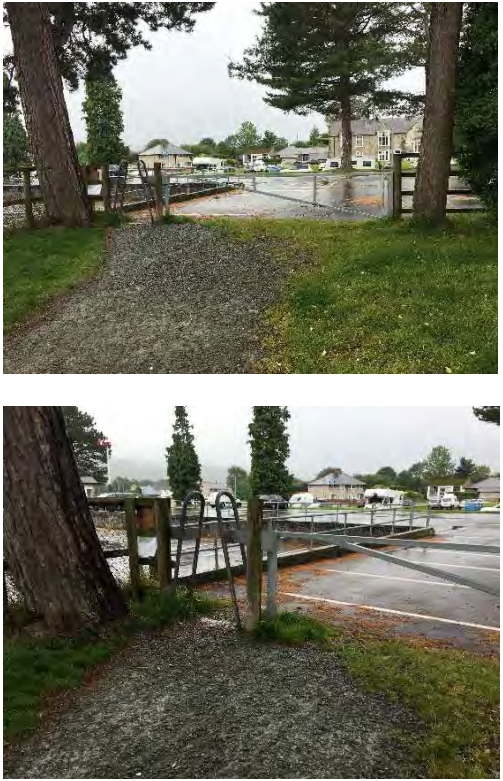
<p>Access onto Y Bala Rhif 1 from 'Green Car Park'</p> <p>Access control barrier (pedestrian): Steel 'K Barrier', base-gap width c.1m, top-gap width c. 300mm.</p> <p>Access control barrier (vehicular): Steel field gate 5m wide, presumed vehicular maintenance access gate.</p> <p>Path gradient: &gt;1:60, width c. 2.0m+</p> <p>Surfacing material: Bound stone surface with loose stones &gt;10mm. Some small step level changes where surface materials change and have worn but none appear to be &gt;15mm.</p> <p>See R1/06 for seating, litter bin and signage information.</p>	<p>Access control barrier does not comply with recommendations set out in BS 8300 (2-way self-closing gates may be used, but not revolving gates, turnstiles, kissing gates or A-frame barriers) or BARM (no steps, or stiles or other physical barriers restricting access).</p> <p>BARM recommends path surfaces should have very few loose stones (none greater than 10mm).</p>	<p>Llyn Tegid Reservoir Safety project to replace existing access gate with 2-way opening self-closing gate (not RADAR kissing gate - on suggestion from GCC PROW officer) but retain vehicular access gate in this location.</p> <p>Llyn Tegid Reservoir Safety project to resurface this footpath in tarmac.</p>

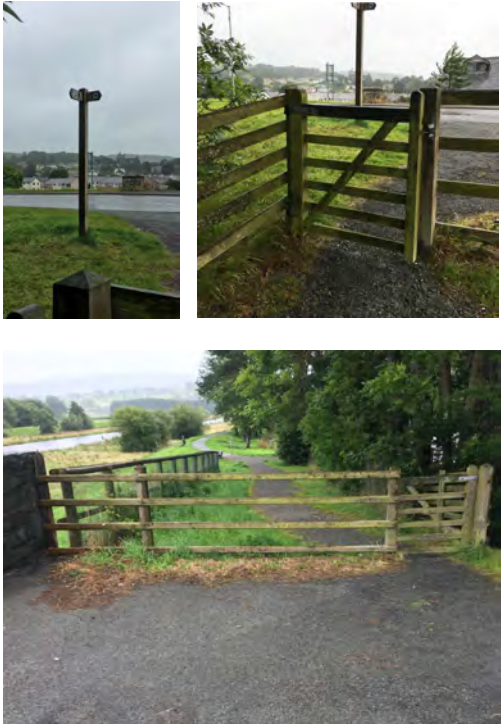
<p>Ramped footpath and access control (Station Road to Y Bala Rhif 1)</p> <p>Access Control Barrier: Timber field gate (broken, closing mechanism missing), 1.0m wide, not self-closing; one-way opening.</p> <p>Path gradient: Varies. c. 1:10 – 1:12, total length c. 40m; total rise c. 3.2; width 1.0m – 6.0m (steepest from Station Road to field gate).</p> <p>Surface material: Tarmac (Station Road to field gate) and bound stone surface with loose stones &gt;10mm below gate. Worn tarmac at top of ramp creates an uneven surface and step level changes &gt;15mm.</p> <p>See R1/06 for seating and litter bin information</p> <p>Directional signage on Station Road (and at base of ramp as described in R1/06).</p>	<p>Access control barrier does not comply with recommendations set out in BS 8300 (2-way self-closing gates may be used, but not revolving gates, turnstiles, kissing gates or A-frame barriers) or BARM (no steps, or stiles or other physical barriers restricting access).</p> <p>BARM recommends path surfaces should have very few loose stones (none greater than 10mm). BS 8300 recommends cobbles, bare earth, sand and unbonded gravel should not be used.</p>	<p>Llyn Tegid Reservoir Safety project to replace existing access gate with 2-way opening self-closing gate (not RADAR kissing gate - on suggestion from GCC PROW officer).</p> <p>Llyn Tegid Reservoir Safety project to resurface this footpath in tarmac.</p>

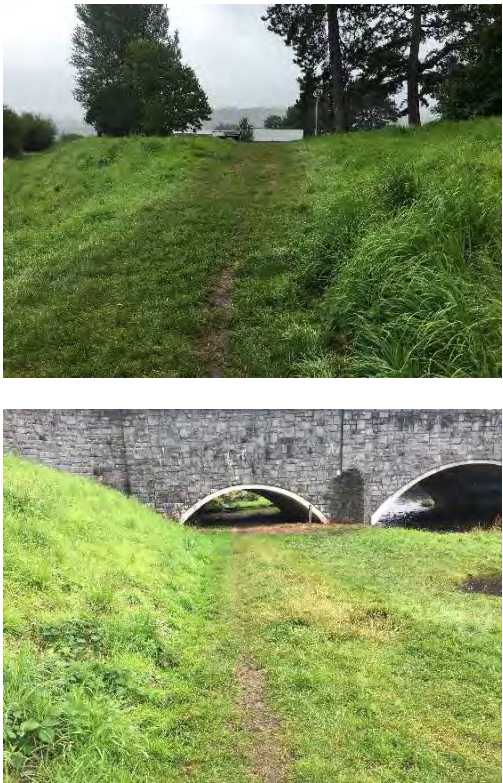
<p>Ramped access on to Y Bala Rhif 11 from Y Bala Rhif 1</p> <p>Path gradient: c 1:10; length c. 20m; rise c. 1.7; width c. 0.5m – 1.0m (no definitive path, just a desire line). No level landings. No handrails.</p> <p>Surface material: Unsurfaced grass and bare earth path, surface is uneven.</p> <p>No seating at base of ramp, bench at top as described in R1/06</p> <p>No litter bins.</p> <p>Directional signage in place at the bottom of the ramp</p> <p>It is likely anglers use this route to get down to the river bank and head back along the river (parallel to Y Bala Rhif 1), it is also an access route for a (NRW?) canoe / kayak egress point.</p>	<p>Ramp does not comply with recommendations of BS 8300, in which the maximum recommended gradient for this rise is 1:20, requiring level landings for every 500mm rise and 10m going, and two handrails. BARM guidance recommends that the steepest gradient be 1:10, no minimum ramp width is given, minimum path width recommended is 1m.</p> <p>BARM recommends path surfaces be non-slip, well-drained and level. BS 8300 recommends slip-resistant surface, bare earth should not be used.</p> <p>BS 8300 recommends minimum path width be 1.8m (although a minimum of 2m is preferred), BARM recommends at least 1m path width.</p>	<p>Opportunities to regrade the ramp, addition of handrails and level landings would be costly and considered impractical at this location due to distance available and nature of the rest of the footpath, they are considered outside the scope of the Llyn Tegid Reservoir Safety project.</p> <p>Opportunities for widening and resurfacing of this path considered outside the scope of the Llyn Tegid Reservoir Safety project.</p>

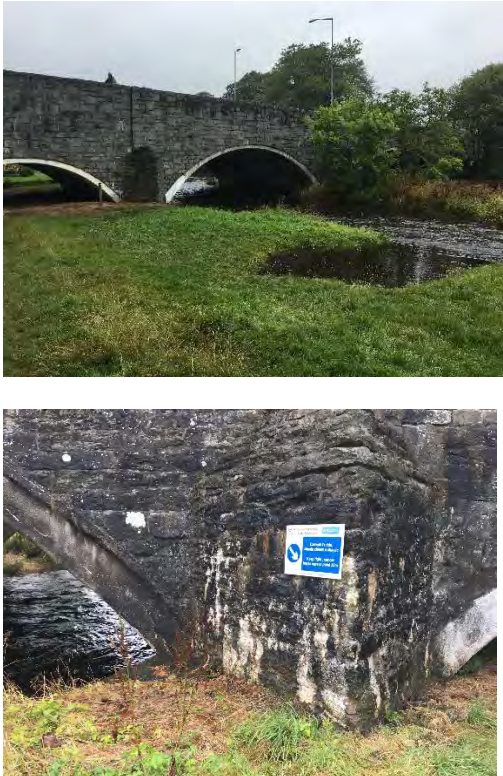
<p>Canoe / kayak egress point</p> <p>No apparent structure here, it appears to be a shallow cut out within the river bank.</p> <p>Car parking and amenities: 'Green Car Park' and adjoining public toilets located c. 50m from egress point.</p> <p>Access: See above (R11/01), not accessible.</p> <p>No seating or resting places at the canoe launch</p> <p>No directional signage for users from footpath, directional signage from river (other side of bridge).</p> <p>No informational signage about use of canoe launch or safety information.</p>	<p>No guidance for canoe access points is given in BS 8300 or BARM. EA publication 'Access for all' recommends inclusive canoe access, but also acknowledges that this is not always possible (particularly creating a fully accessible launch point).</p> <p>In this case, the route is not safe and accessible down to the launch point as recommended in available guidance.</p>	<p>Any works associated with this kayak launch point are considered outside the scope of the Llyn Tegid Reservoir Safety project.</p>

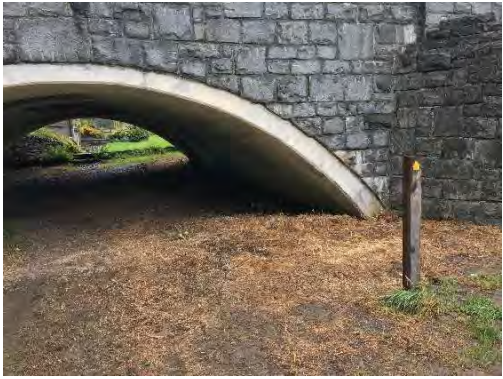
<p>Y Bala Rhif 11 (base of ramp to Tryweryn Terrace)</p> <p>Access control barrier: None.</p> <p>Path gradient: c. 1:20. No clear level landings.</p> <p>Surface material: Unsurfaced, bare earth footpath. Loose stone surface (&gt;10m) under bridge arch. Footpath informal and uneven, no step level &gt;15mm noted. Bridge arch restricts clear walking tunnel to less than 2.1m (vertically) clear of footpath. Nettles reduce clear walking tunnel to less than 1m (horizontally) at field gate.</p> <p>No seating provided.</p> <p>No litter bins.</p> <p>Directional waymarker signage is present throughout.</p>	<p>BARM recommends path surfaces be 'hard and firm with very few loose stones (no bigger than 10mm)' and that 'the ideal is non-slip, well-drained, level path'. BS 8300 recommends 'an access route should have a firm, slip-resistant and reasonably smooth surface. Cobbles, bare earth, sand and unbonded gravel should not be used'.</p> <p>BS 8300 recommends that where an access route has a gradient steeper than 1:60, but not as steep as 1:20, it should usually have a level landing for each 500 mm rise of the access route. On access routes with a gradient not steeper than 1:30, a level resting place adjacent to the route may be provided as an exception'</p>	<p>Opportunities for widening and resurfacing of this path considered outside the scope of the Llyn Tegid Reservoir Safety project.</p> <p>Opportunities to improve gradient / provide level landings considered outside the scope of the Llyn Tegid Reservoir Safety project</p>

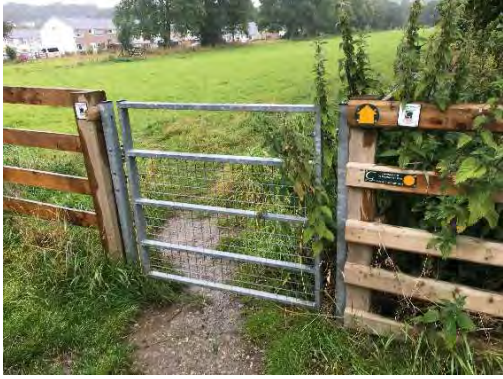
<p>Y Bala Rhif 11 access control</p> <p>Access control barrier (adjacent to Tryweryn Terrace): Steel field gate. 1.0m wide; self-closing; one way opening.</p> <p>Path gradient: c. 1:20. No clear level landings.</p> <p>Surface material: Unsurfaced, bare earth footpath.</p> <p>No seating provided.</p> <p>No litter bins.</p> <p>Directional waymarker signage present.</p>	<p>Access control barrier does not comply with recommendations set out in BS 8300 (2-way self-closing gates may be used, but not revolving gates, turnstiles, kissing gates or A-frame barriers) or BARM (no steps, or stiles or other physical barriers restricting access).</p>	<p>Removal of the access barrier altogether is unlikely to be an option in this area as the PRow runs through farmland; replacing the gate is considered outside the scope of the Llyn Tegid Reservoir Safety project.</p>

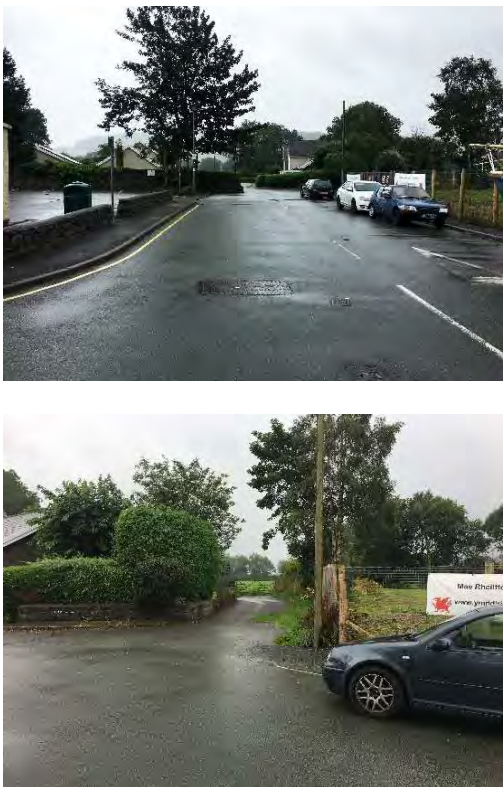
<p>Access onto Y Bala Rhif 5 from Aran Street</p> <p>Path gradient: &gt;1:60 for most, if not all of route. Dropped kerbs have been put in place from Plasey Street car park (and public toilets) and Aran Street. No significant step level changes noted.</p> <p>Path width: c. 1.5m - 4.0m.</p> <p>Surface material: Tarmac.</p> <p>No access control to prevent vehicular access, large field gate at the end of the track so may be used for farming vehicle access as well as footpath.</p> <p>Low wall enclosing the car park could be used as a resting / perching place, but no formal seating provided.</p> <p>Litter bin provided in Plasey Street car park.</p> <p>Fingerpost sign directs users down the path to the lake and leisure centre, and small sign attached to lamppost indicates public right of way. Entrance to a residential road may be mistaken for the public right of way here.</p>	<p>No issues, although addition of directional waymarker signage at the entrance to Y Bala Rhif 5 may make the route clearer to visitors.</p>

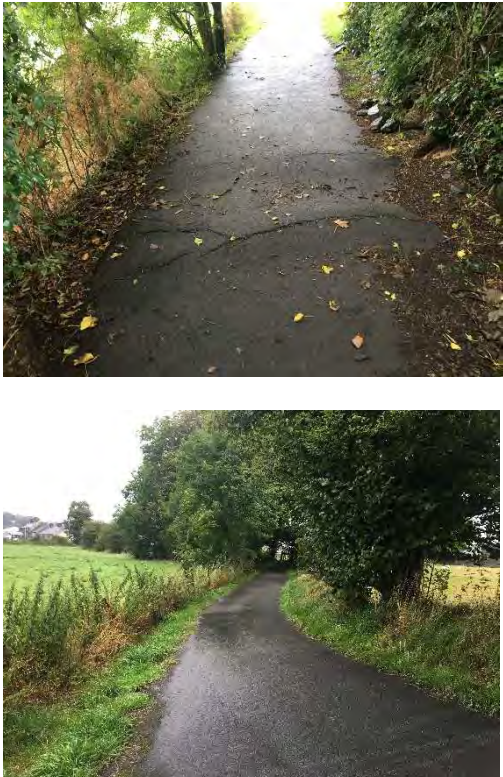
<p>Surface material: Tarmac surfaced. Uneven tarmac caused by root disturbance has led to step level changes &gt;15mm at some points.</p> <p>No access control until the end of the footpath, path is wide enough in parts for a small vehicle to drive down.</p> <p>No seating along this route (or within 150m either side of the starting points of this route).</p> <p>No litter bins.</p> <p>No signage noted along the route. There are two spurs off the route, one is also Y Bala Rhif 5 and one is not (see R5/03 and R5/04). Signage would be useful at these points to clarify direction of PRow.</p> <p>Some vegetation hangs low along this footpath (difficult to tell if it falls below 2.1m clear of the footpath).</p>	<p>BARM recommends the maximum distance between resting spaces in 300m. BS 8300 recommends that seating should be located such that it and its users do not reduce the access route width below 1.8m when in use by a variety of people.</p>	<p>This location is quite remote from the Llyn Tegid Reservoir Safety project, therefore no scope to deliver improvements.</p> <p>Suggestions below may be considered by GCC/ SNPA/ BTC as future opportunities.</p> <p>Additional seating / resting spaces along this route would improve compliance with BARM, although scope for this may be limited as path widths are relatively restricted, addition of seating along this route may reduce the access route width to below 1.8m in parts, which reduces compliance with BS 8300.</p>

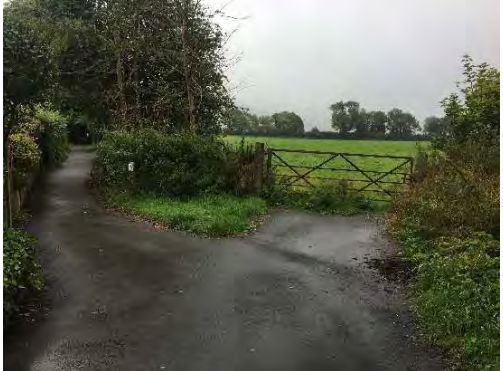
<p>Maintenance access gate off Y Bala Rhif 5. (Gate leads onto farmland, no public access)</p> <p>Access control barrier: Steel field gate. c. 3m wide, presumed vehicular maintenance access gate for farmland.</p> <p>Path gradient: c. 1:20 + (no topographic survey information for this area); length c. 2m; rise c. 0.1m, width c. 3m.</p> <p>Surface material: Path is tarmac surfaced as a continuation of Y Bala Rhif 4. No step level &gt;15mm noted.</p> <p>See R1/06 for seating, litter bin and signage information.</p>	<p><i>Access barrier is not continuation of Y Bala Rhif 5, and therefore not considered.</i></p> <p>BS 8300 recommends that signage reaffirm directions on a route that continues over a long distance or at changes in direction.</p>	<p>This location is quite remote from the Llyn Tegid Reservoir Safety project, therefore no scope to deliver improvements.</p> <p>Suggestions below may be considered by GCC/ SNPA/ BTC as future opportunities.</p> <p>Given that some Y Bala Rhif 5 does run through farmland, a directional waymarker sign would be useful here to confirm that the PRow continues to the left, and that there is no public access through this gate.</p>

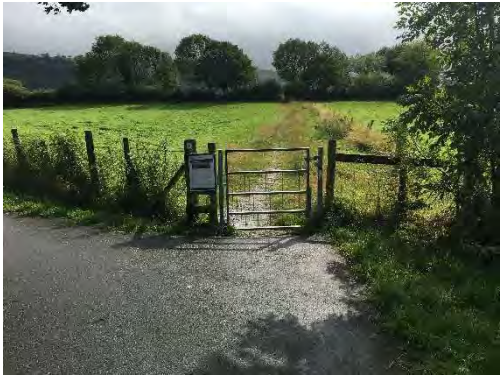
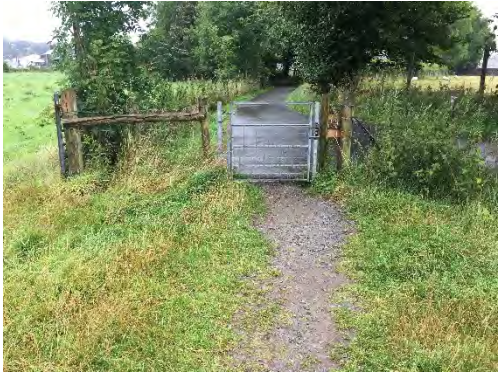
<p>Path gradient: c. 1:20 + (no topographic survey information for this area). Length c. 2m; width: c. 1.2m.</p> <p>Surface material: Tarmac to unsurfaced (bare earth / grass). Change in surface here creates a step level change &gt;15mm.</p> <p>No seating</p> <p>No litter bins</p> <p>No signage provided from Y Bala Rhif 5 (route A) to indicate that this also a PRoW. Signage would be useful at this point as spur route is much less formal than the rest of Y Bala Rhif 5 and provides the most direct route to Y Bala Rhif 4.</p>	<p>Change in height between surfaces creates a step level greater than 15mm, which is the recommended maximum set out in the BARM guidance.</p> <p>BS 8300 recommends that 'information and signage should be located where it is clearly identifiable and visible from all directions' and 'signage should reaffirm directions on a route that continues over a long distance or at changes in direction'</p>	<p>Opportunities to improve levels considered outside the scope of the Llyn Tegid Reservoir Safety project.</p> <p>Reservoir Safety project to provide addition of directional waymarker signage at this access control barrier to clarify that this route is also a PRoW, making the route clearer to users and improving compliance with BS 8300.</p>

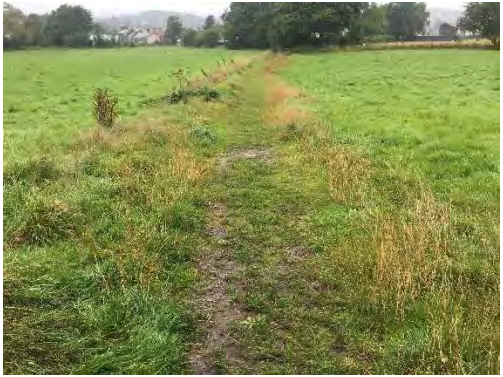
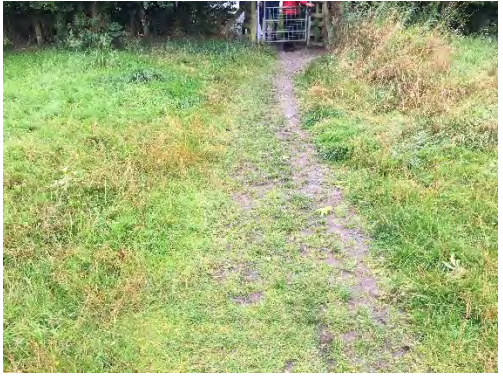
<p>Y Bala Rhif 5 (Route B)</p> <p>Path gradient: 1:20 - 1:60 for most, if not all the route (no topographical survey information for this area).</p> <p>Path width c. 0.5 – 1.0m (no definitive path width as it is grassland).</p> <p>Surface material: Unsurfaced (bare earth / grass), lack of formal surface makes the path very uneven in parts.</p> <p>No seating.</p> <p>No litter bins.</p> <p>No signage noted along the route, although it is present at the end of the path before joining Y Bala Rhif 4 (see R4/15).</p>	<p>BARM recommends path surfaces be 'hard and firm with very few loose stones' and that 'the ideal is non-slip, well-drained, level path'. BS 8300 recommends 'an access route should have a firm, slip-resistant and reasonably smooth surface. Cobbles, bare earth, sand and unbonded gravel should not be used'.</p> <p>BS 8300 recommends minimum path width be 1.8m (although a minimum of 2m is preferred), BARM recommends at least 1m path width.</p>	<p>Opportunities to improve surfacing considered outside the scope of the Llyn Tegid Reservoir Safety project.</p> <p>Opportunities to widen paths considered outside the scope of the Llyn Tegid Reservoir Safety project.</p>

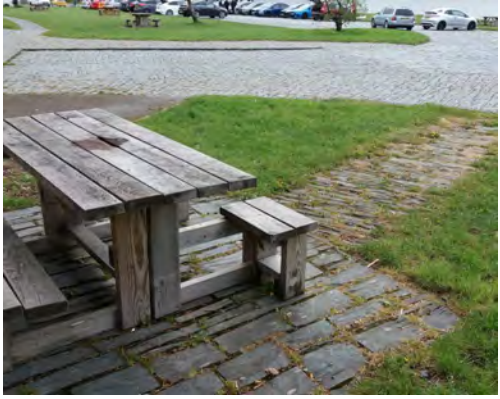
<p>Foreshore car park seating</p> <p>Nine benches noted in total, two are connected to the footpaths via small stone paved paths. Two dropped kerbs noted. Ramped access to both seating areas (c. 1:30 and &gt;1:60), width c. 1.8m.</p> <p>Grass between stone pavers and uneven slabs mean the surface isn't 'level' in parts, paving joints don't appear to comply with recommendations set out in guidance.</p>	<p>Access to seating is not compliant with BS 8300, 'where joints are filled but recessed below the surface, the difference in level between adjacent units should not be greater than 2mm, with joints not wider than 10mm and recess not deeper than 5mm'. BARM recommends path surfaces be 'hard and firm with very few loose stones' and that 'the ideal is non-slip, well-drained, level path'.</p>	<p>Opportunities to improve surfacing considered outside the scope of the Llyn Tegid Reservoir Safety project.</p>
