Condition Assessment using 2016 River Habitat Survey data and Common Standards Monitoring guidance for the Afon Teifi and Afon Eden – Cors Goch Trawsfynydd SACs

NRW Evidence Report No. 192

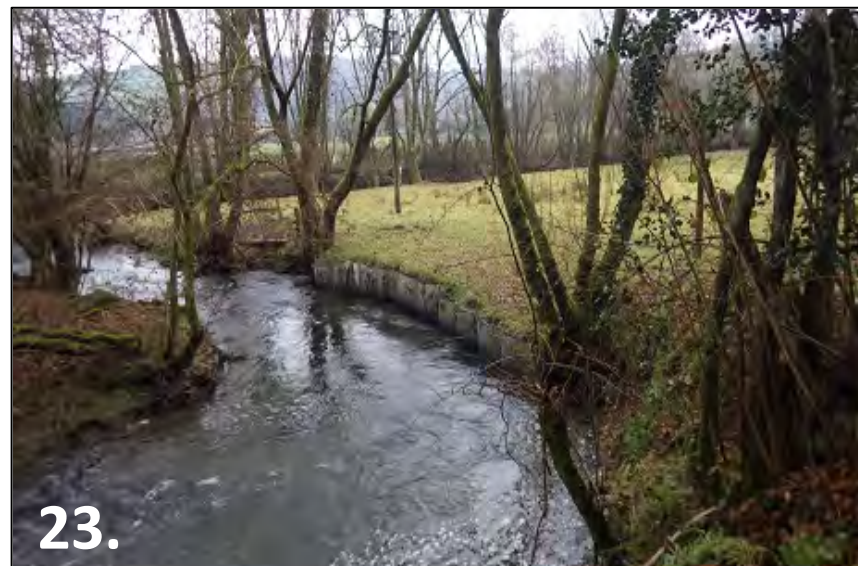
Image 23: Example of a gabion basket revetment (Site ID: 10583).

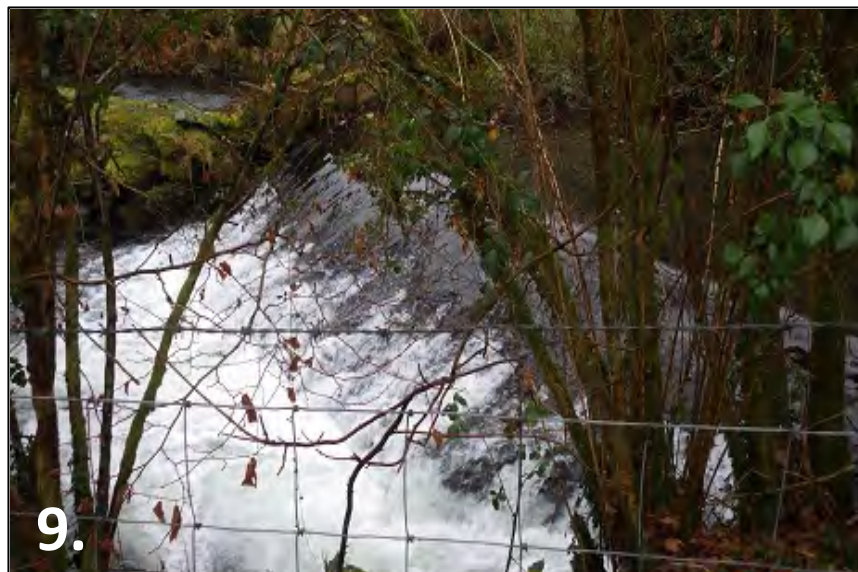
Image 9: Example of a weir on the Afon Clettwr (Site ID 10573)

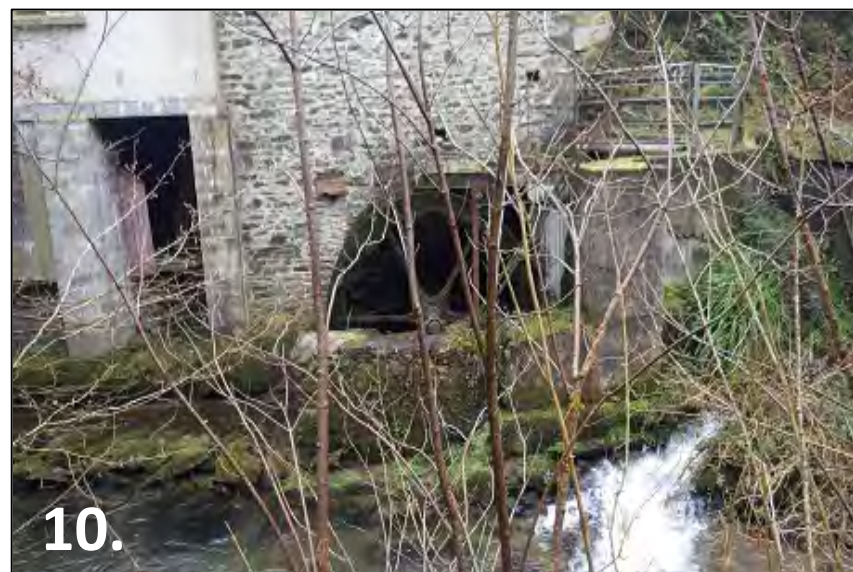
Image 10: An off-channel water wheel on the Afon Clettwr (Site ID 10573)

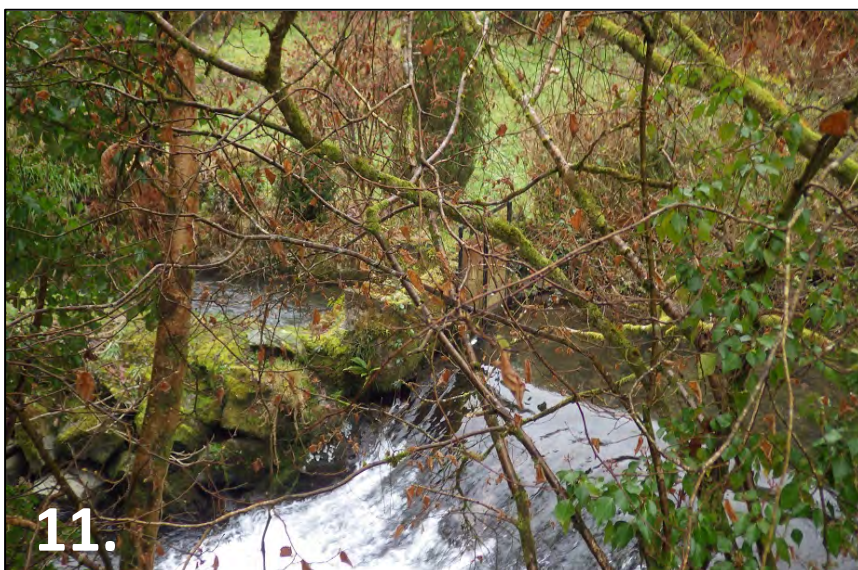
Image 11: A mill leat present above a weir on the Afon Clettwr (Site ID 10573)

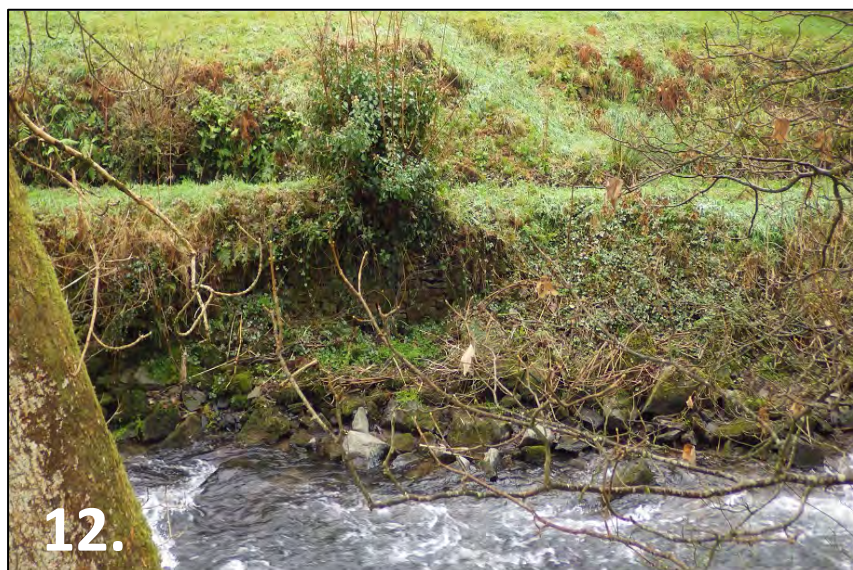
Image 12: A resectioned and reinforced section of the channel (Site ID 10573)

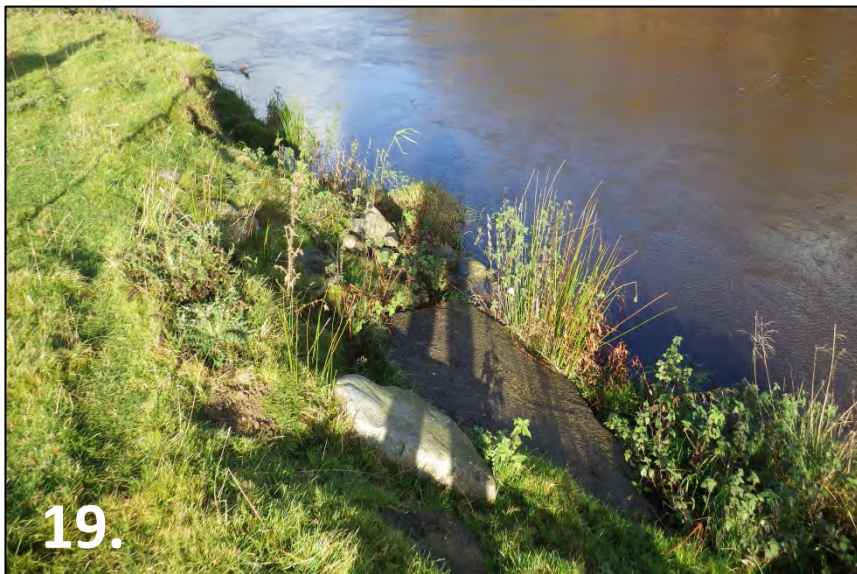
Image 19: Example of a section reinforced with boulders (Site ID 881)

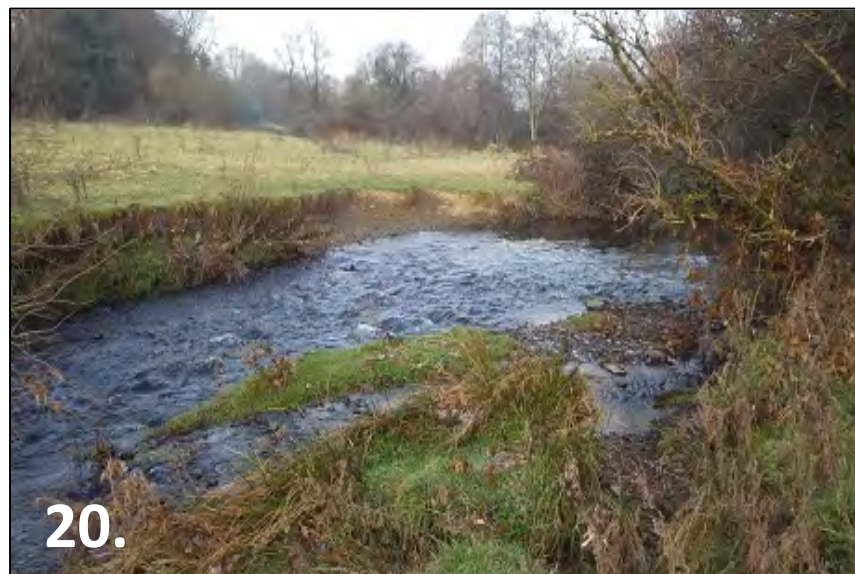
Image 20: Example of poaching by livestock (far bank), and a vegetated side-bar (near bank) (Site ID 10553)

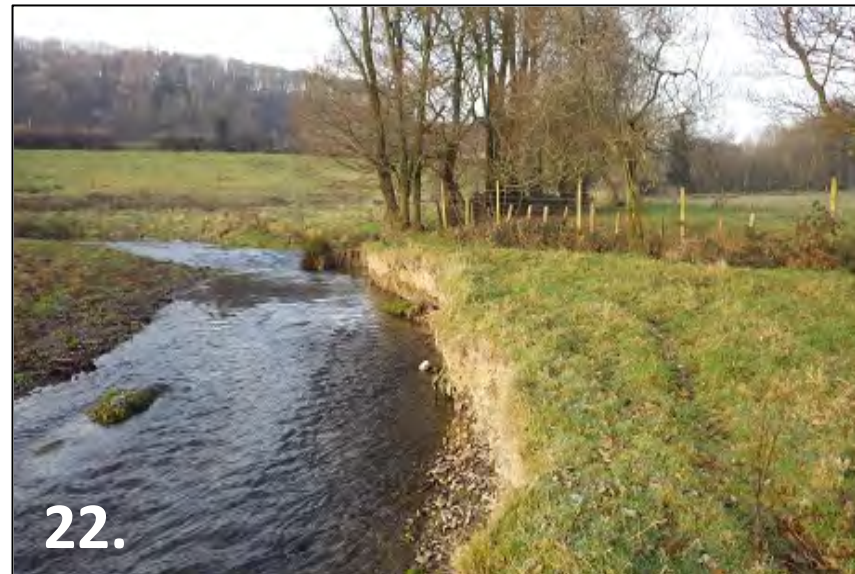
Image 22: An example of an eroding cliff on the Afon Grannell (Site ID 10553)

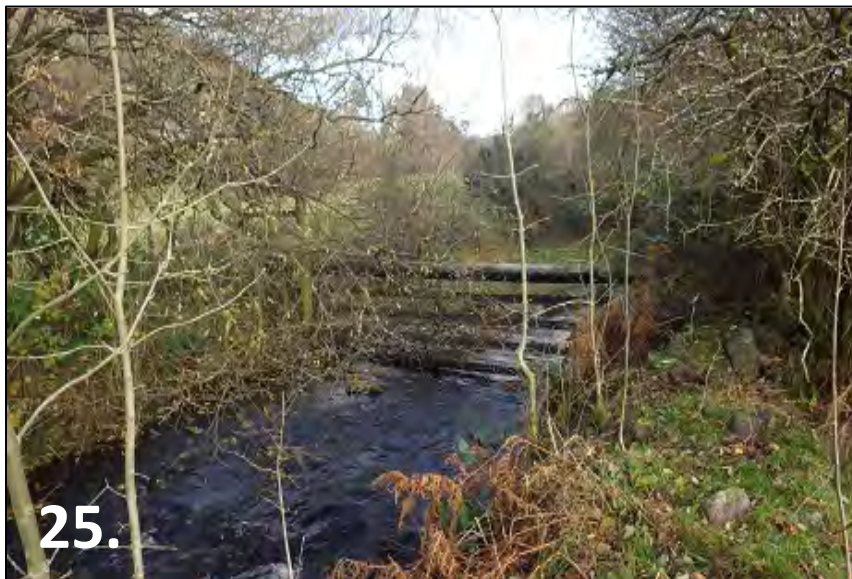
Image 25: An example of a watergate present on the Afon Groes (Site ID 18496)

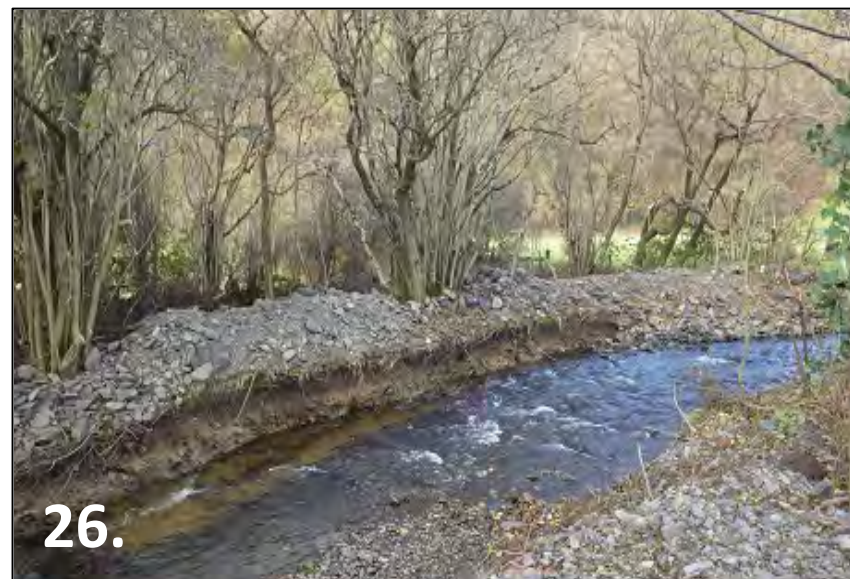
Image 26: An example of resectioned bank and channel on the Afon Groes (Site ID 18496)

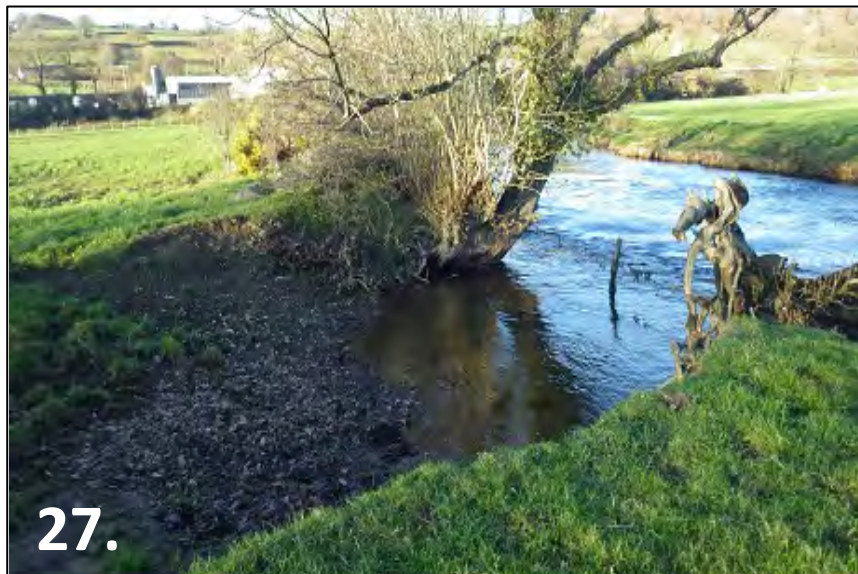
Image 27: An example of a poached section of the Afon Teifi (Site ID 10556)

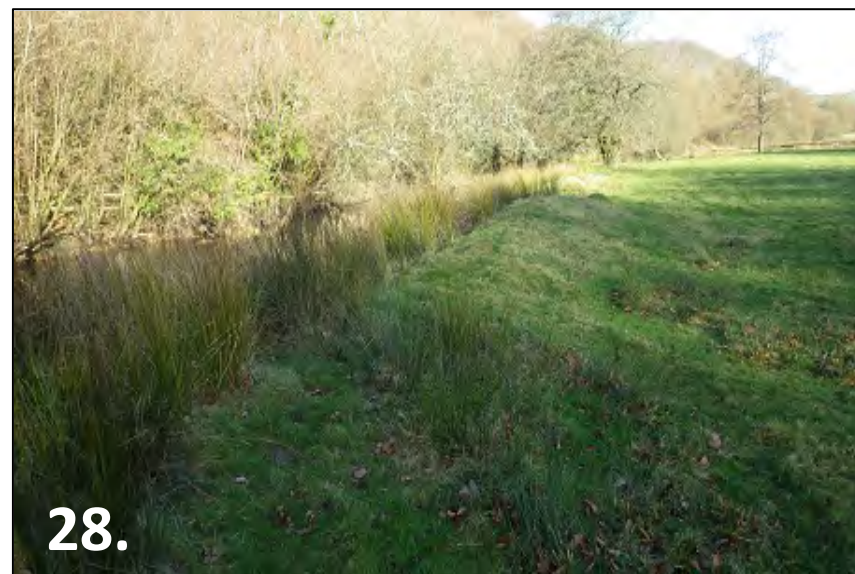
Image 28: An example of a historic embankment (Site ID 10561)

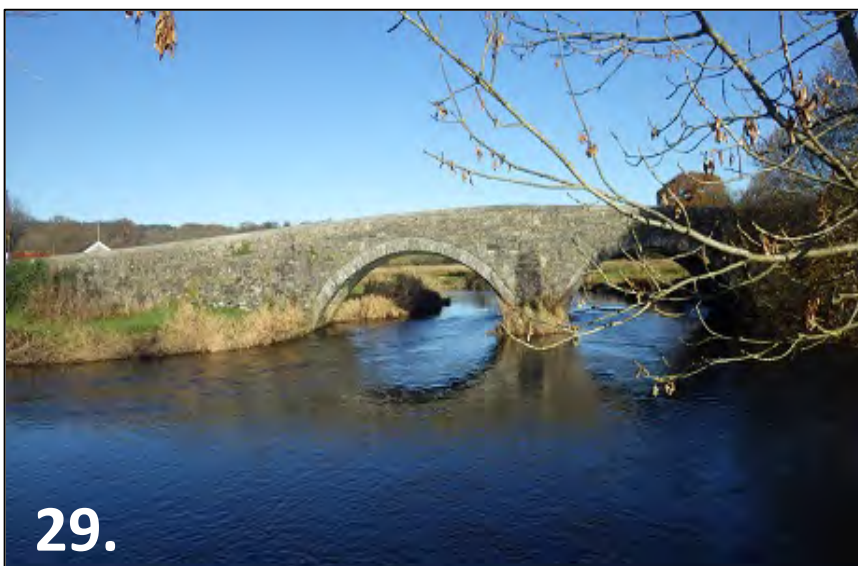
Image 29: An example of a major bridge (Site ID 21766).

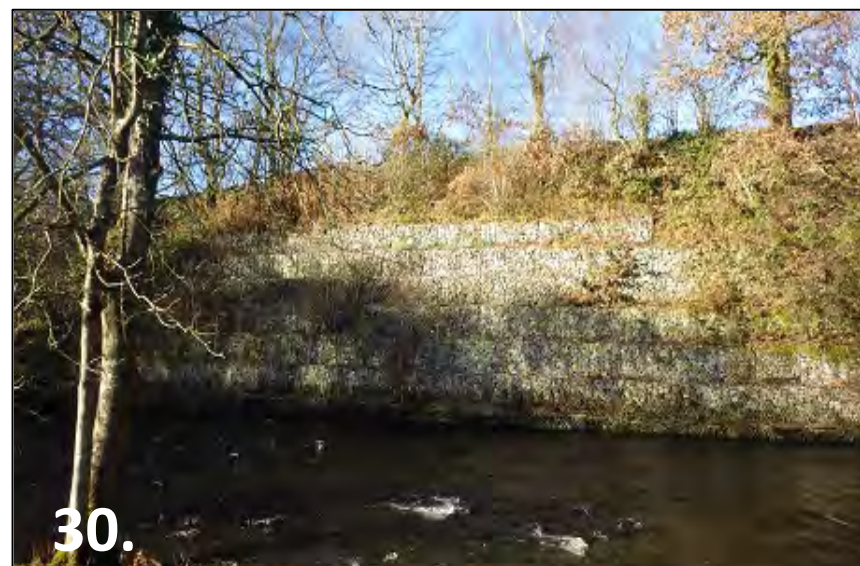
Within SAC Unit 4, 66% of the survey sites were classified as either Class 1 or Class 2, reflecting relatively natural conditions. Two tributaries contributed to SAC Unit 4 failing to meet the habitat modification target. The channel of the Afon Dulas within the survey site had been resectioned and contained an intermediate bridge. The Afon Groes also had the channel and bank resectioned through a small part of the survey site. These are not thought to be representative of characters of the wider tributary. Site 21766 on the Afon Teifi was also Significantly Modified (Class 4) due to extensive bank resectioning and reinforcement with gabion baskets (Appendix B1: Afon Teifi SAC Unit 4, Image 30).

Image 30: An example of a reprofiled and resectioned section of channel (Site ID 21766).

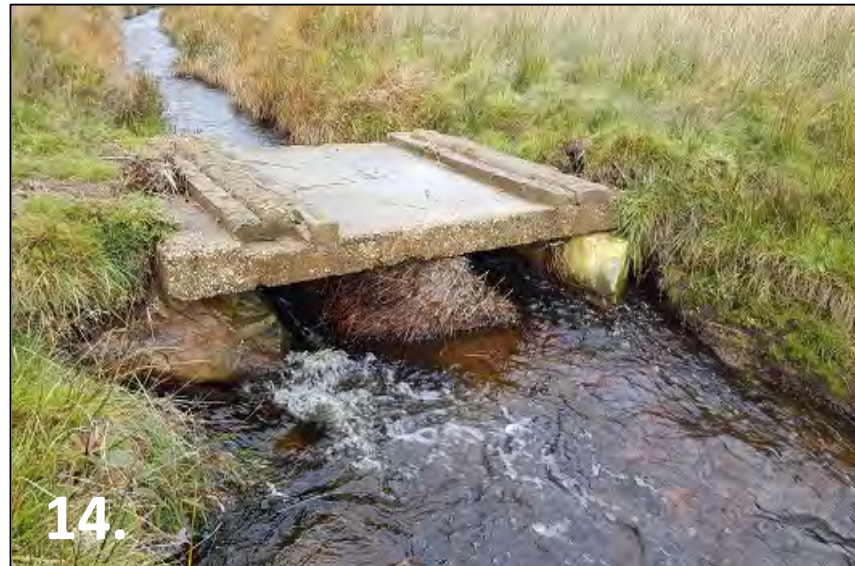
Image 14: A minor bridge present on the Afon Eden with a bale blockage. The bank is also undercut behind the bridge footing (BrynRe).

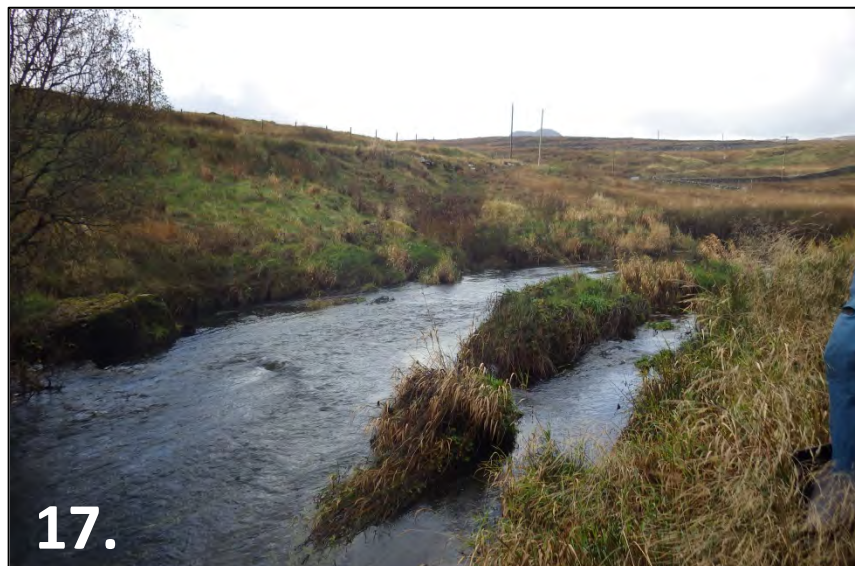
Image 17: An example of a vegetated mid-bar and asymmetric bank heights (Pont-y-Grible).
