Newborough Phase 1 Dune Rejuvenation Works Topographic Survey Report

Kenneth Pye Associates Ltd

Report No: 95

Date: March 2014

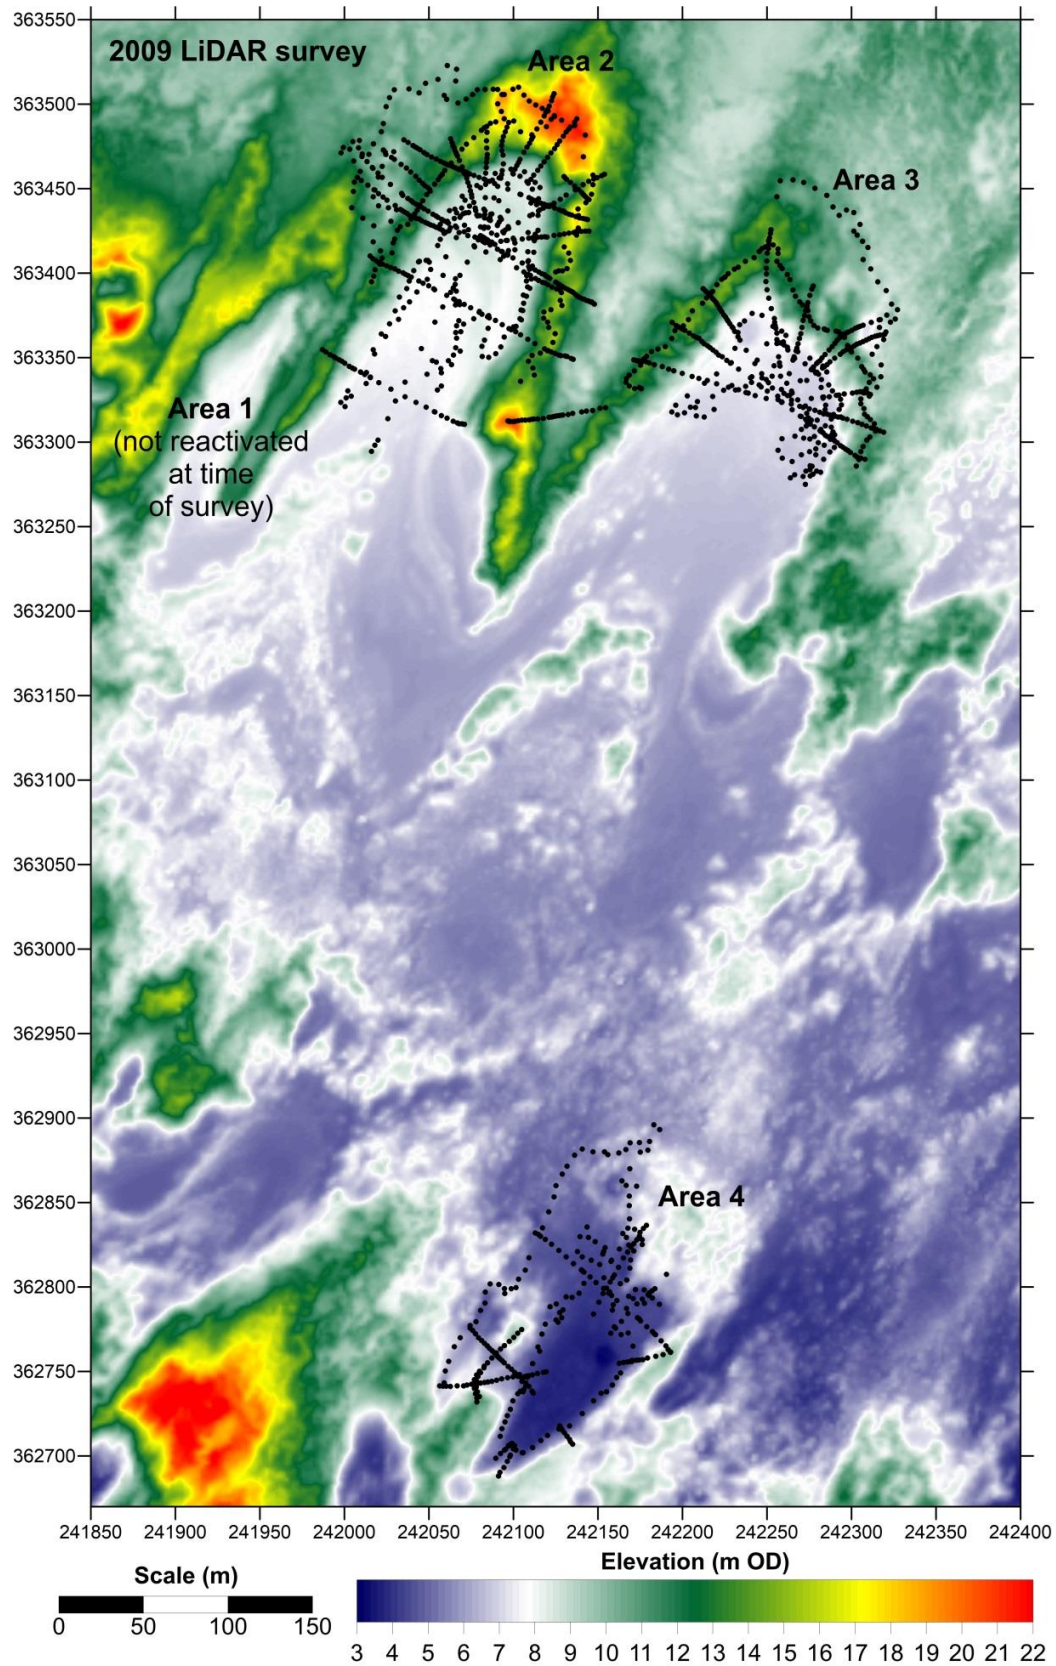
Figure 1. Locations of March 2014 survey data points (black dots) within the three rejuvenation trial areas 2,3 and 4, overlaid on a 2009 LiDAR DEM

In the March 2014 survey ground surface elevations were determined at 1565 points using Leica RTK GPS SmartRover equipment listed in the Job Summary (Section 1.0) above. The distribution of survey points in relation to the three rejuvenation trial areas is shown in Figures 1 and 2. Many of the survey points were located on profile lines which were also surveyed in May 2013. The limits of defined features, including areas of windblown sand deposition, the main dune crest, and areas of standing water, were also mapped by survey points.

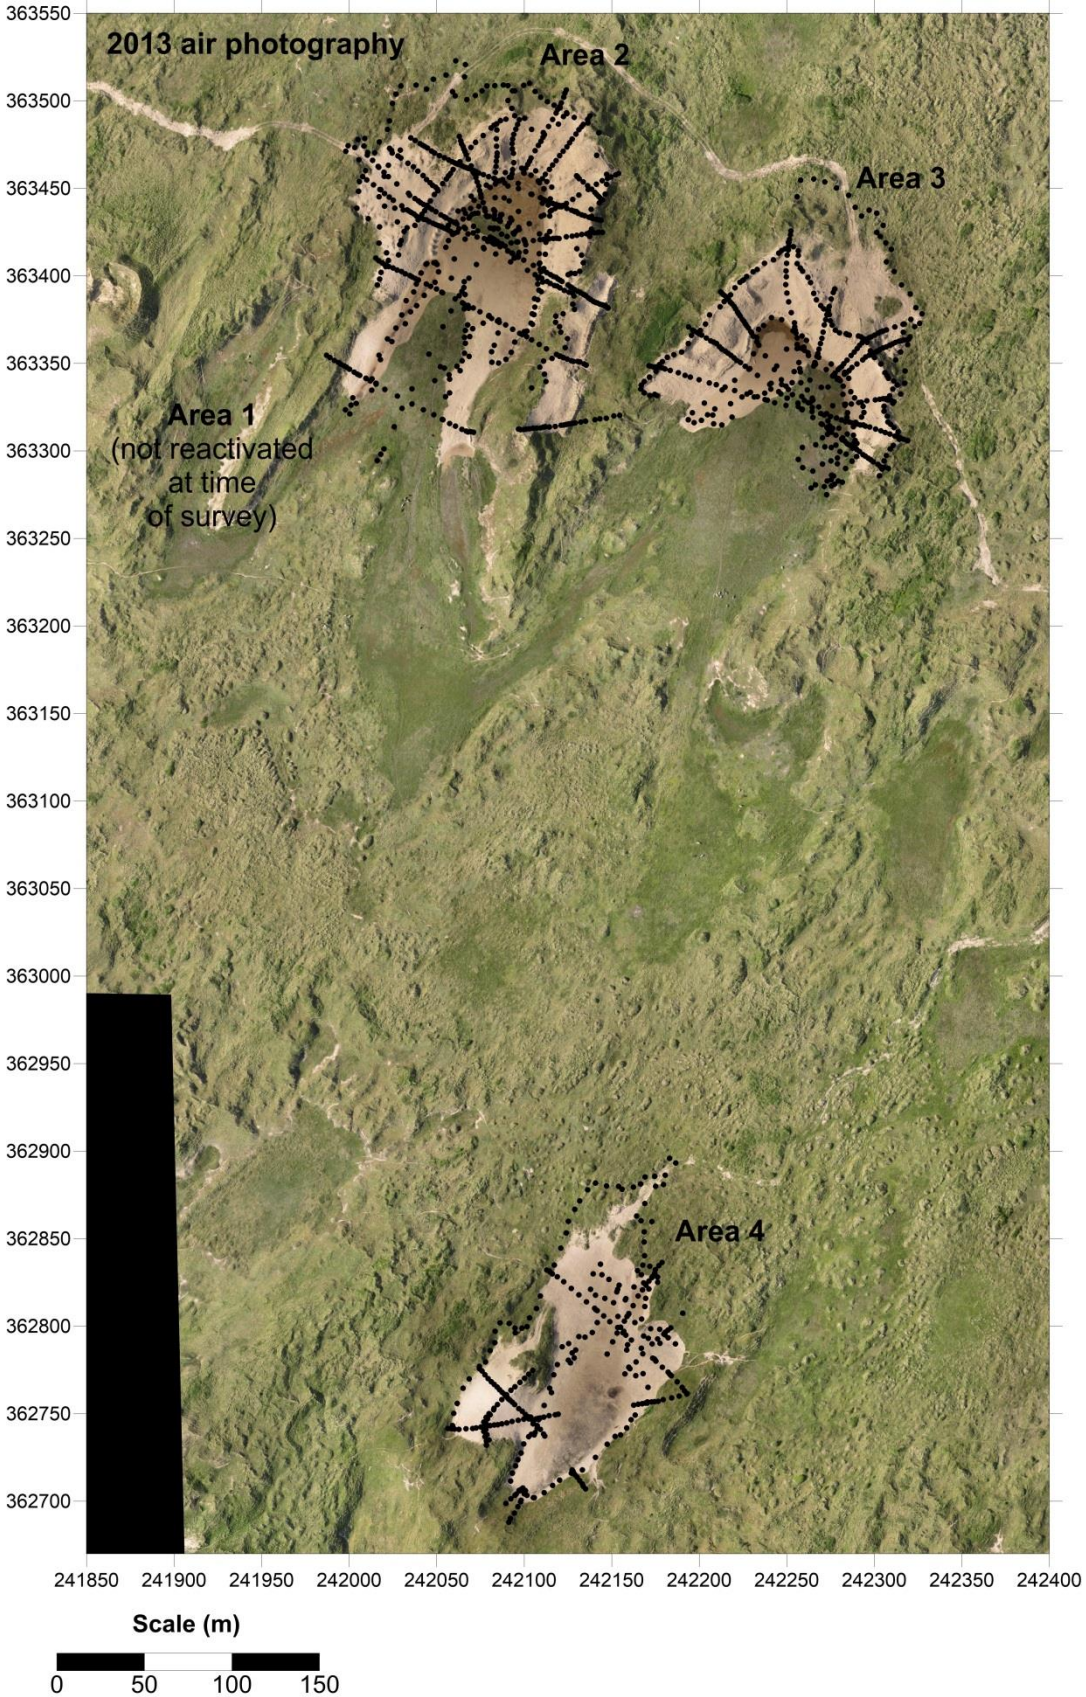
Figure 2. Locations of March 2014 survey data points (black dots) overlaid on June 2013 aerial photographs (flown by exeGesIS).

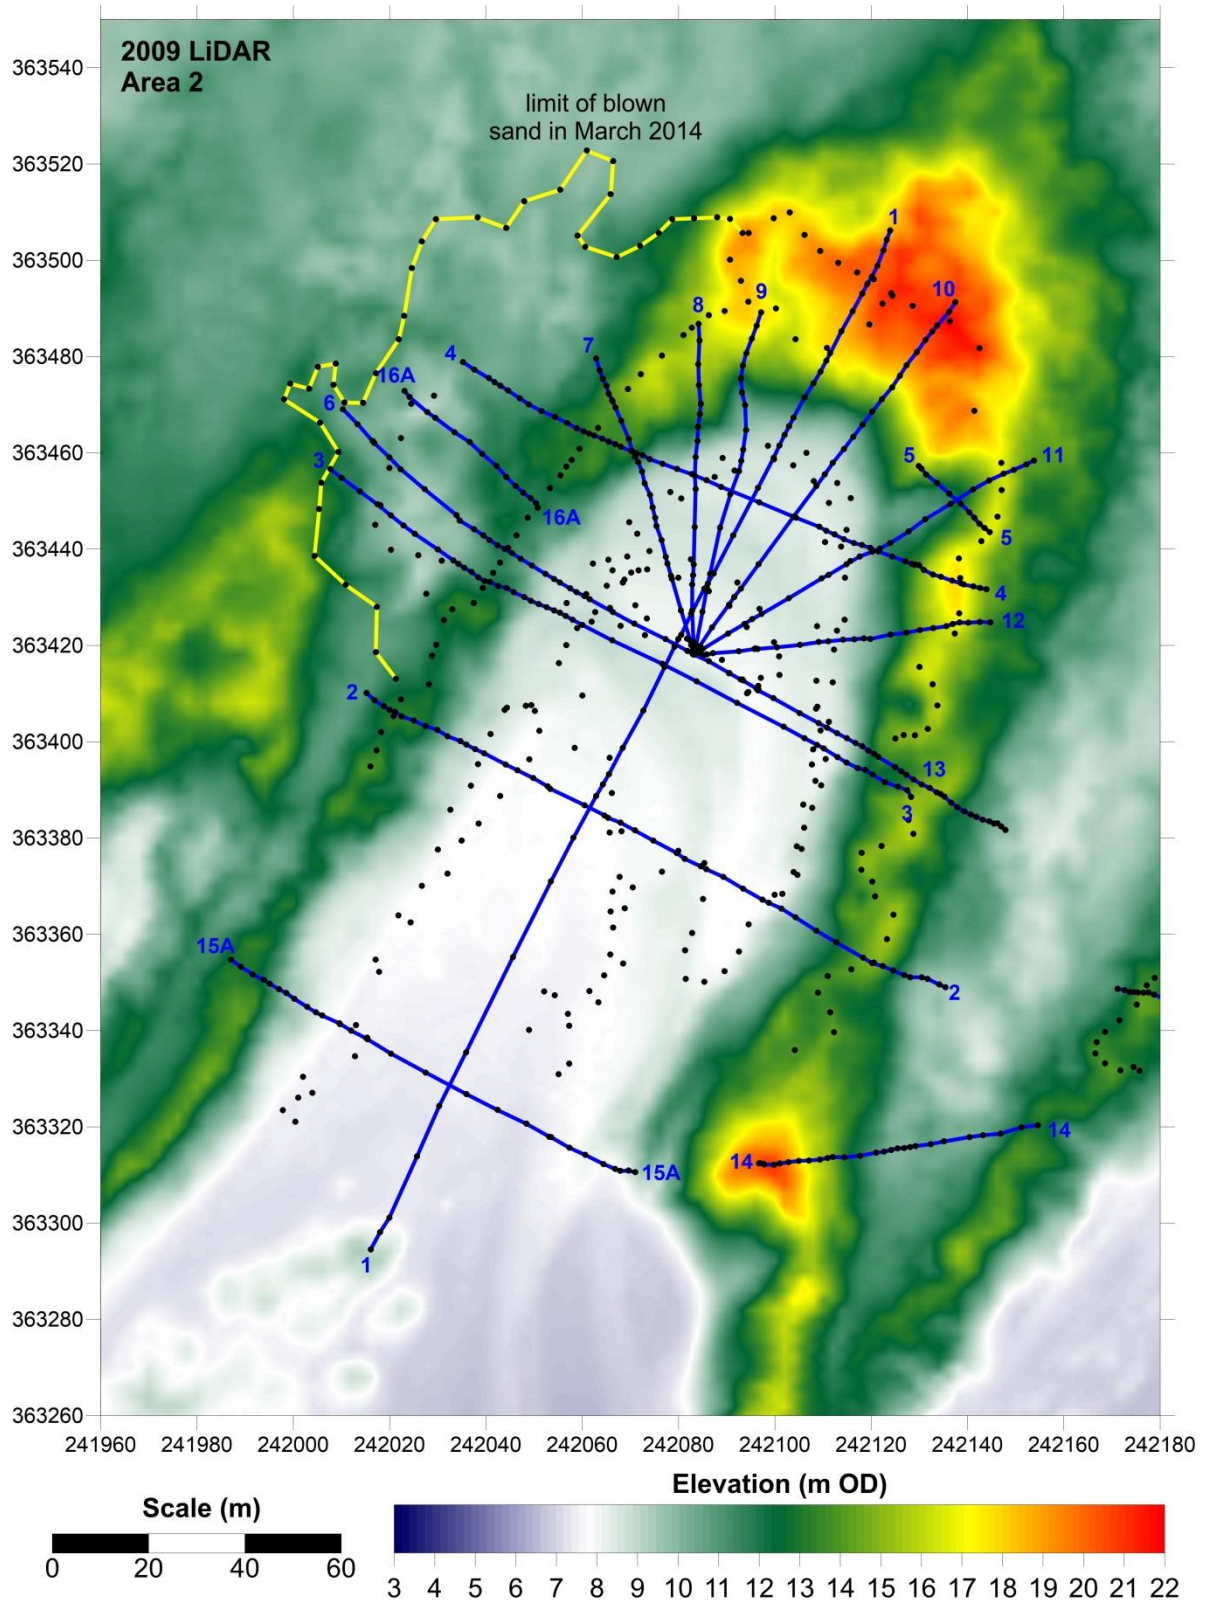
Figure 3. Locations of March 2014 data points (black dots) and cross-profiles (blue lines) in Area 2, overlaid on 2009 LiDAR.

The locations of survey profile lines within Area 2 are shown in Figures 3 and 4. The locations of ground photographs reproduced in this report are shown in Figure 5. Topographic profiles recorded during the March 2014 survey are compared with those of the May 2013 survey in Figure 6.

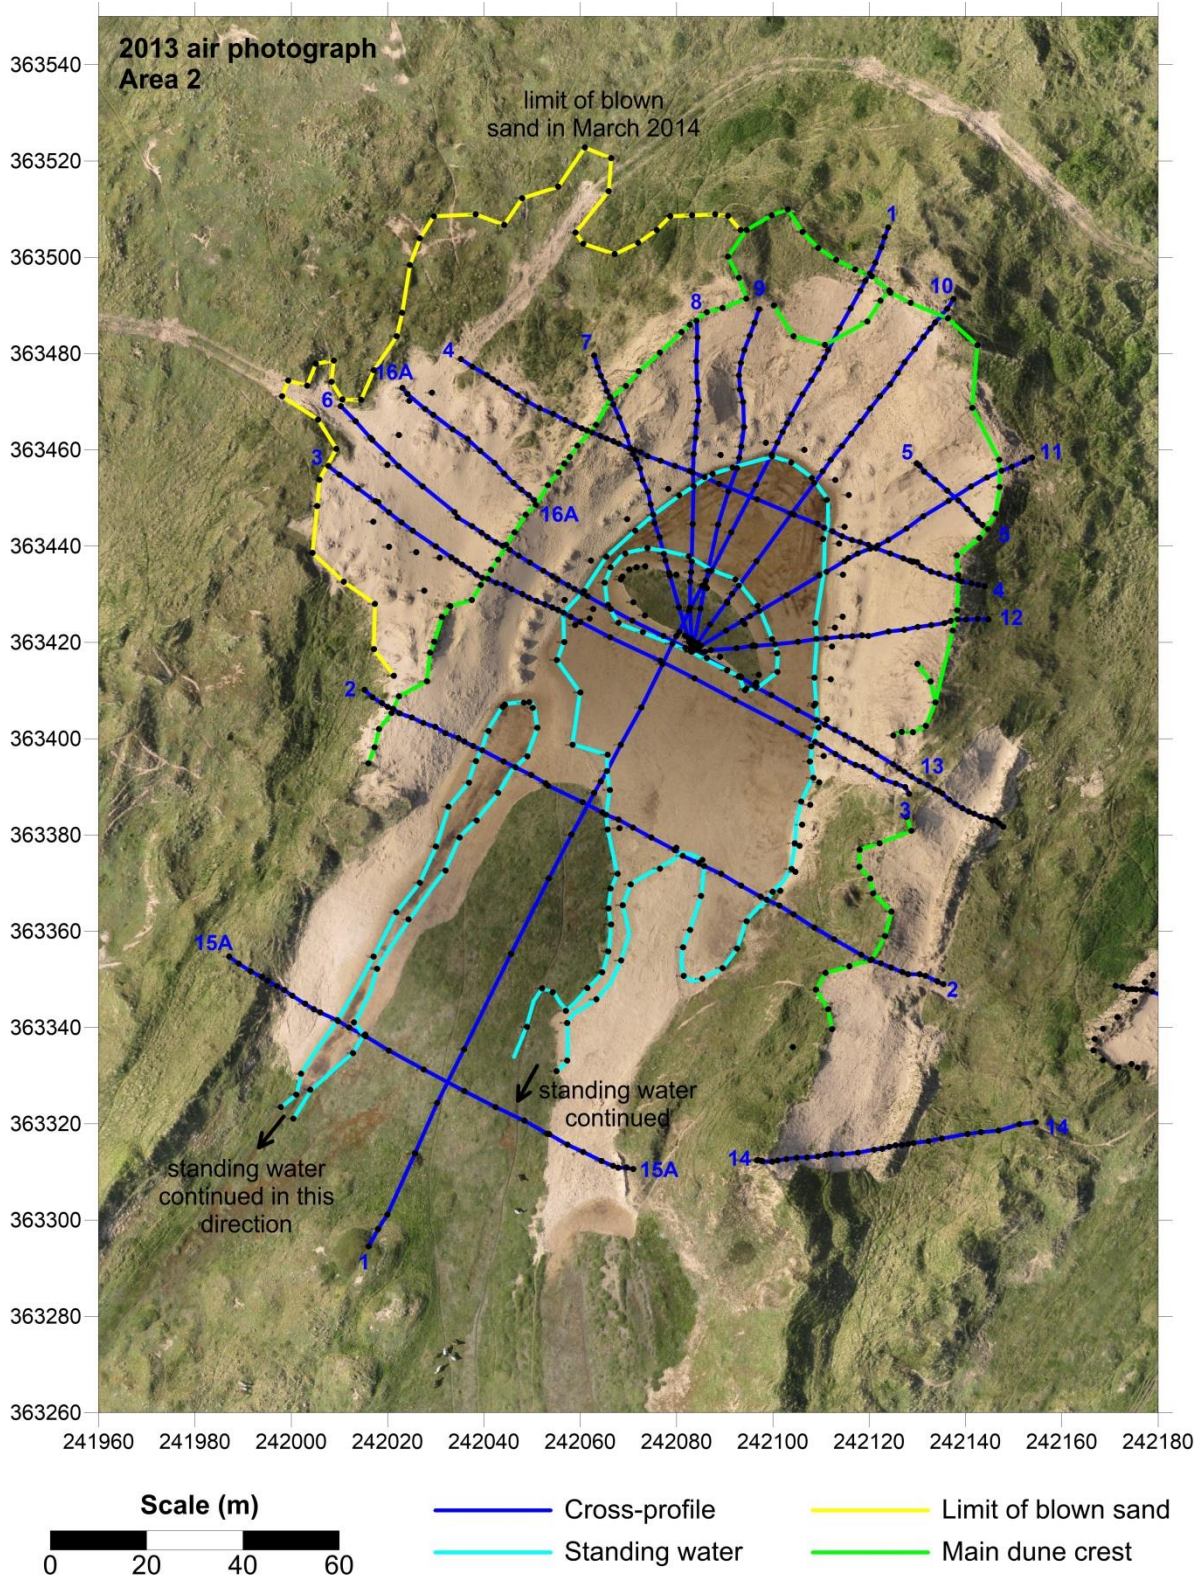
Figure 4. Locations of March 2014 data points (black dots) and cross-profiles (dark blue lines) in Area 2, overlaid on June 2013 aerial photographs (flown by exeGesIS). The limit of blown sand, standing water, and the main dune crest surveyed in March 2014 are also shown.

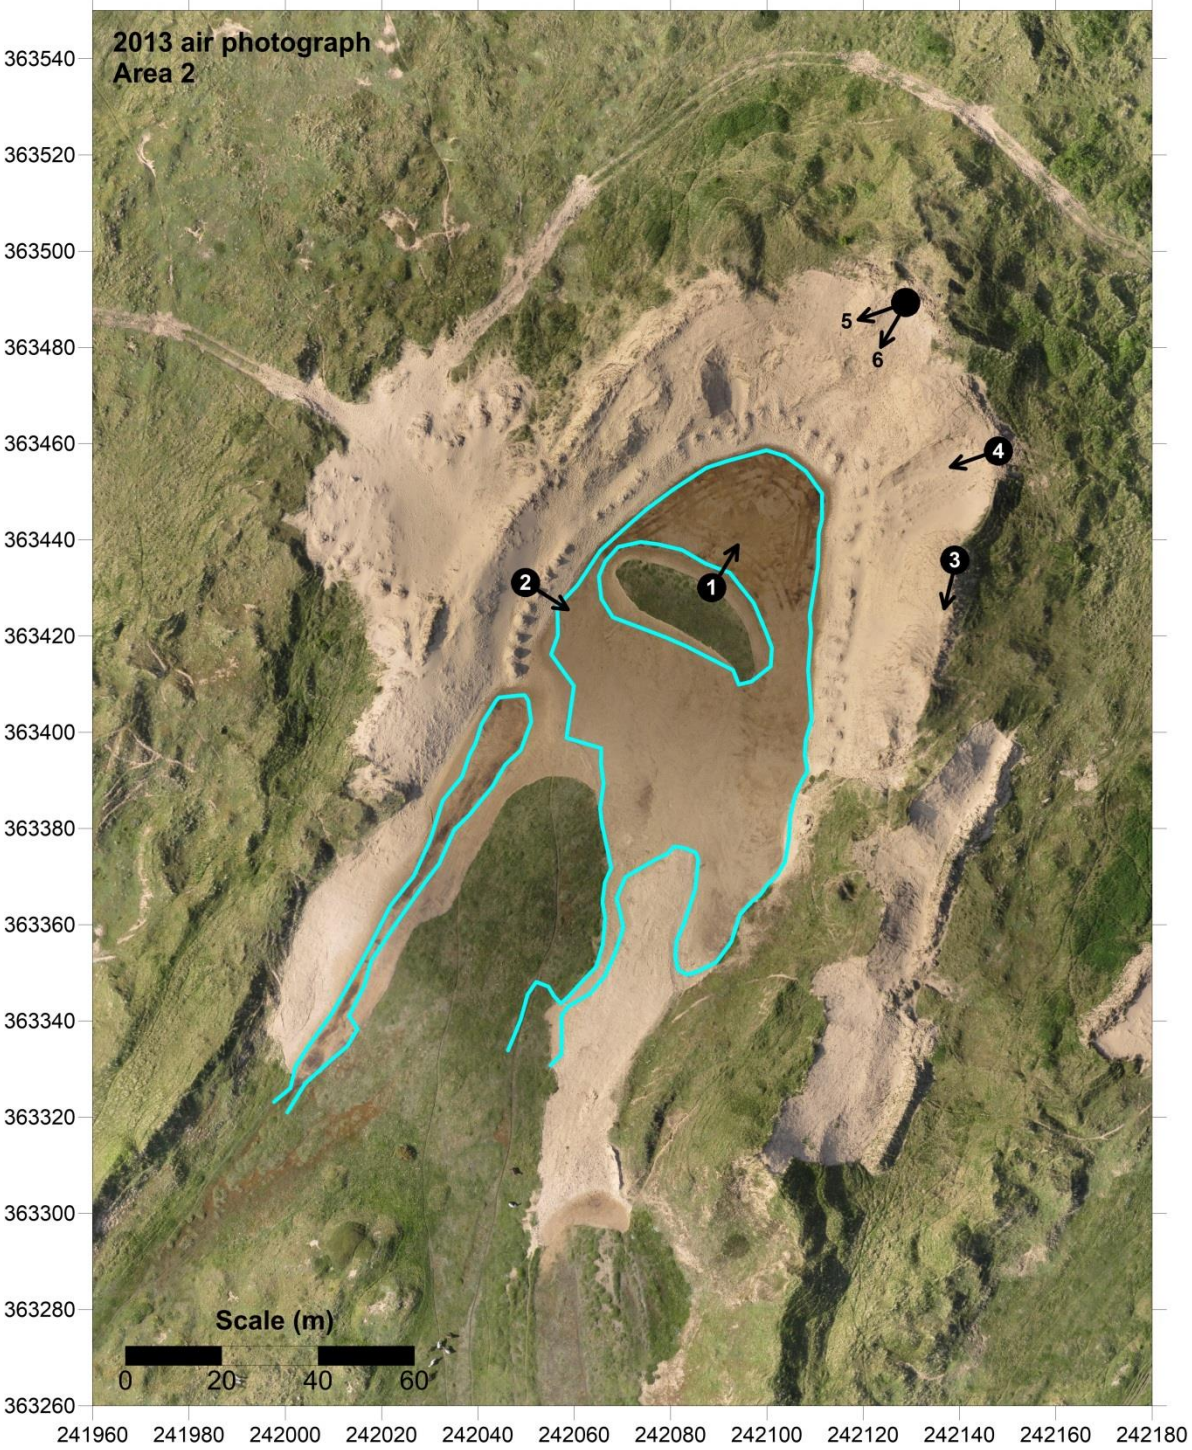
Figure 5. Locations of field photographs 1 to 6 in Area 2 reproduced in this report. Arrows indicate direction of view; base 2013 aerial photography from Google Earth

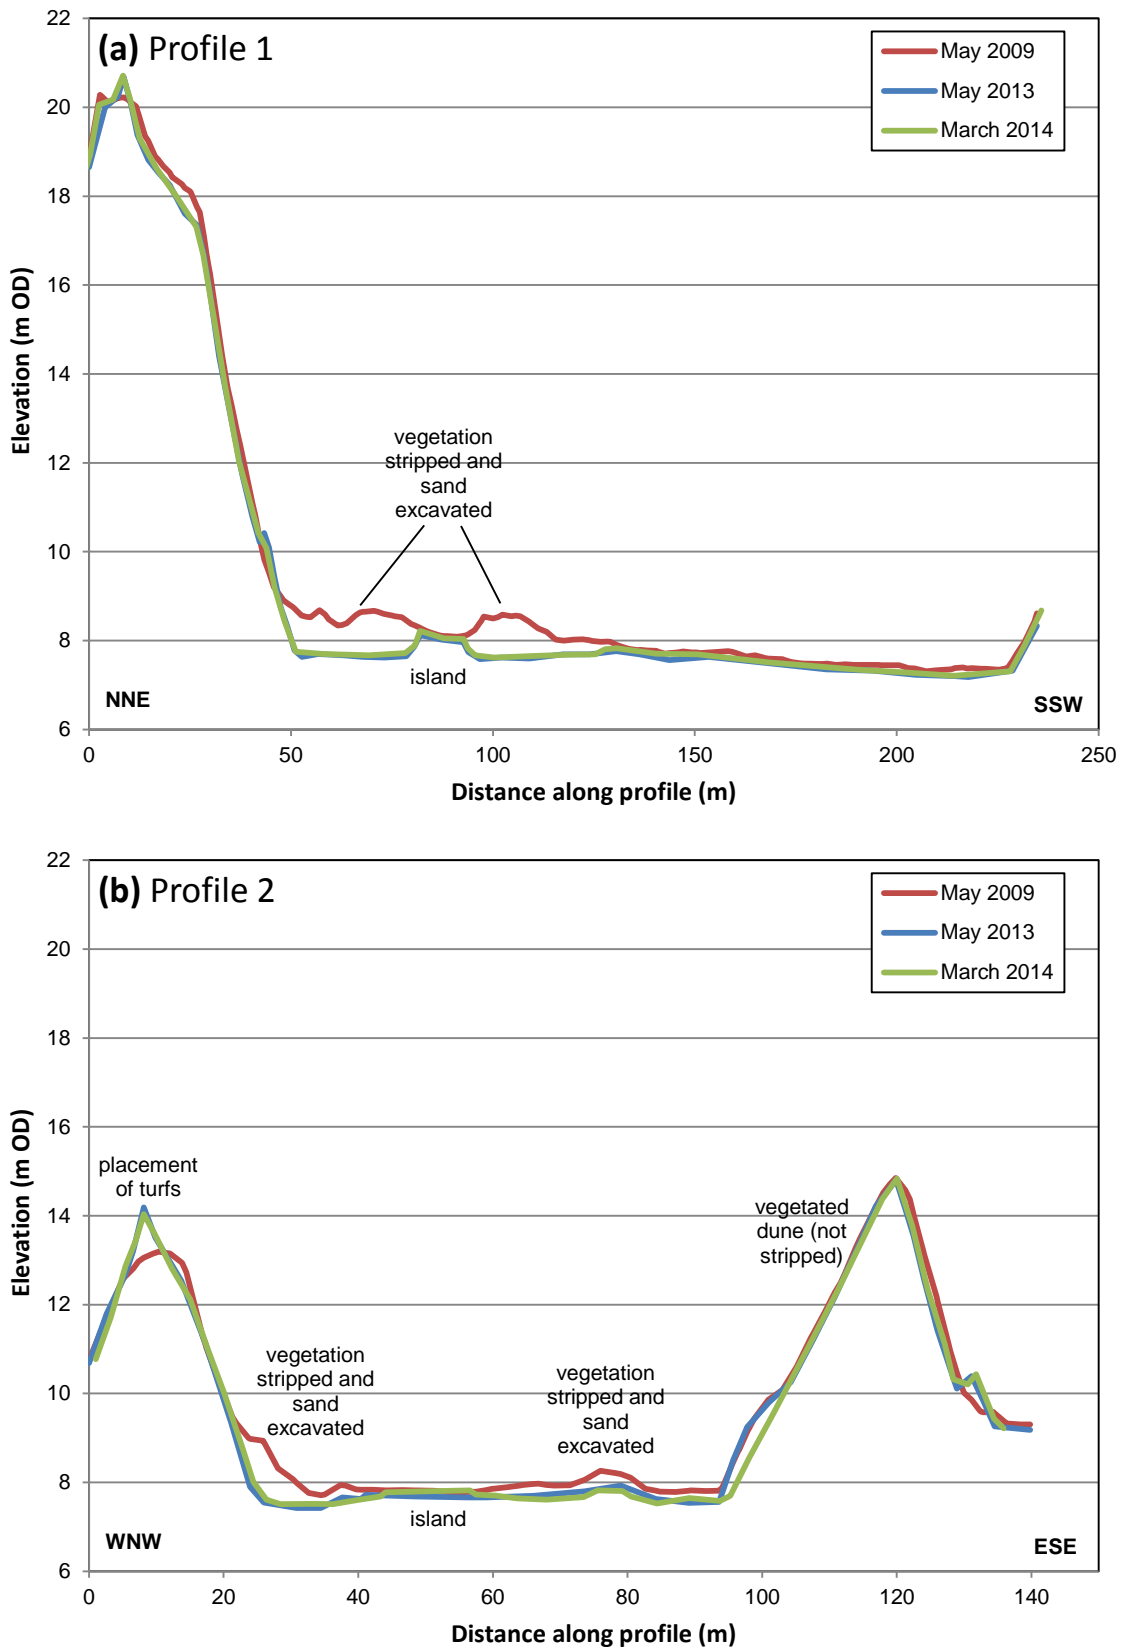
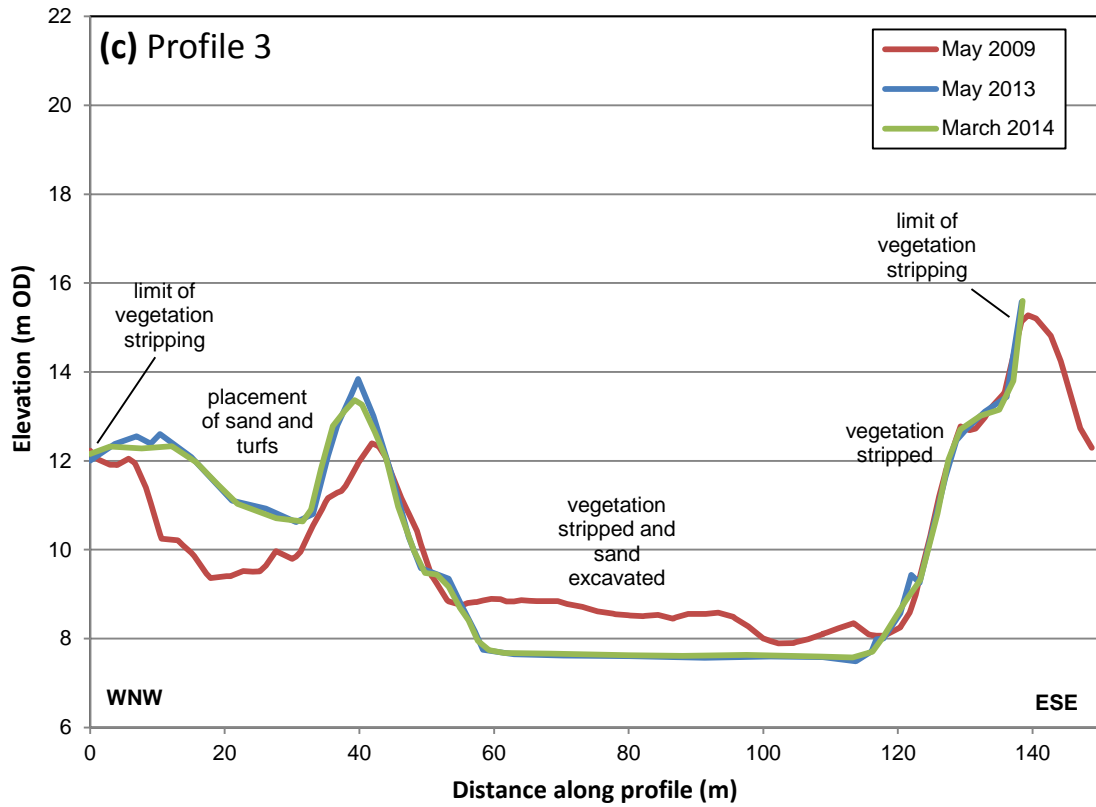
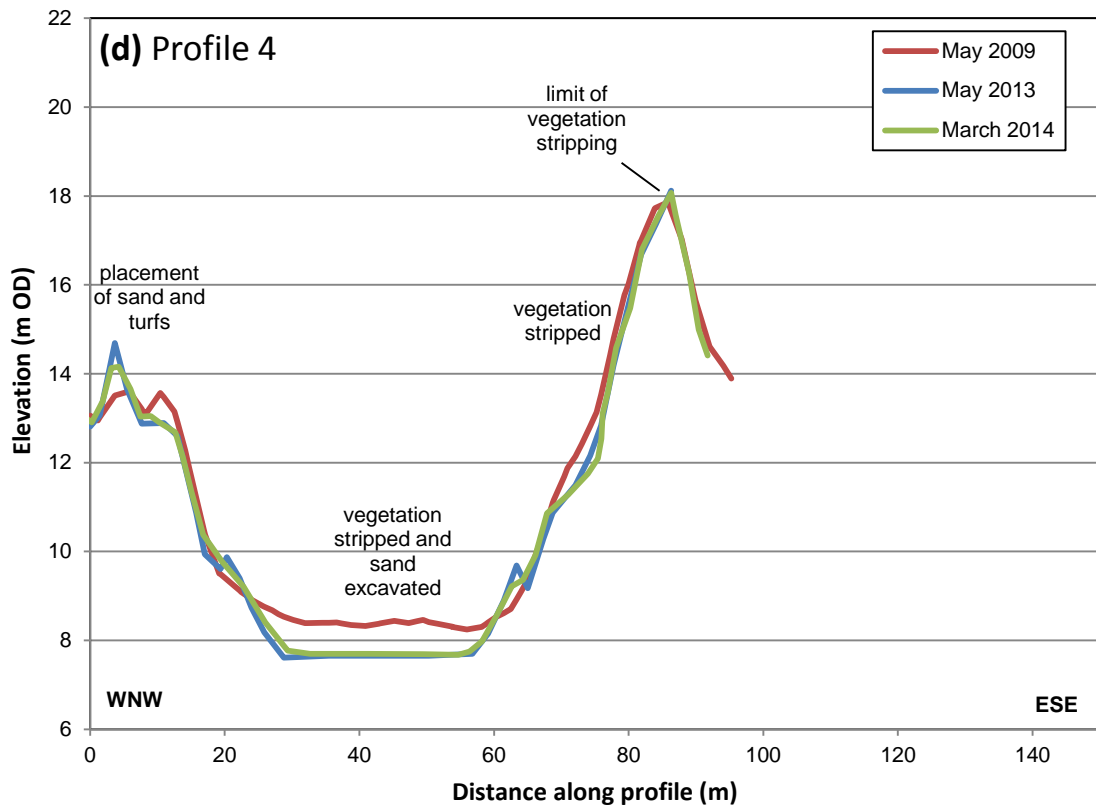
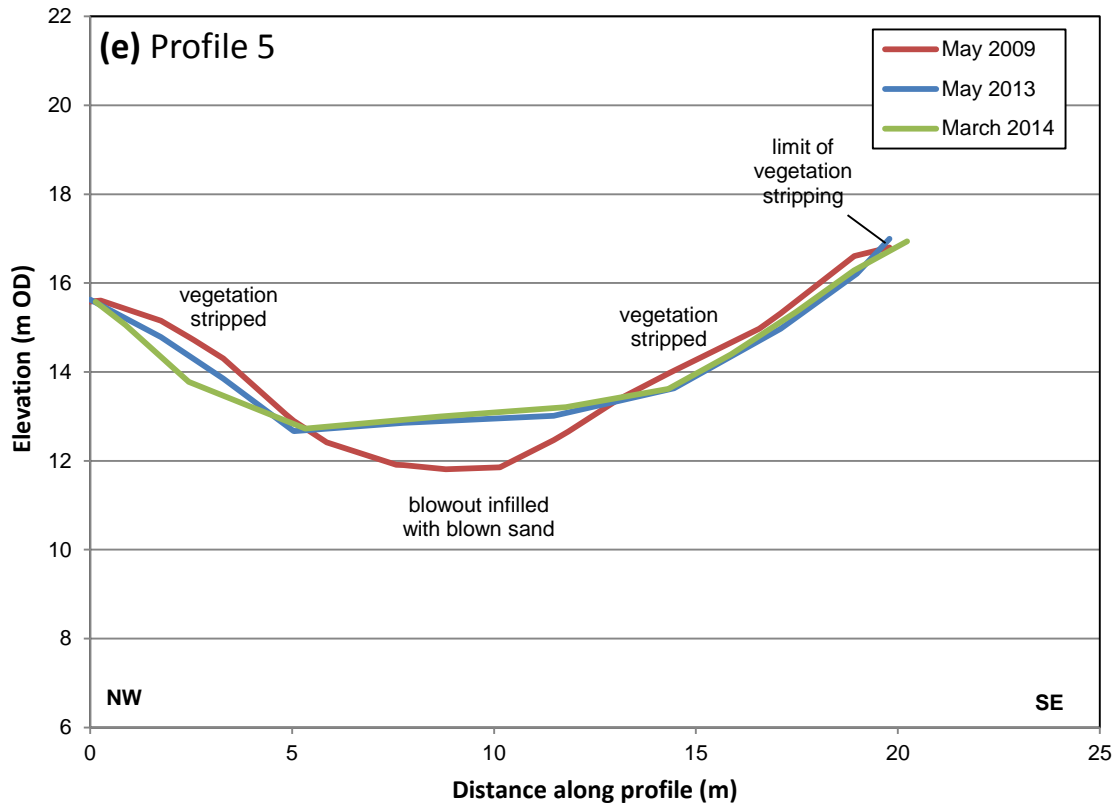
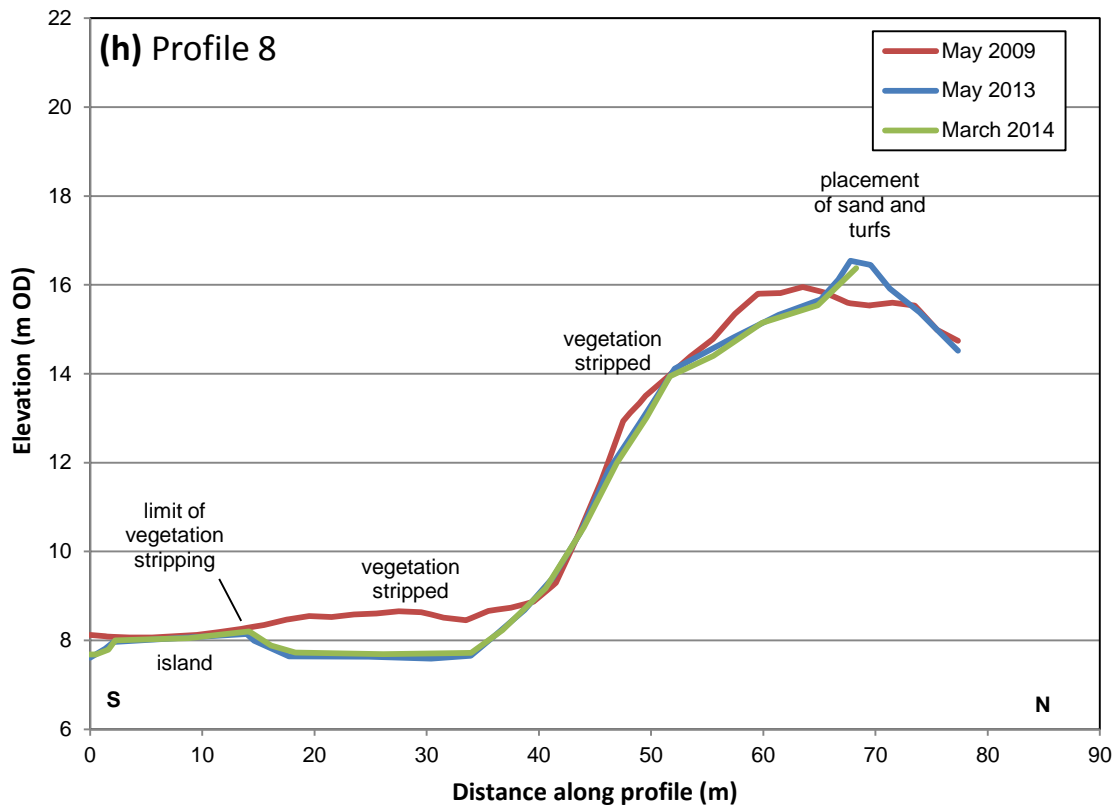
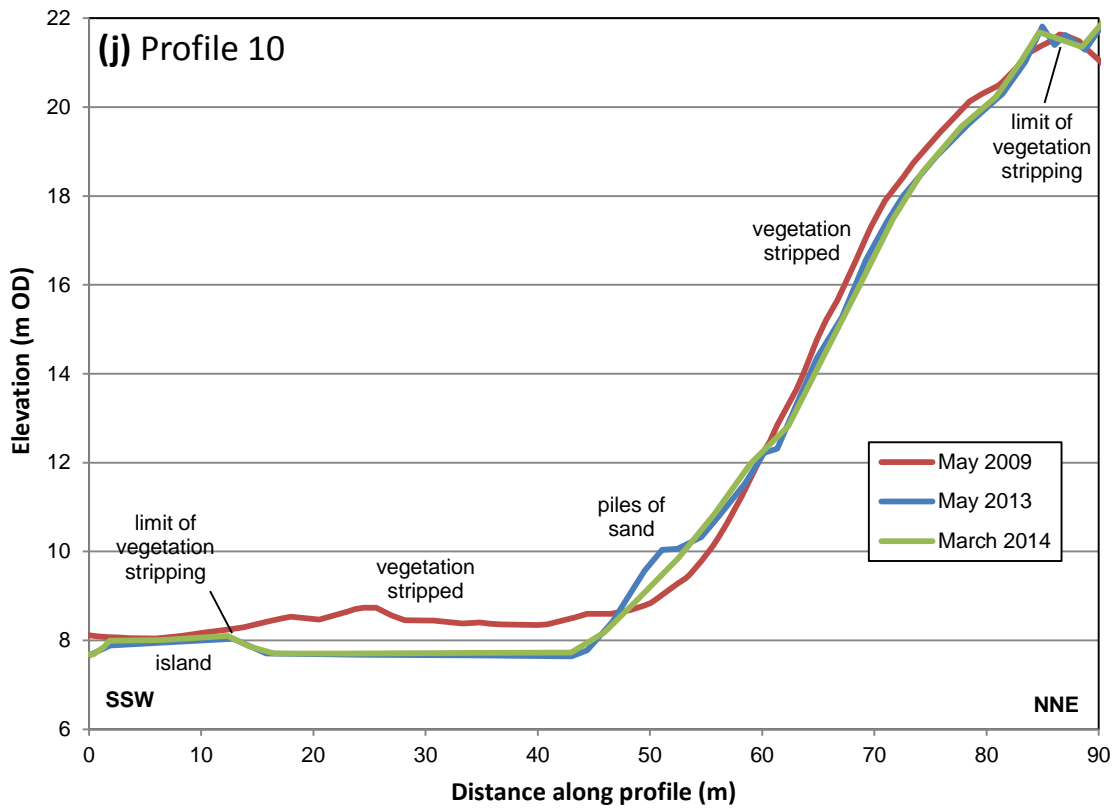
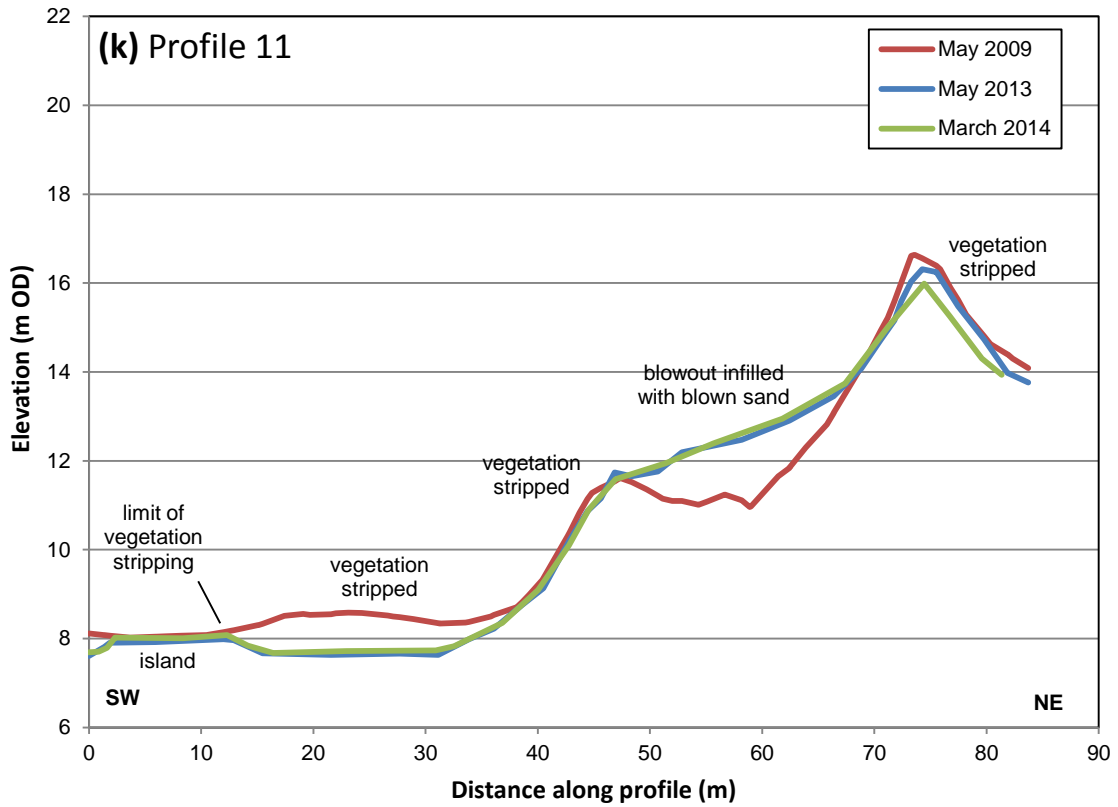
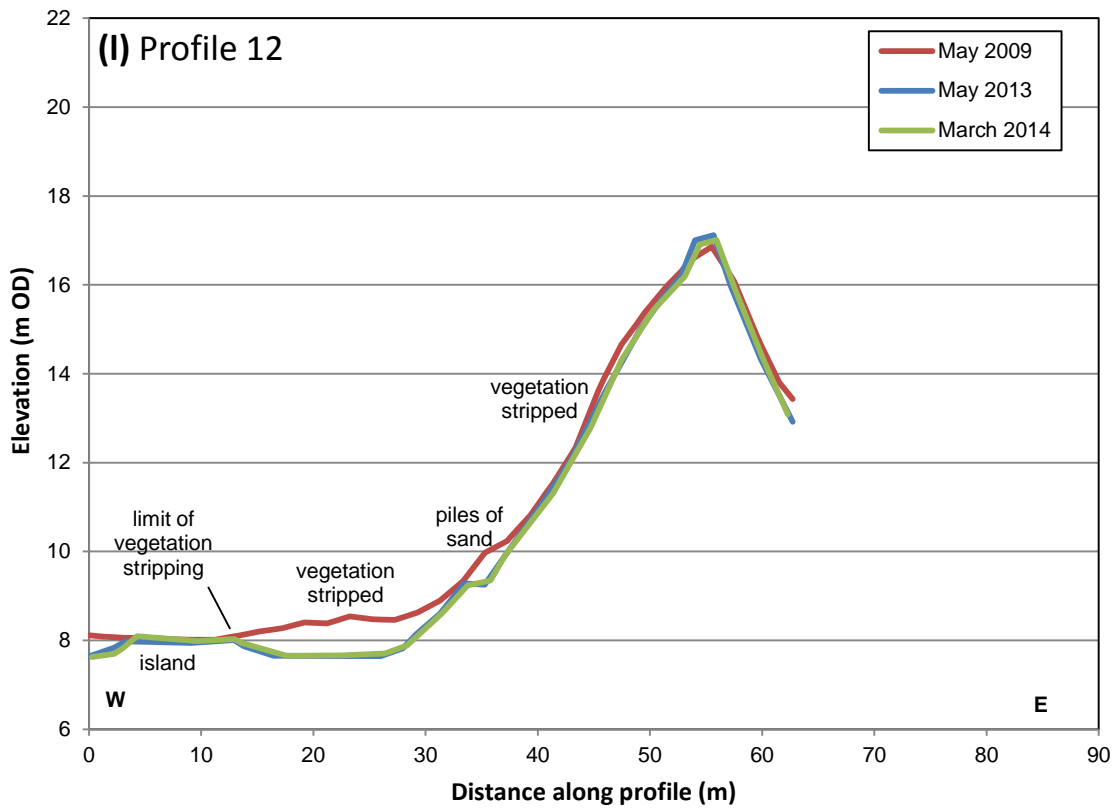
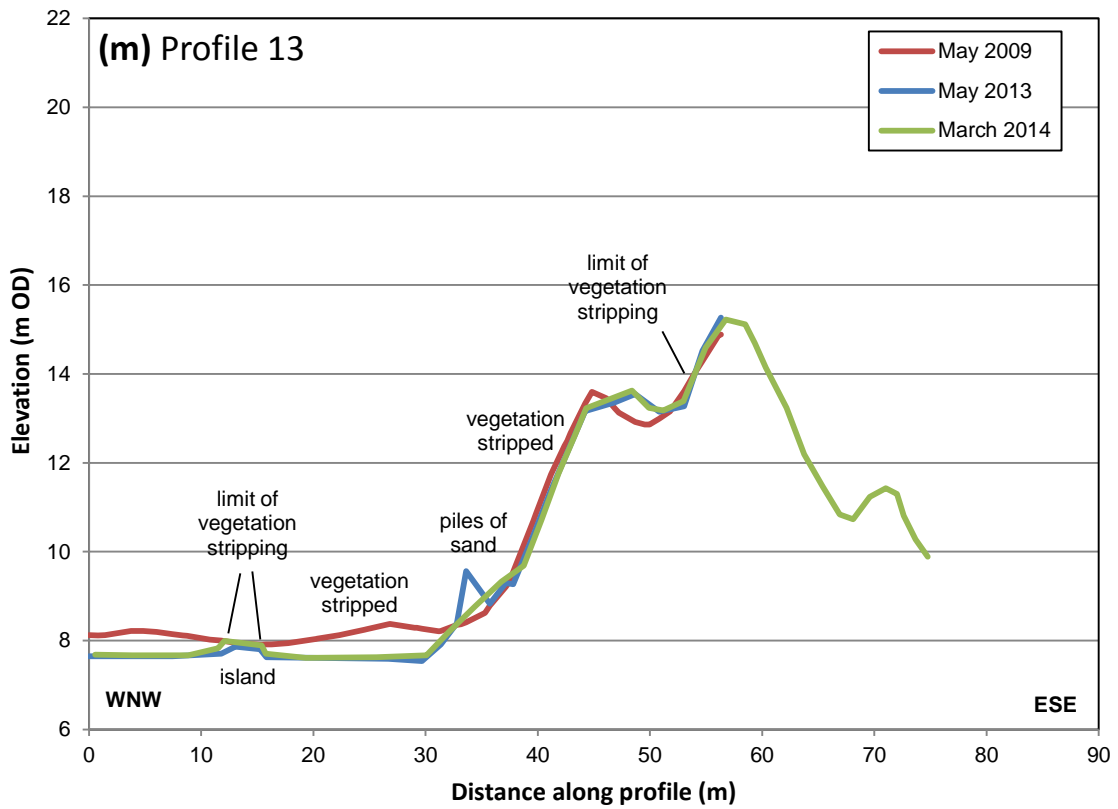
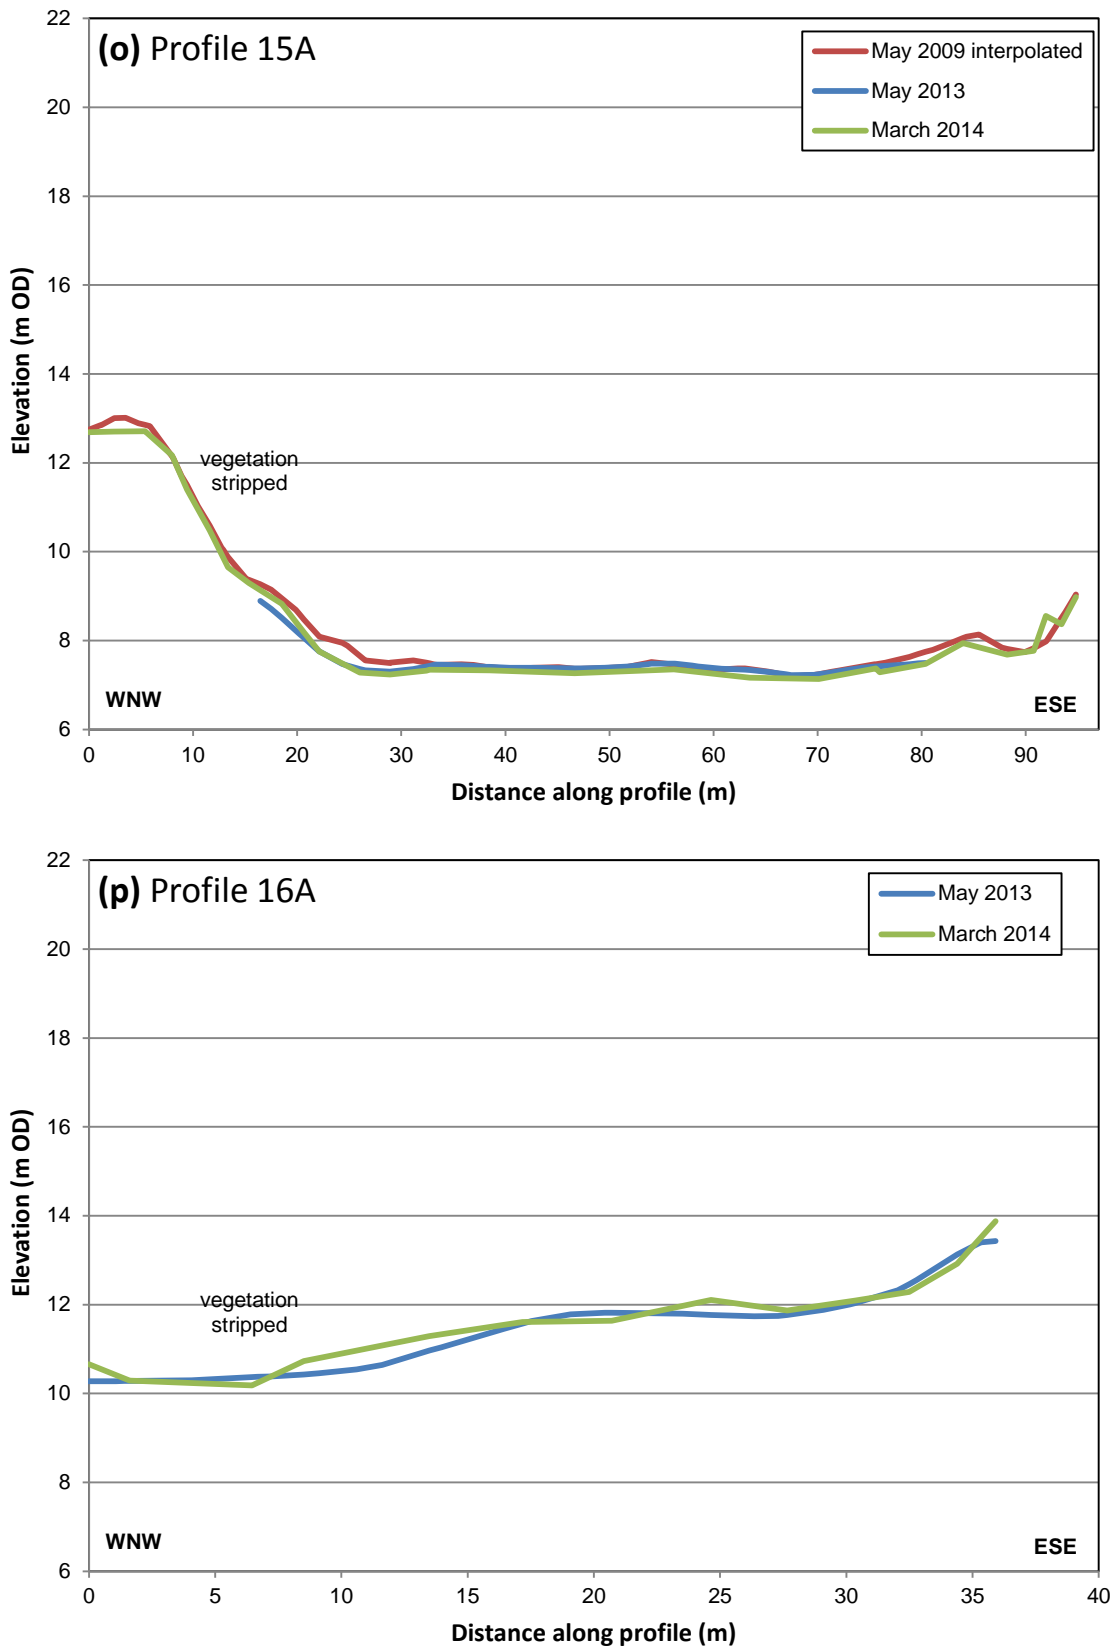
The changes in elevation along most of the profiles were relatively small, amounting to less than 10 cm on the margins of the deflation troughs and the greater part of the side walls. Greater lowering was evident on parts of the stoss slope, the sacrificial sand heaps around the margin of the deflation trough, and the area where turves and loose sand were deposited on the western side of the dune in during the original excavation works. A thin layer of deposited windblown sand was evident on the NW margin of the trial area, having been transported there from the adjoining upwind area by southwesterly and southerly winds.

Figure 6. Comparison of surface levels at profiles 1 and 2 in Area 2, indicated by LiDAR survey on 12th May 2009 (pre-works) and ground surveys on 16 May 2013 and 13 March 2014

Figure 6. continued. Comparison of surface levels at profiles 3 and 4 in Area 2, indicated by LiDAR survey on 12th May 2009 (pre-works) and ground surveys on 16 May 2013 and 13 March 2014

Figure 6. continued. Comparison of surface levels at profiles 5 and 6 in Area 2, indicated by LiDAR survey on 12th May 2009 (pre-works) and ground surveys on 16 May 2013 and 13 March 2014

Figure 6. continued. Comparison of surface levels at profiles 7 and 8 in Area 2, indicated by LiDAR survey on 12th May 2009 (pre-works) and ground surveys on 16 May 2013 and 13 March 2014

Figure 6. continued. Comparison of surface levels at profiles 9 and 10 in Area 2, indicated by LiDAR survey on 12th May 2009 (pre-works) and ground surveys on 16 May 2013 and 13 March 2014

Figure 6. continued. Comparison of surface levels at profiles 11 and 12 in Area 2, indicated by LiDAR survey on 12th May 2009 (pre-works) and ground surveys on 16 May 2013 and 13 March 2014

Figure 6. continued. Comparison of surface levels at profiles 13 and 14 in Area 2, indicated by LiDAR survey on 12th May 2009 (pre-works) and ground surveys on 16 May 2013 and 13 March 2014

Figure 6. continued. Comparison of surface levels at profiles 15A and 16A in Area 2, indicated by LiDAR survey on 12th May 2009 (pre-works) and 13 March 2014. Data have been interpolated from the ground survey on 16 May 2013 for profile 15A, but was not possible for profile 16A due to a lack of survey points.

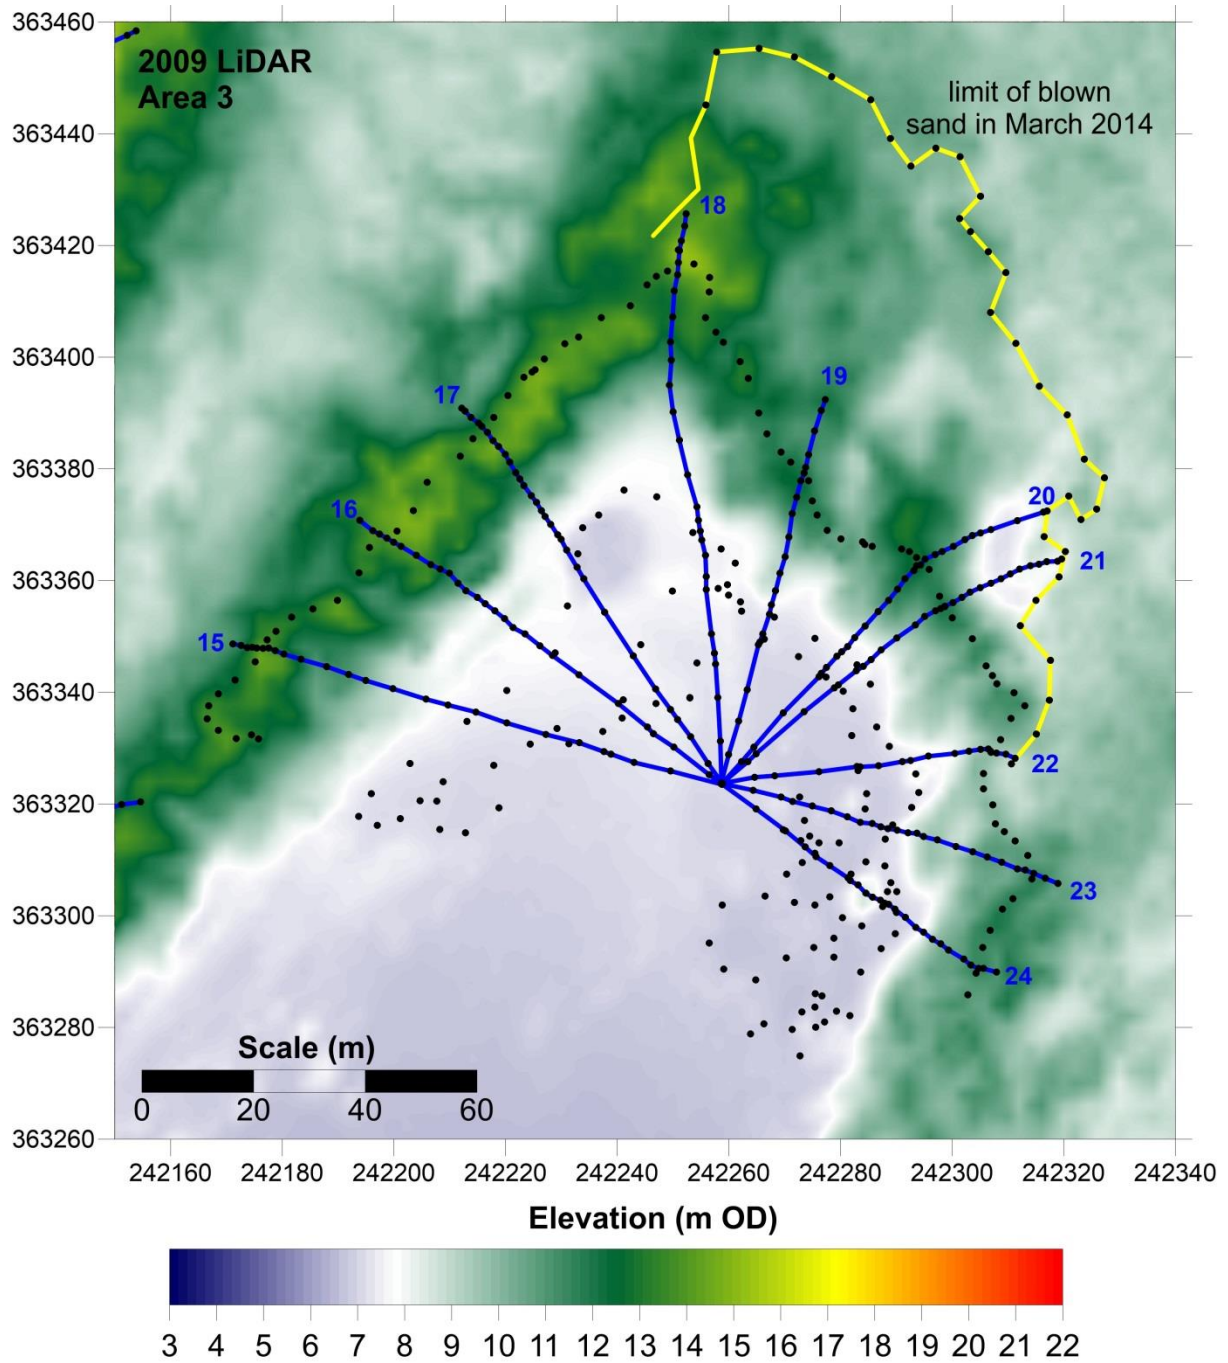
Figure 7. Locations of March 2014 data points (black dots) and cross-profiles (blue lines) in Area 3, overlaid on 2009 LiDAR.

The locations of survey profile lines within Area 3 are shown in Figures 7 and 8. The locations of ground photographs reproduced in this report are shown in Figure 9. Topographic profiles recorded during the March 2014 survey are compared with those of the May 2013 survey in Figure 10.
