Newborough Phase 1 Dune Rejuvenation Works Topographic Survey Report

Kenneth Pye Associates Ltd

Report No: 95

Date: March 2014

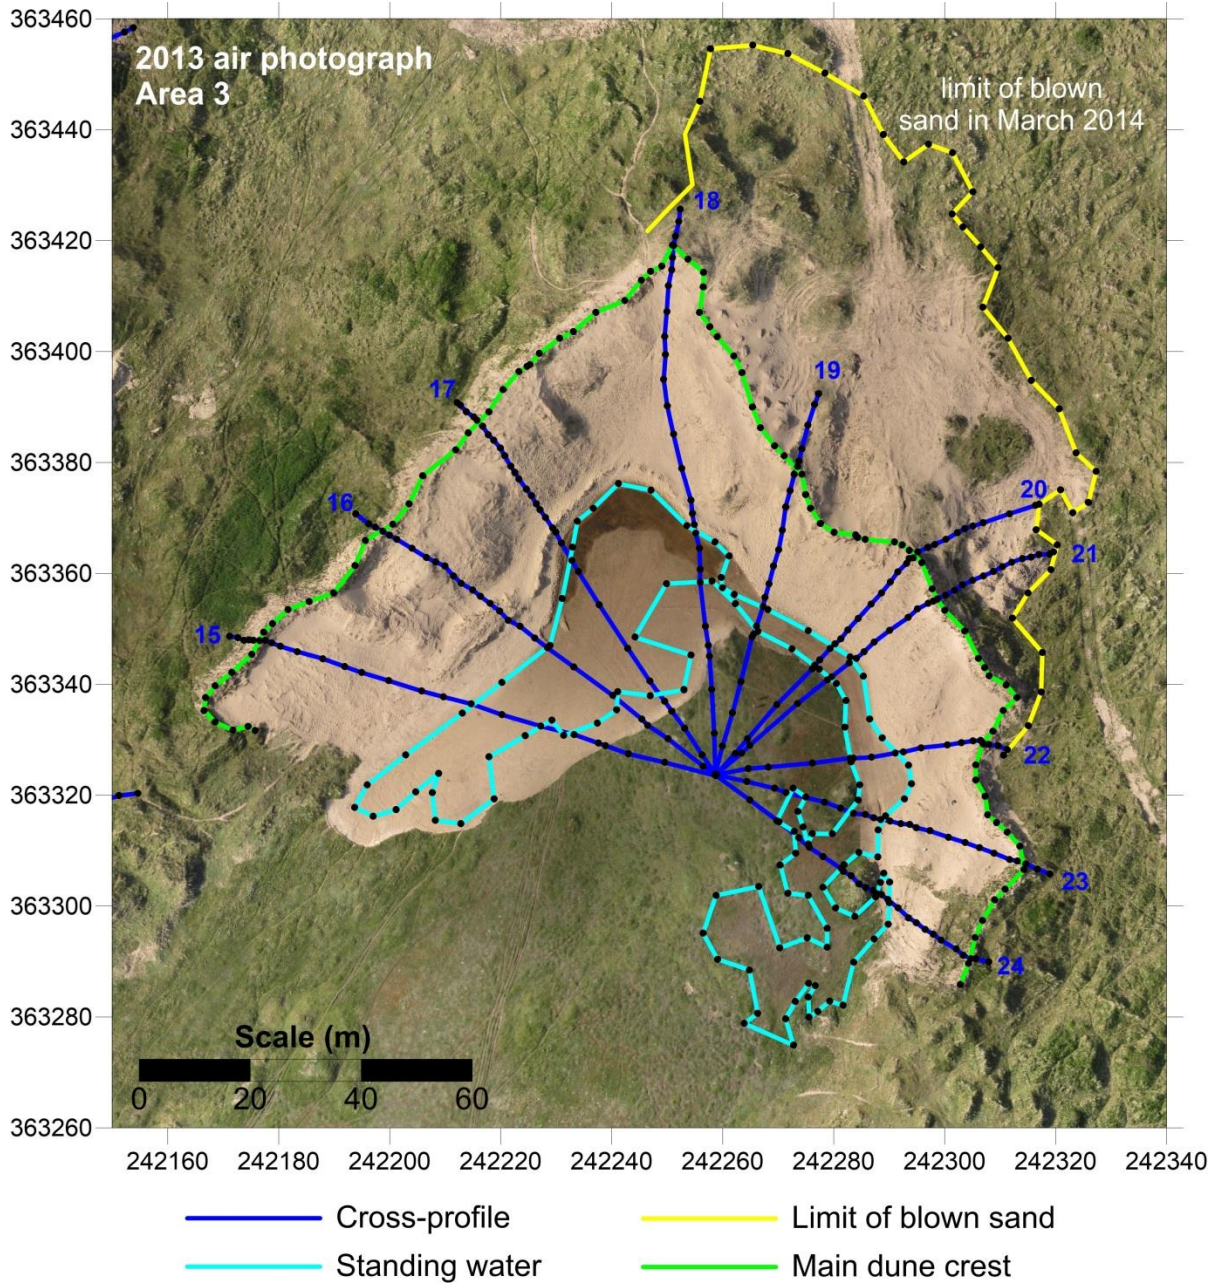
Figure 8. Locations of March 2014 data points (black dots) and cross-profiles (blue lines) in Area 3, overlaid on June 2013 aerial photographs (flown by exeGesIS). The limit of blown sand, standing water, and the main dune crest surveyed in March 2014 are also shown.

The locations of survey profile lines within Area 3 are shown in Figures 7 and 8. The locations of ground photographs reproduced in this report are shown in Figure 9. Topographic profiles recorded during the March 2014 survey are compared with those of the May 2013 survey in Figure 10.

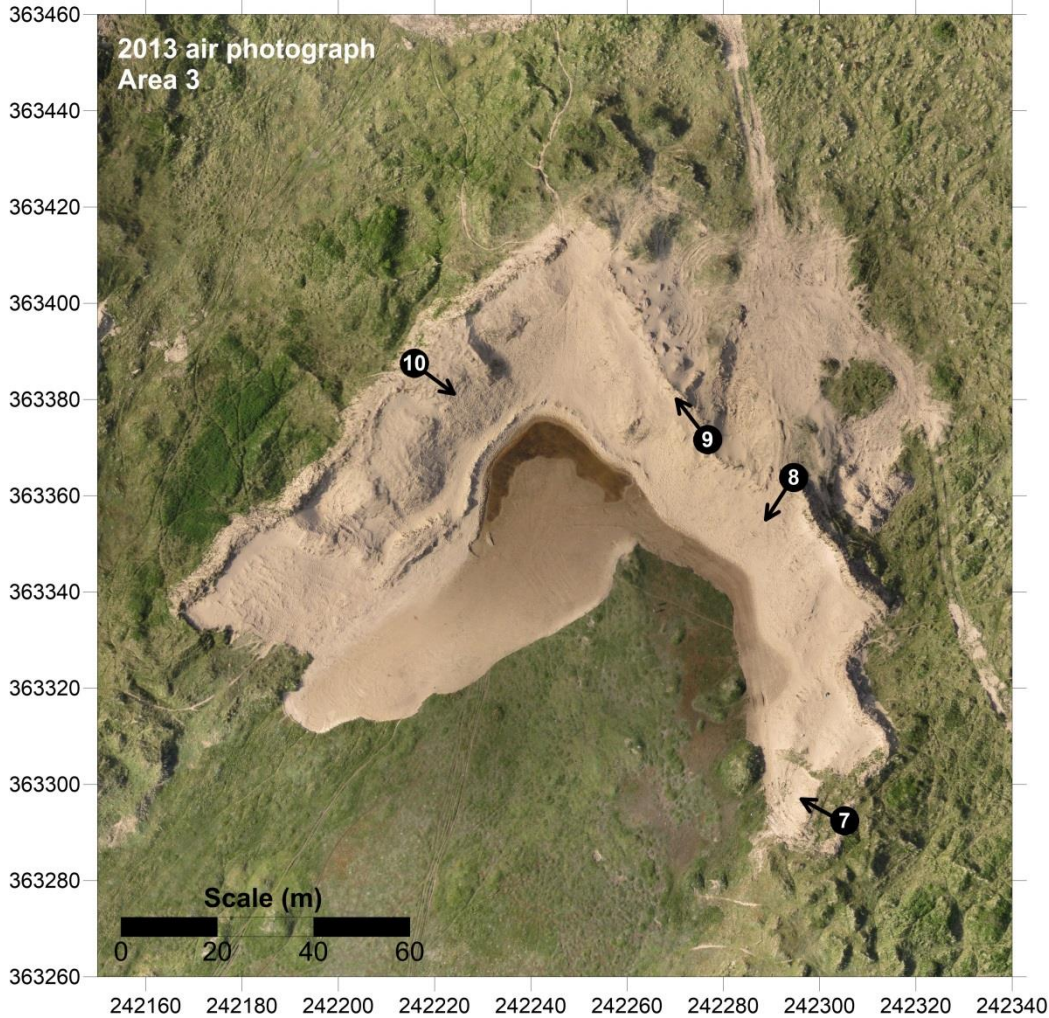
Figure 9. Locations of field photographs 7 to 10 in Area 3 reproduced in this report. Arrows indicate direction of view; base 2013 aerial photography from Google Earth

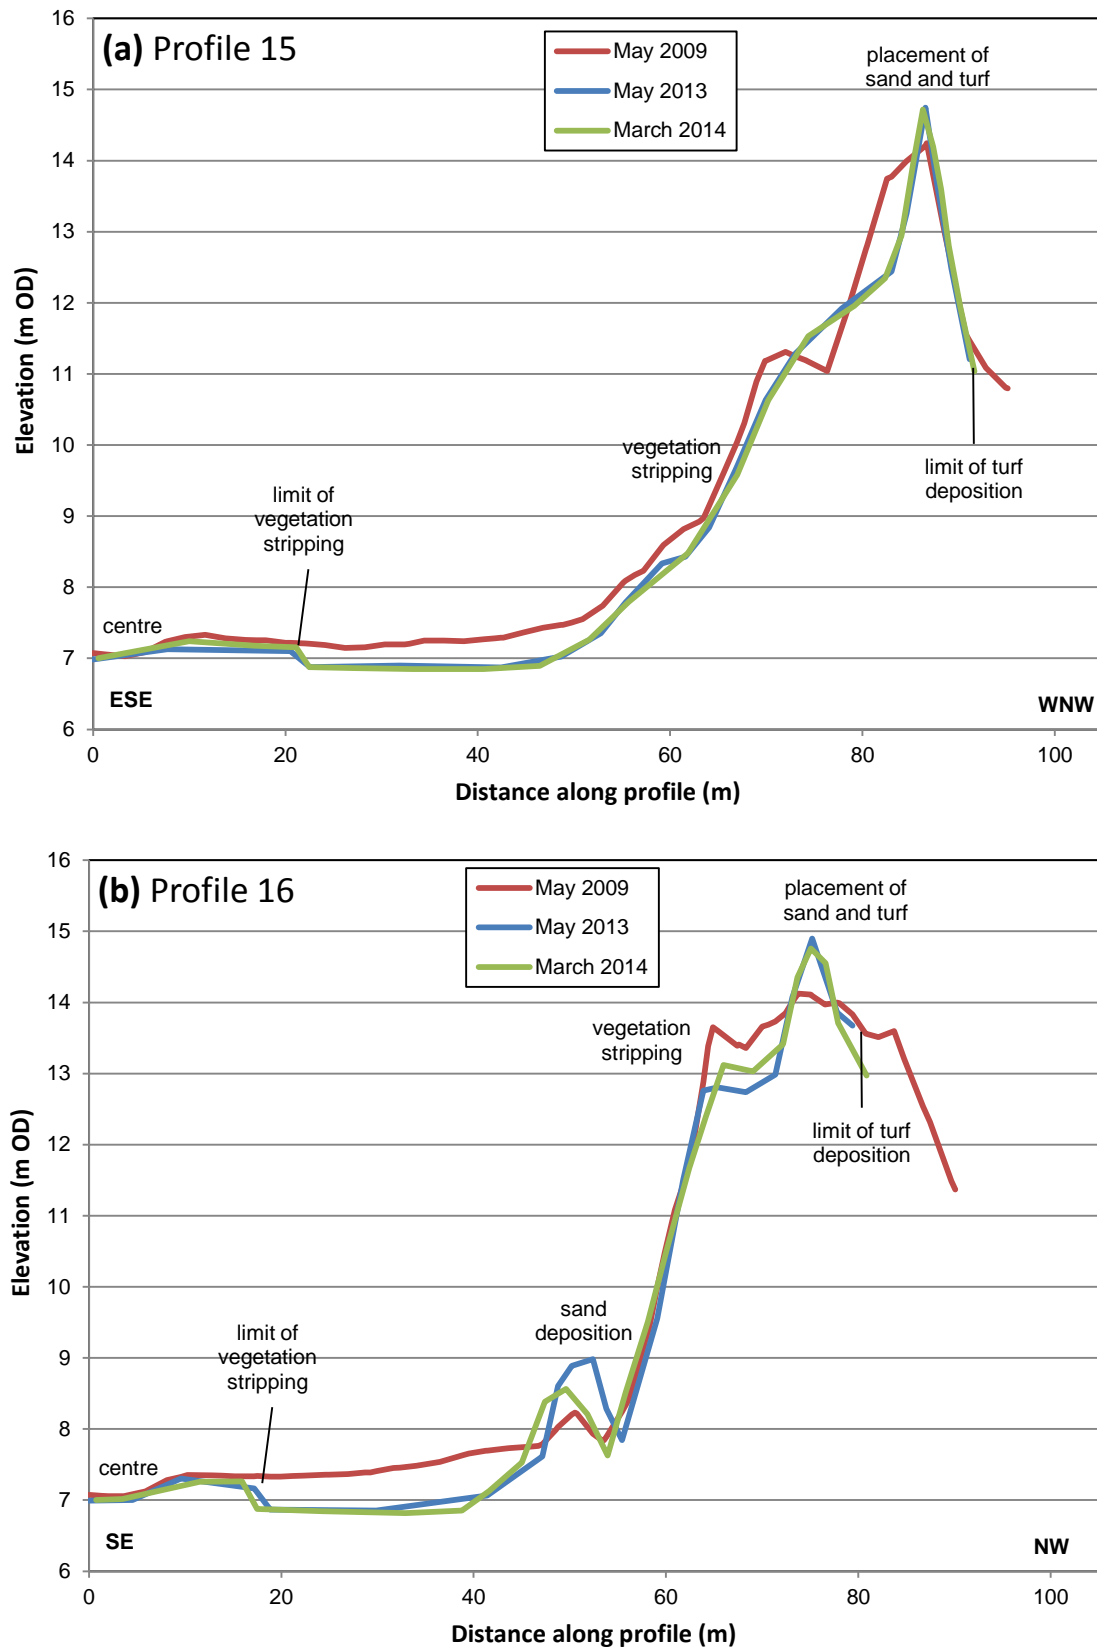
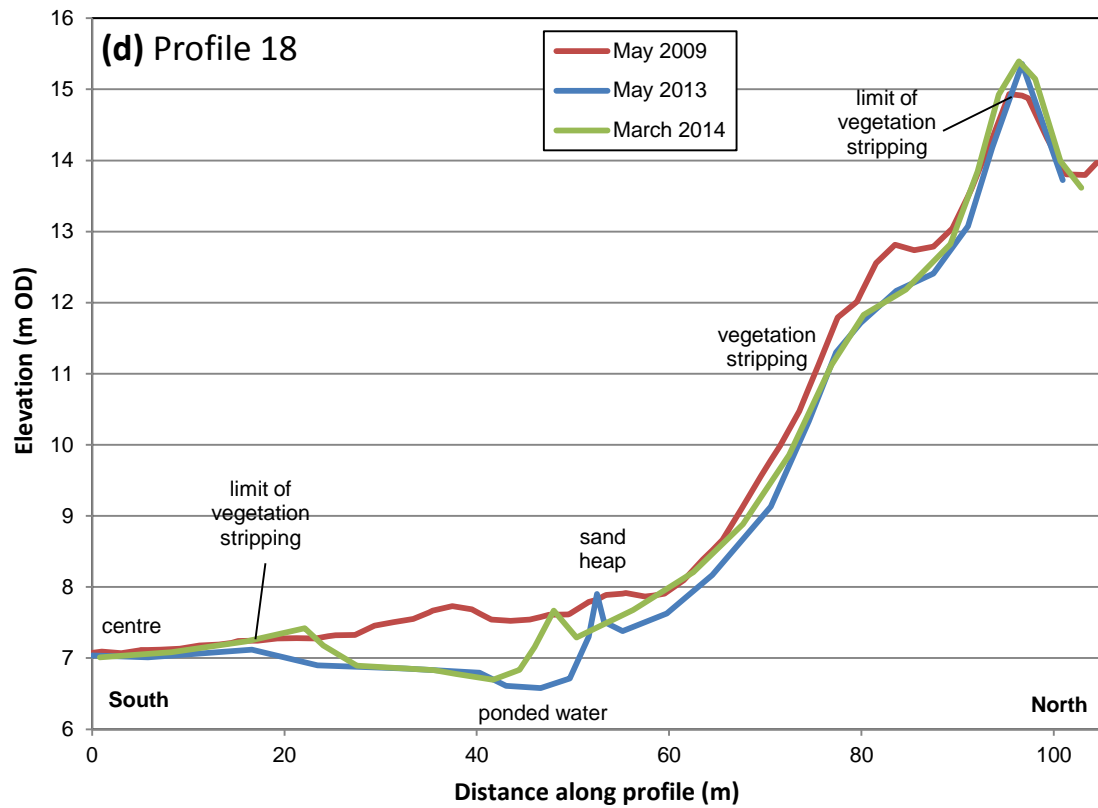
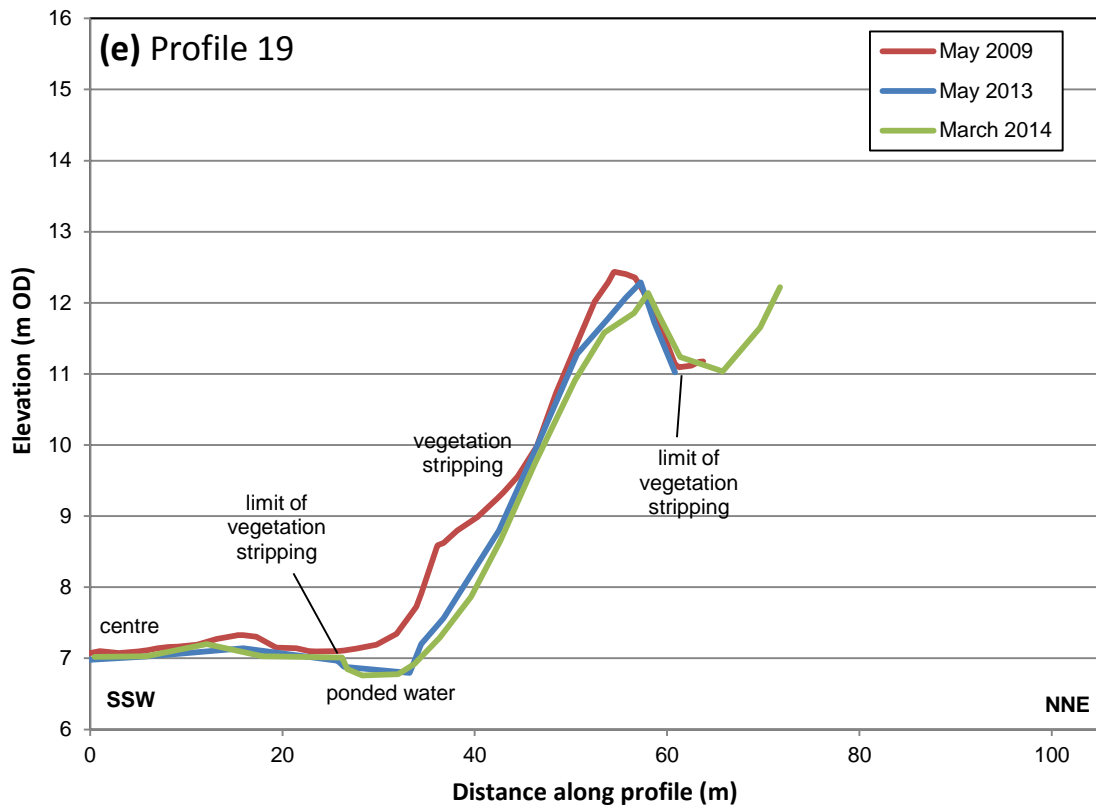
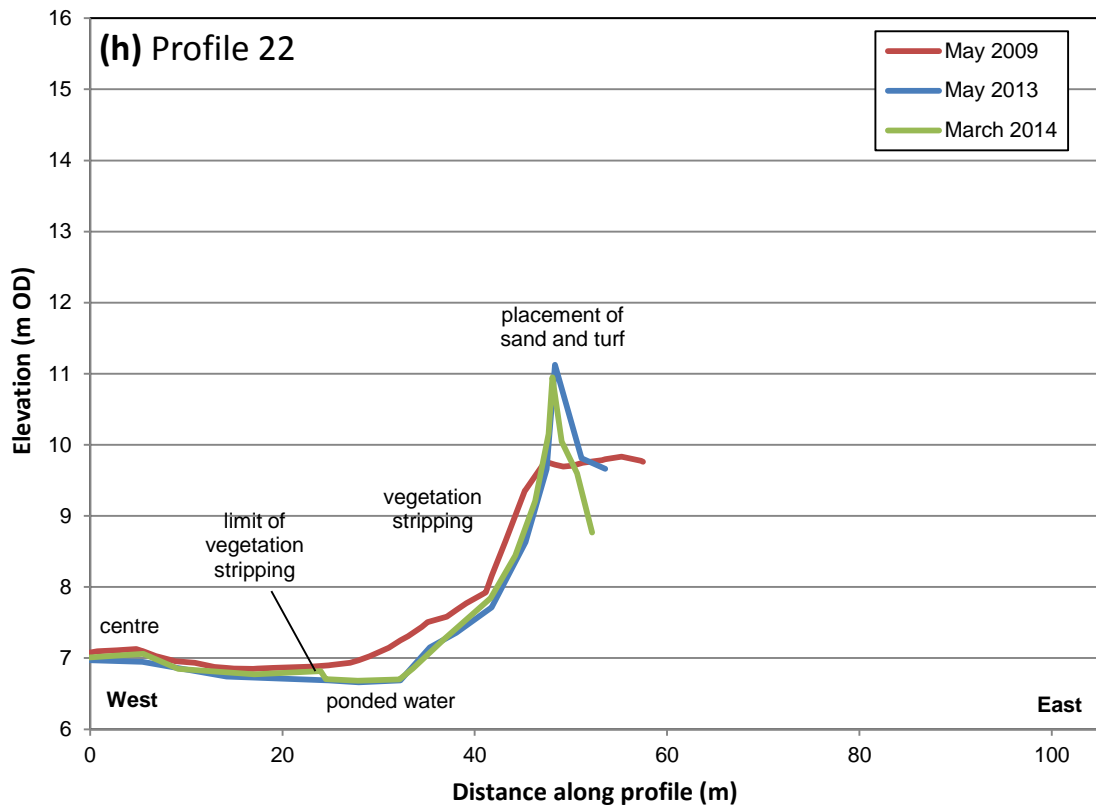
Changes in elevation since May 2013 were again small (0 to 20 cm, depending on location). The main areas of lowering due to deflation were on some lower parts of the stoss slope of the dune (e.g. Profile 18), and parts of the sacrificial sand heaps around the edge of deflation trough. A layer of wind-deposited sand, 1 – 10 cm thick, was evident on the downwind side of the dune crest, having been transported there by southwesterly winds. Some areas of sand accretion were also evident on parts of the stoss side of the dune (e.g. Profile 19).

Figure 10. Comparison of surface levels at profiles 15 and 16 in Area 3, indicated by LiDAR survey on 12th May 2009 (pre-works) and ground surveys on 17 May 2013 and 13 March 2014

Figure 10. continued. Comparison of surface levels at profiles 17 and 18 in Area 3, indicated by LiDAR survey on 12th May 2009 (pre-works) and ground surveys on 17 May 2013 and 13 March 2014

Figure 10. continued. Comparison of surface levels at profiles 19 and 20 in Area 3, indicated by LiDAR survey on 12th May 2009 (pre-works) and ground surveys on 17 May 2013 and 13 March 2014

Figure 10. continued. Comparison of surface levels at profiles 21 and 22 in Area 3, indicated by LiDAR survey on 12th May 2009 (pre-works) and ground surveys on 17 May 2013 and 13 March 2014

Figure 10. continued. Comparison of surface levels at profiles 23 and 24 in Area 3, indicated by LiDAR survey on 12th May 2009 (pre-works) and ground surveys on 17 May 2013 and 13 March 2014

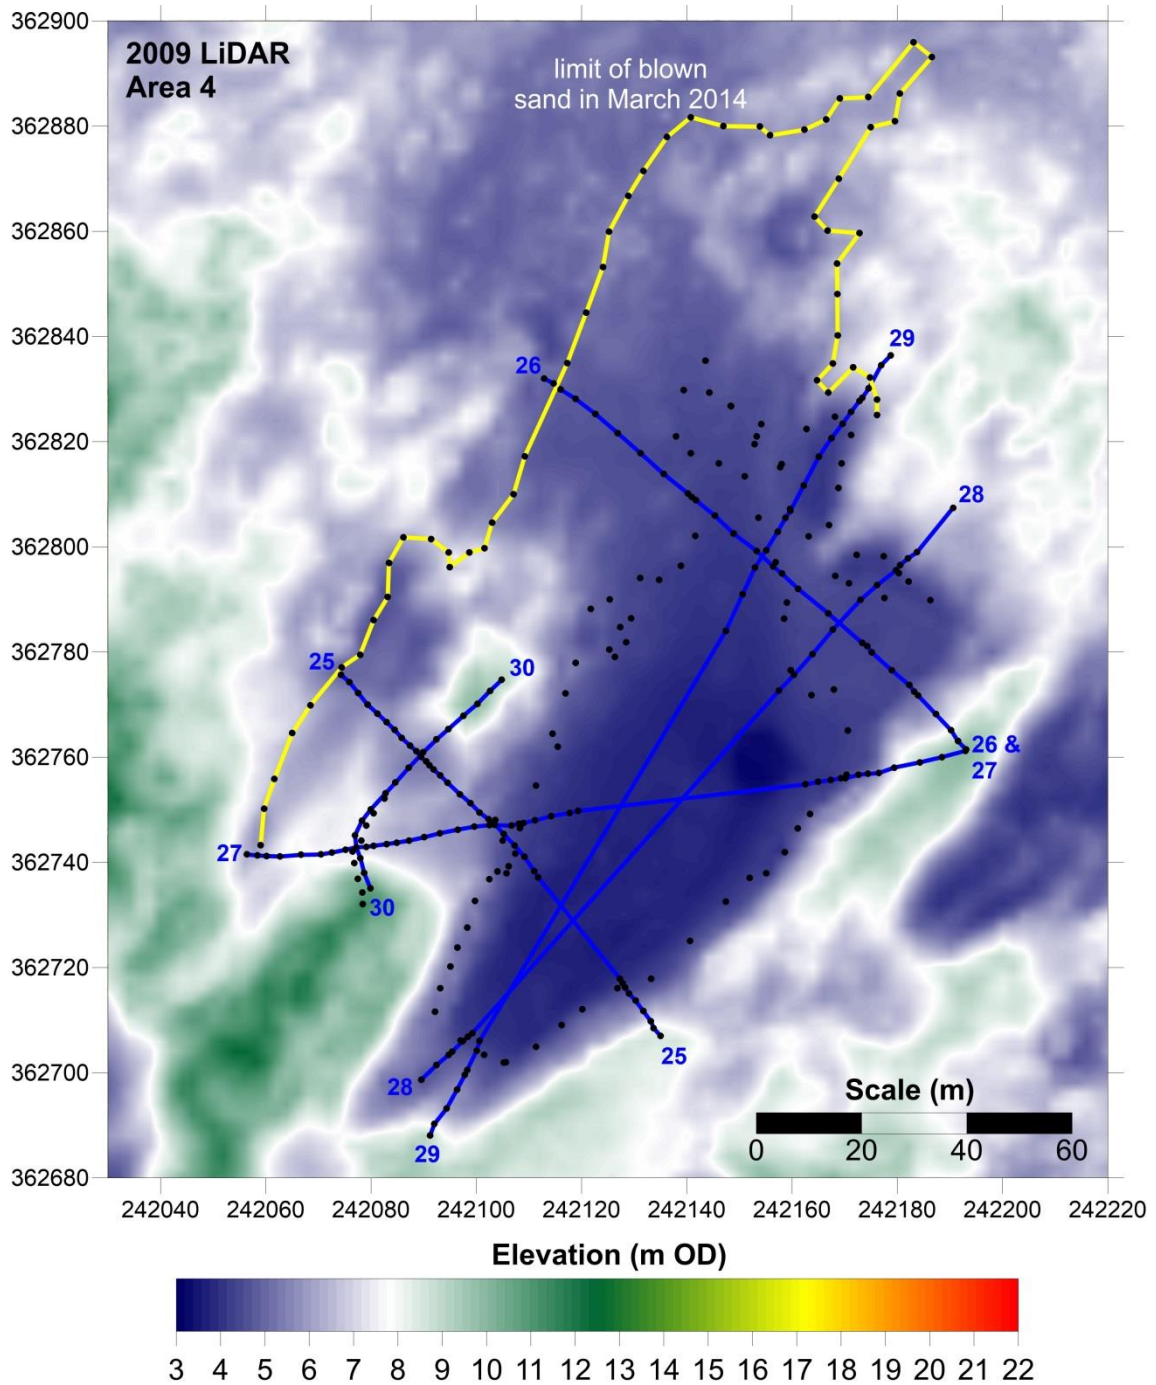
Figure 11. Locations of March 2014 data points (black dots) and cross-profiles (blue lines) in Area 4, overlaid on 2009 LiDAR.

The locations of survey profile lines within Area 4 are shown in Figures 11 and 12. The locations of ground photographs reproduced in this report are shown in Figure 13. Topographic profiles recorded during the March 2014 survey are compared with those of the May 2013 survey in Figure 14.

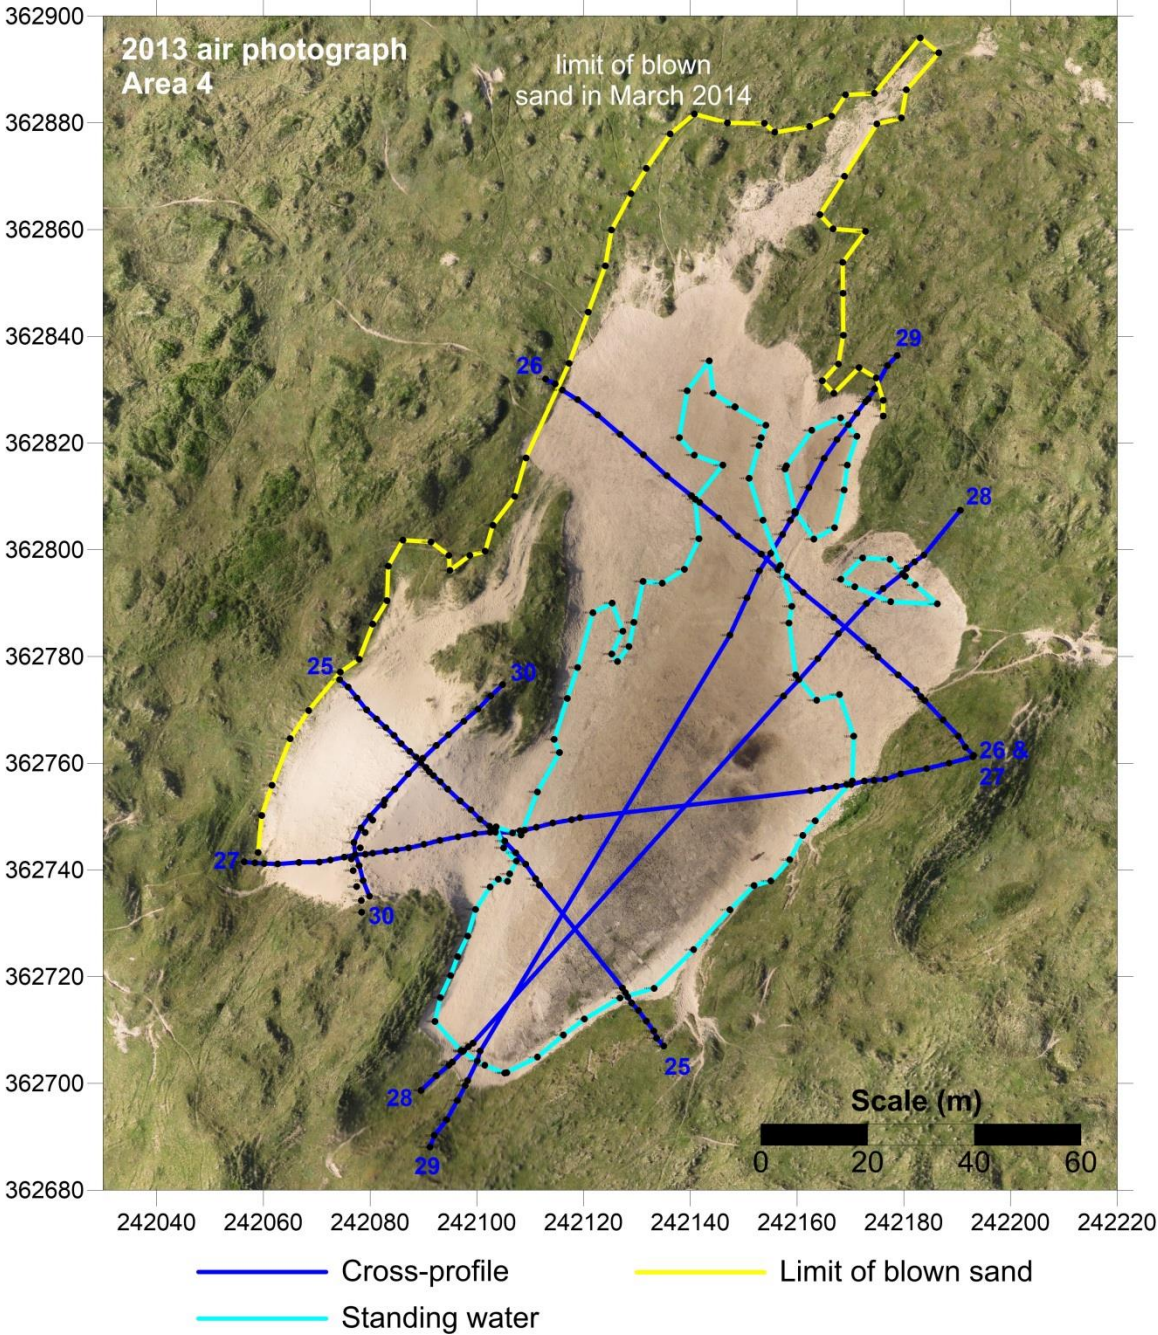
Figure 12. Locations of March 2014 data points (black dots) and cross-profiles (blue lines) in Area 4, overlaid on June 2013 aerial photographs (flown by exeGesIS). The limit of blown sand and areas of standing water surveyed in March 2014 are also shown.

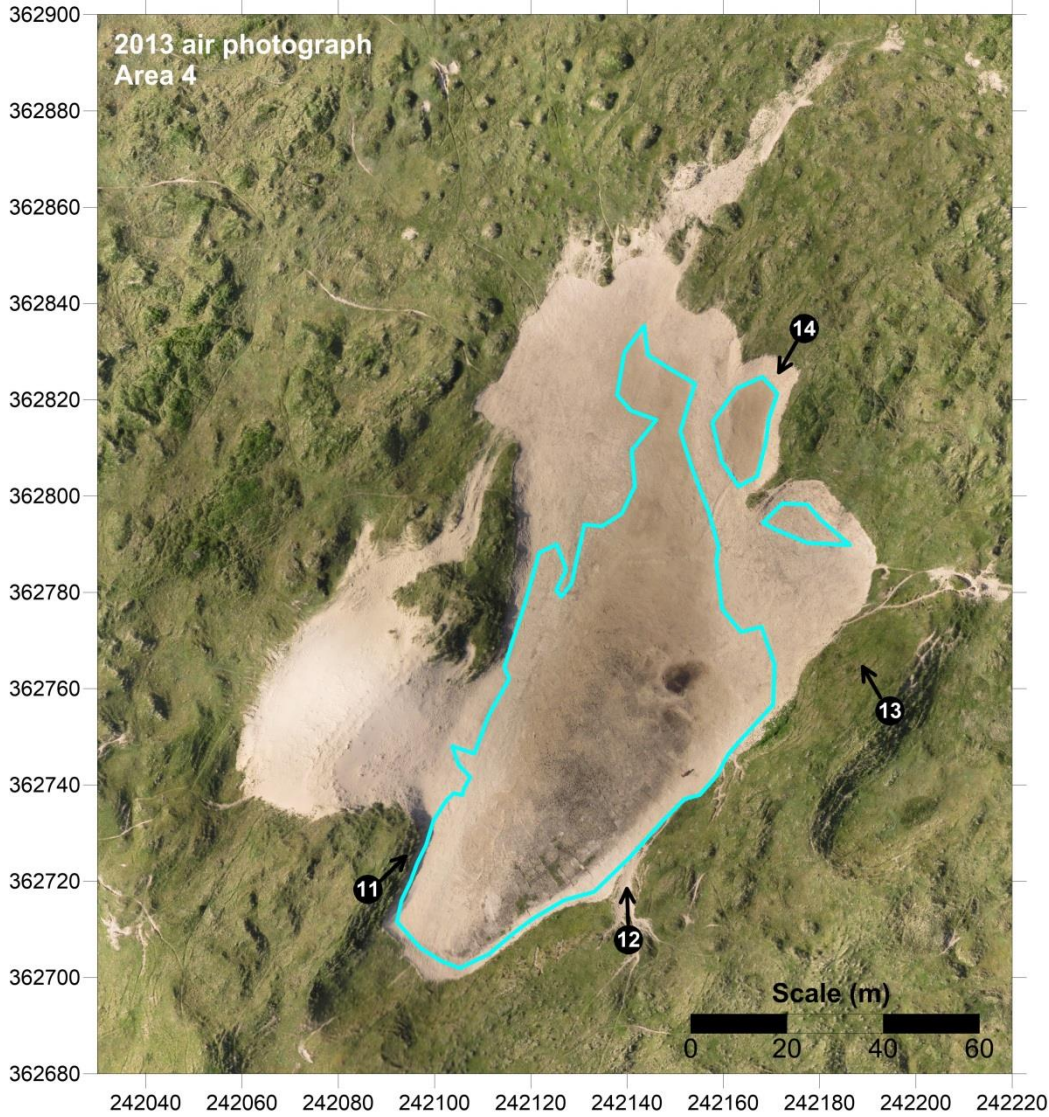
Figure 13. Locations of field photographs 11 to 14 in Area 4 reproduced in this report. Arrows indicate direction of view; base 2013 aerial photography from Google Earth

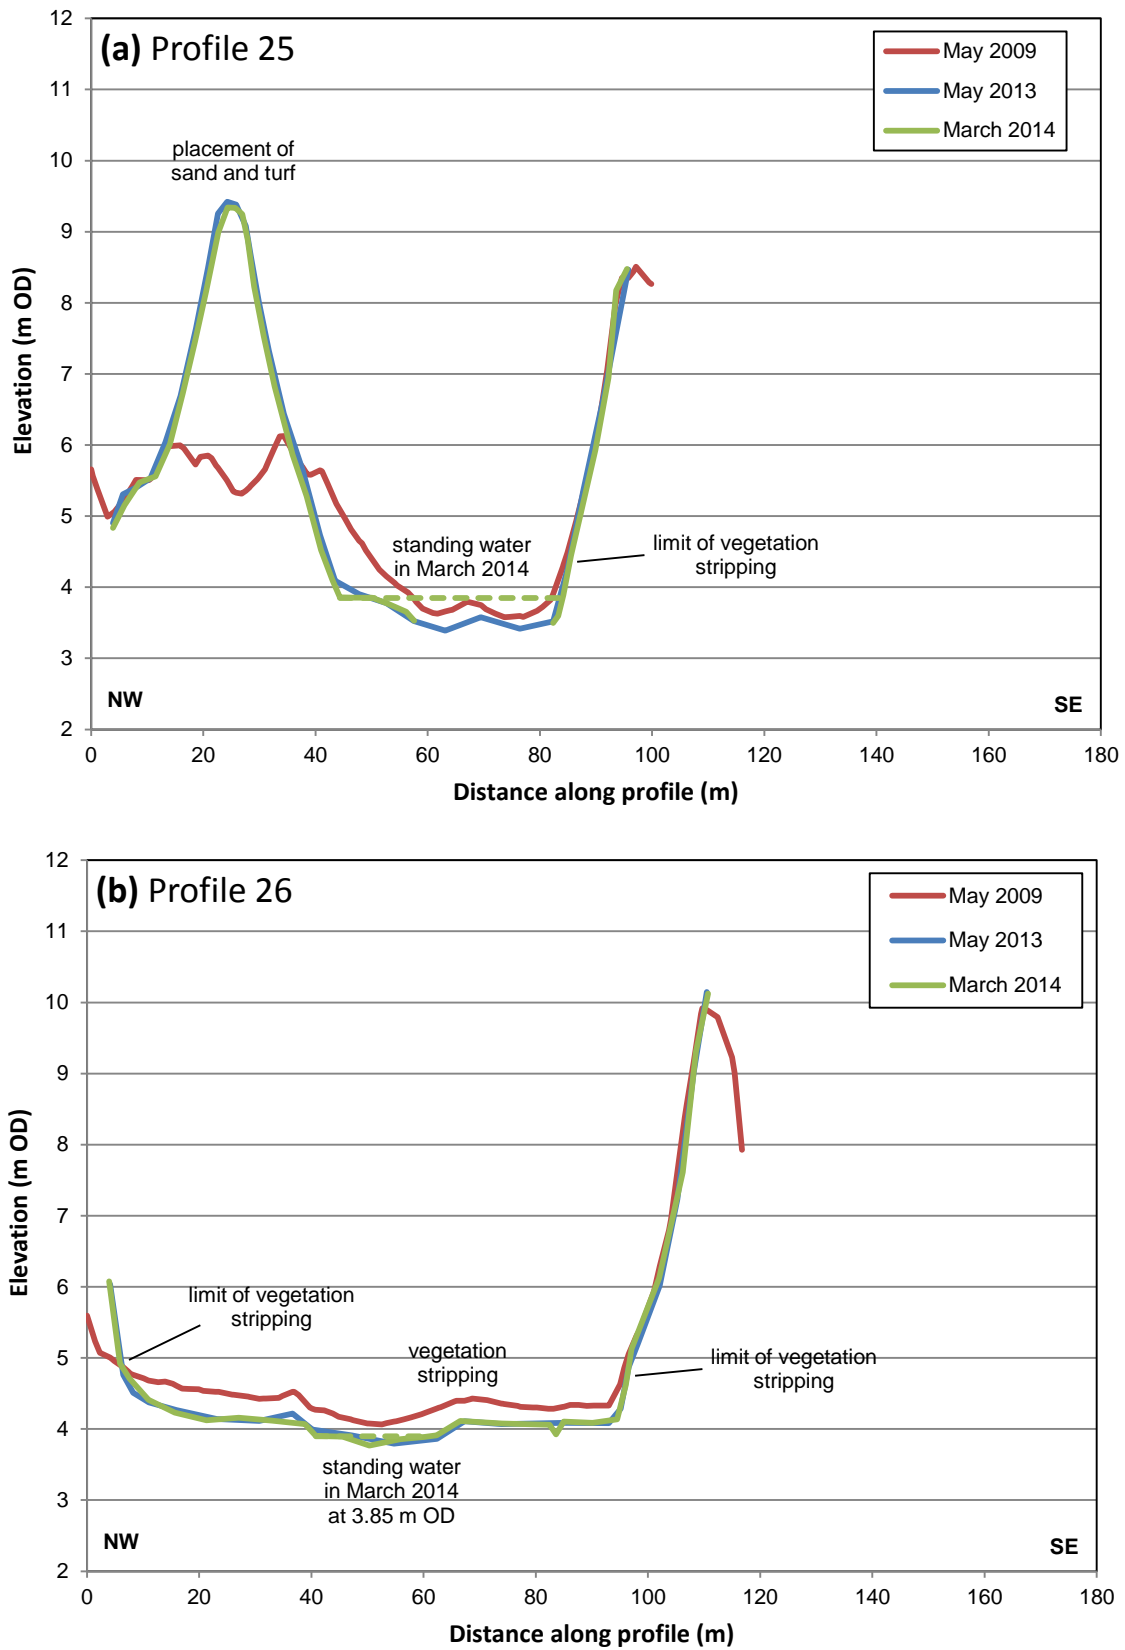
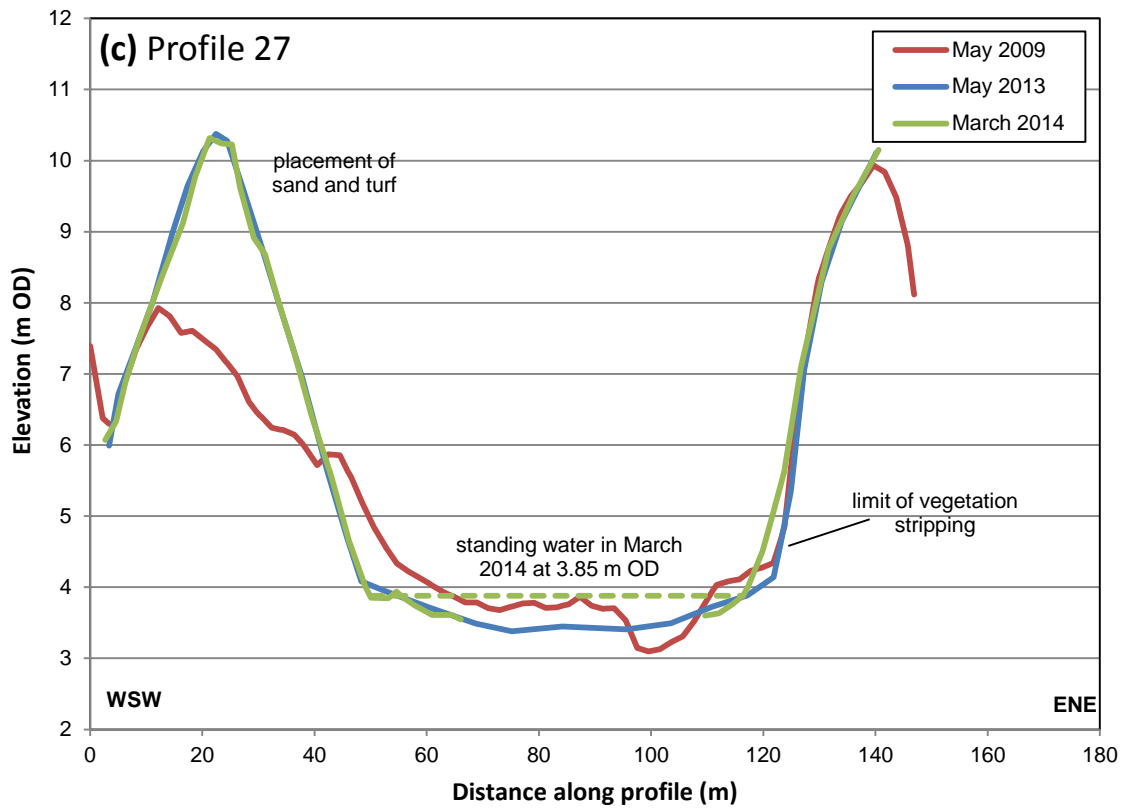
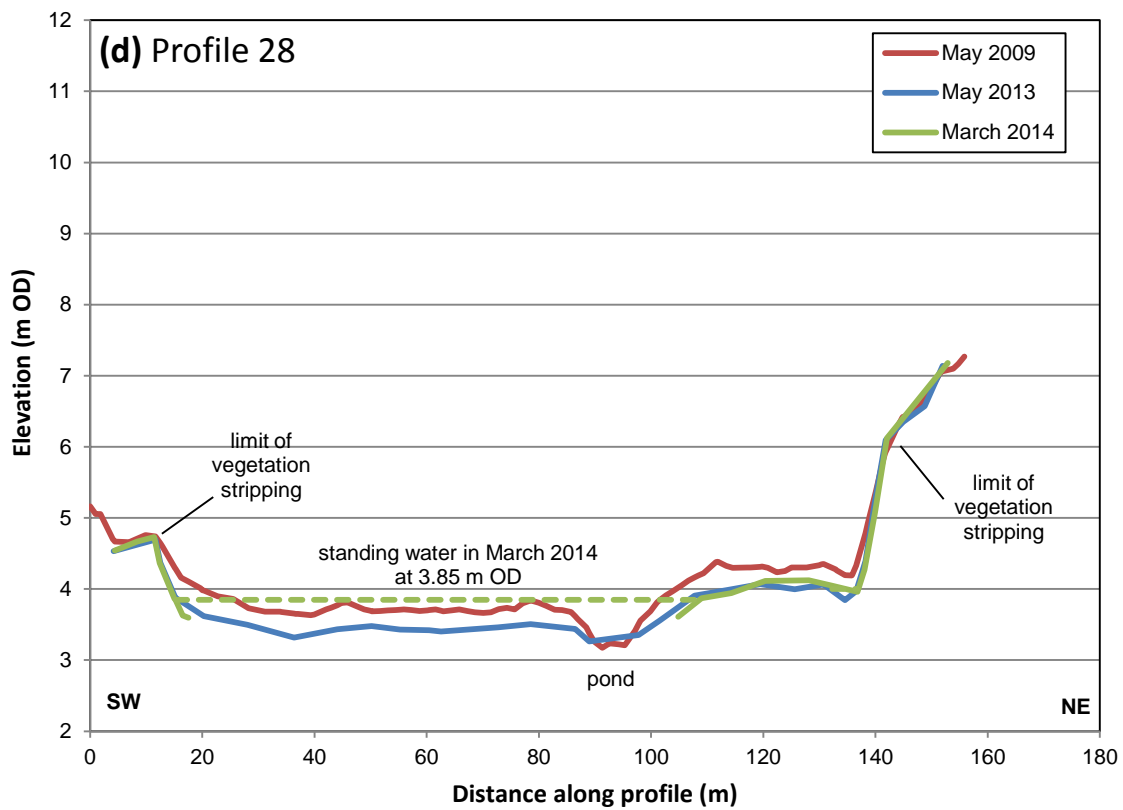
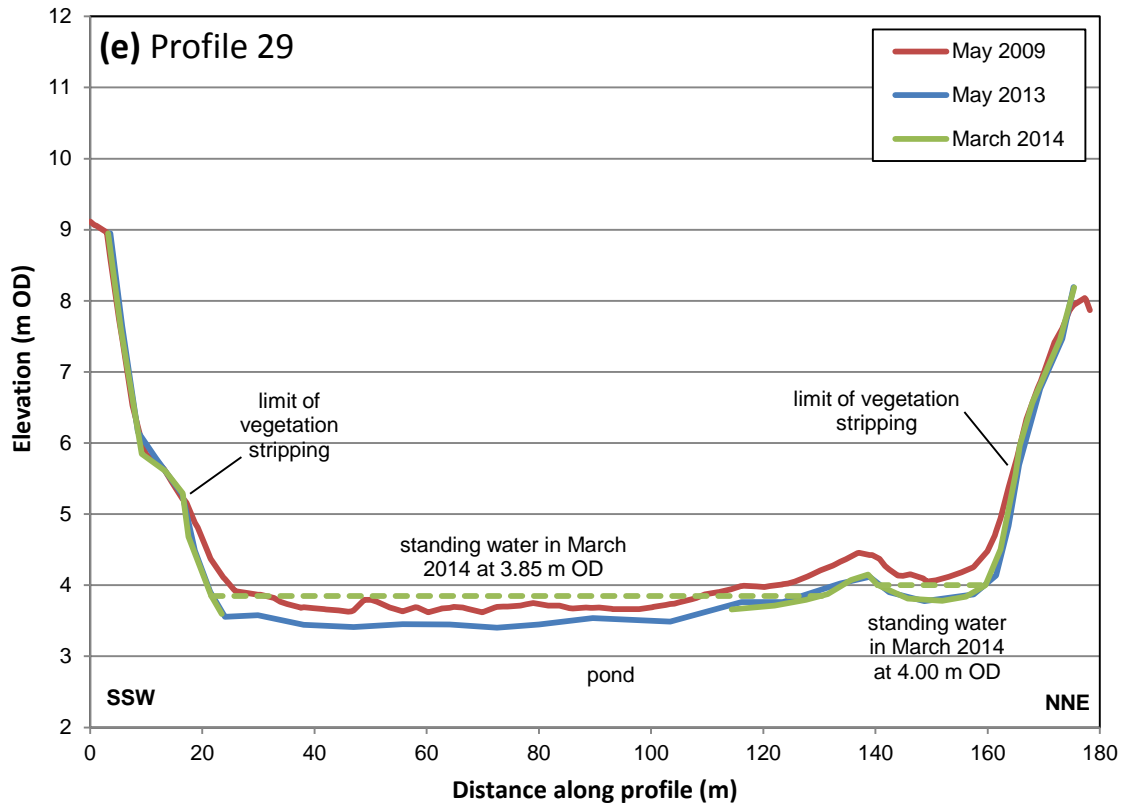
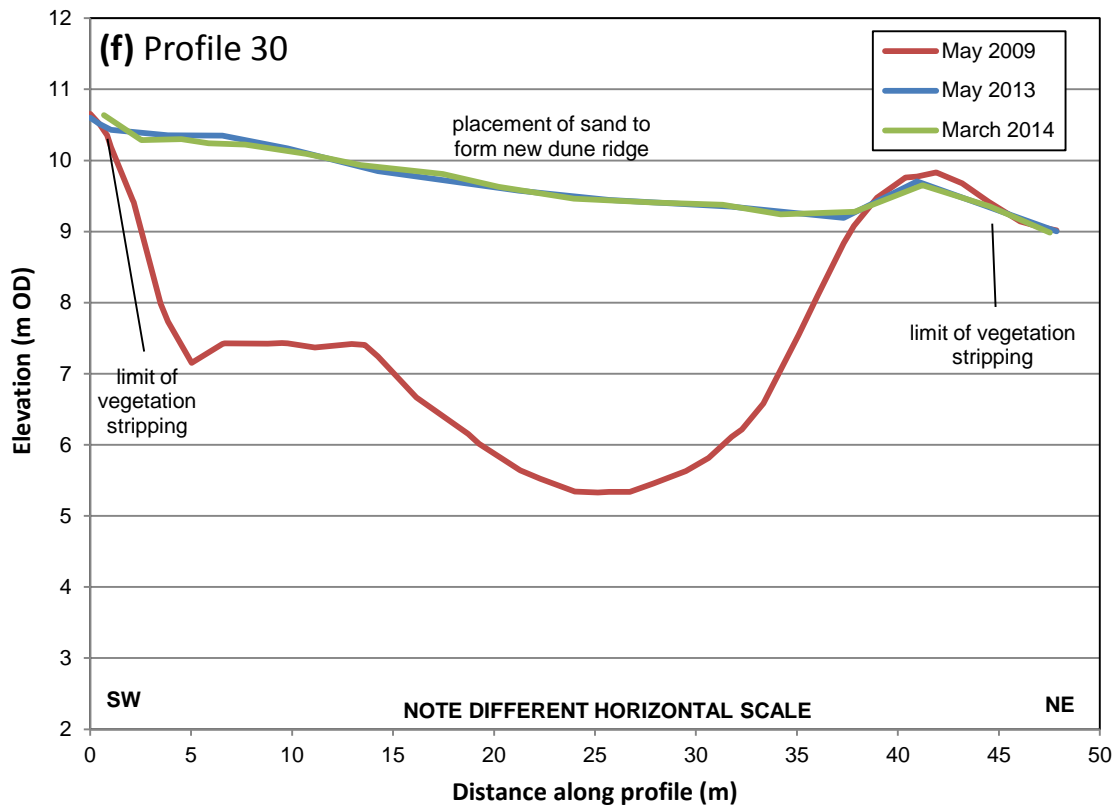
Only very small elevation differences are evident on the higher sand areas around Area 4. Some limited deflation has taken place at the downwind (northeastern) end of the scraped area where the water level had fallen sufficiently to expose bare sand. Sand transported by the wind from the margins of this area and from the artificial sand mound had formed a thin (0-10cm) thick layer on the vegetation on the downwind side of the trial area.

Figure 14. Comparison of surface levels at profiles 25 and 26 in Area 4, indicated by LiDAR survey on 12 May 2009 (pre-works) and ground surveys on 17 May 2013 and 13 March 2014

Figure 14. continued. Comparison of surface levels at profiles 27 and 28 in Area 4, indicated by LiDAR survey on 12 May 2009 (pre-works) and ground surveys on 17 May 2013 and 13 March 2014

Figure 14. continued. Comparison of surface levels at profiles 29 and 30 in Area 4, indicated by LiDAR survey on 12 May 2009 (pre-works) and ground surveys on 17 May 2013 and 13 March 2014

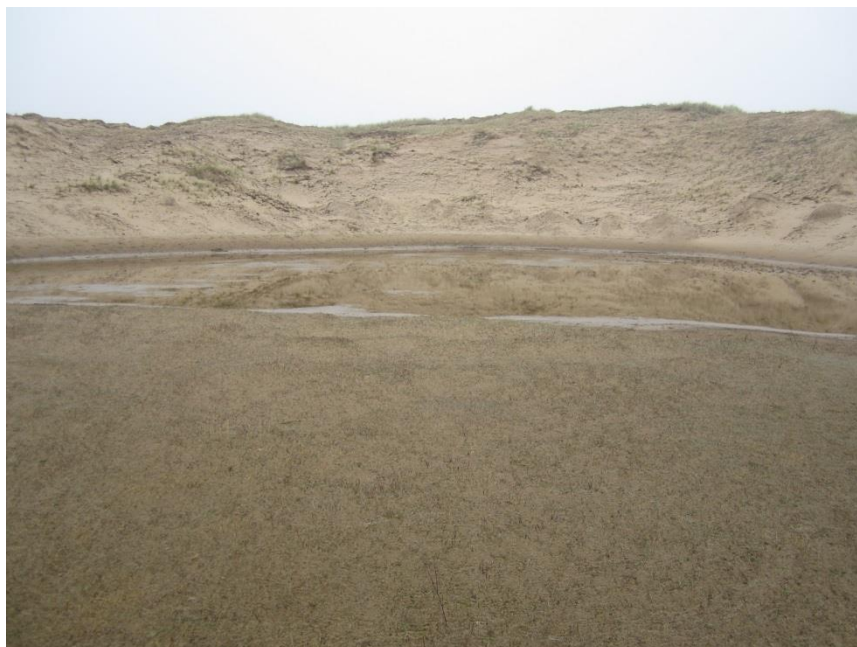
Photograph 1. Central axis of the Area 2, looking NE

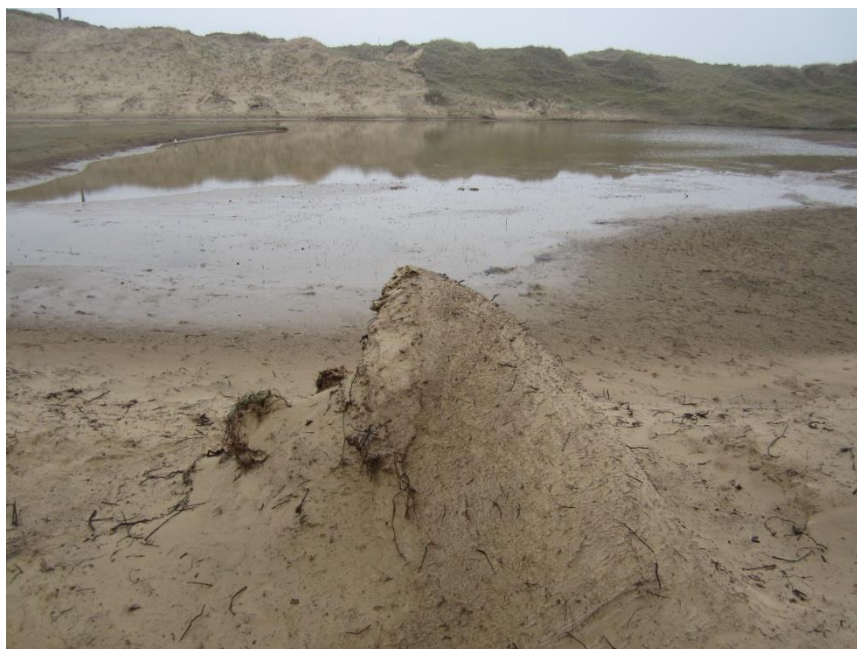
Photograph 2. View across deflation trough of Area 2, looking E

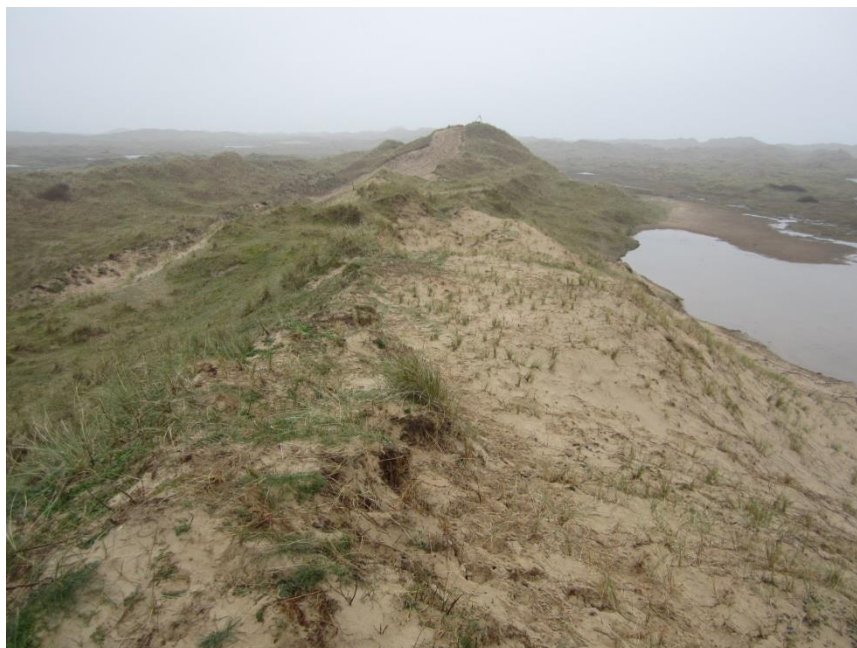
Photograph 3. Southern 'arm' of Area 2, looking seawards

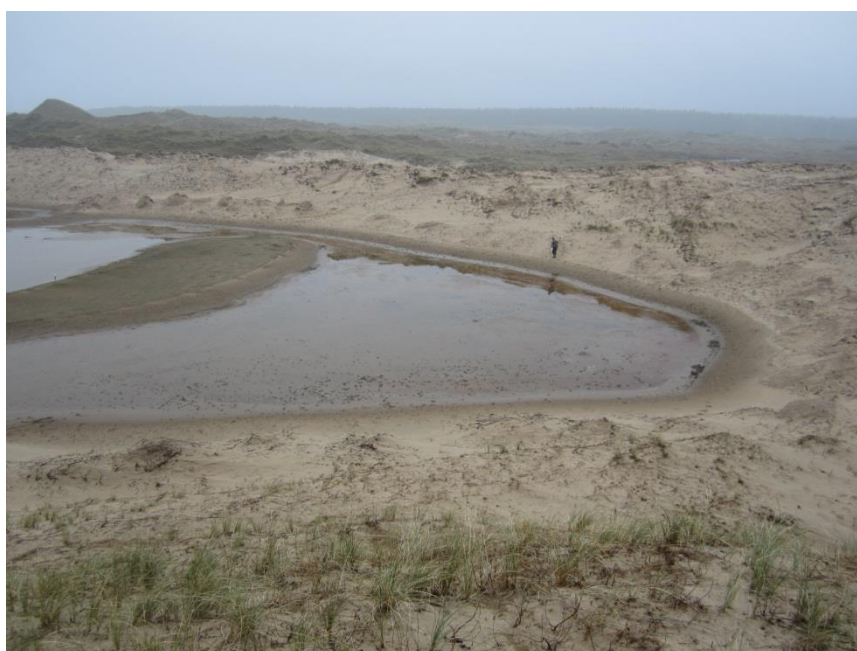
Photograph 4. Deflation corridor of Area 2, looking W

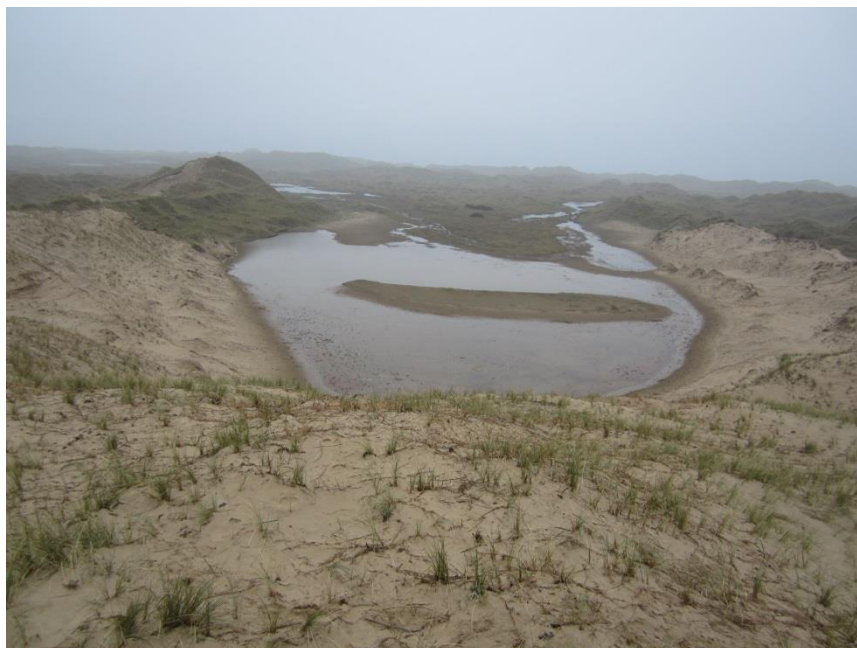
Photograph 5. Central axis of the Area 2, looking SW

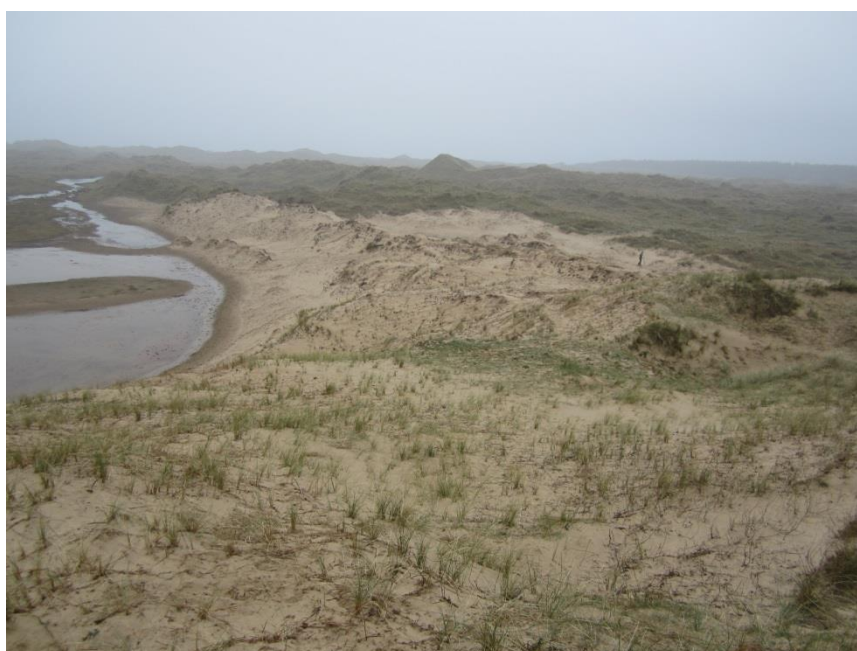
Photograph 6. Northern 'arm' of Area 2, looking seawards

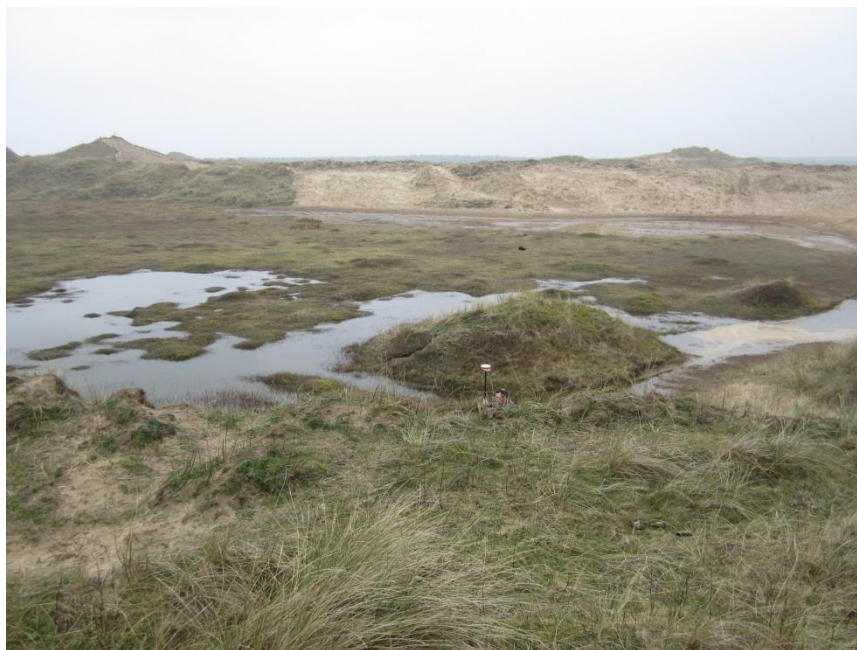
Photograph 7. View north across deflation trough of Area 3.

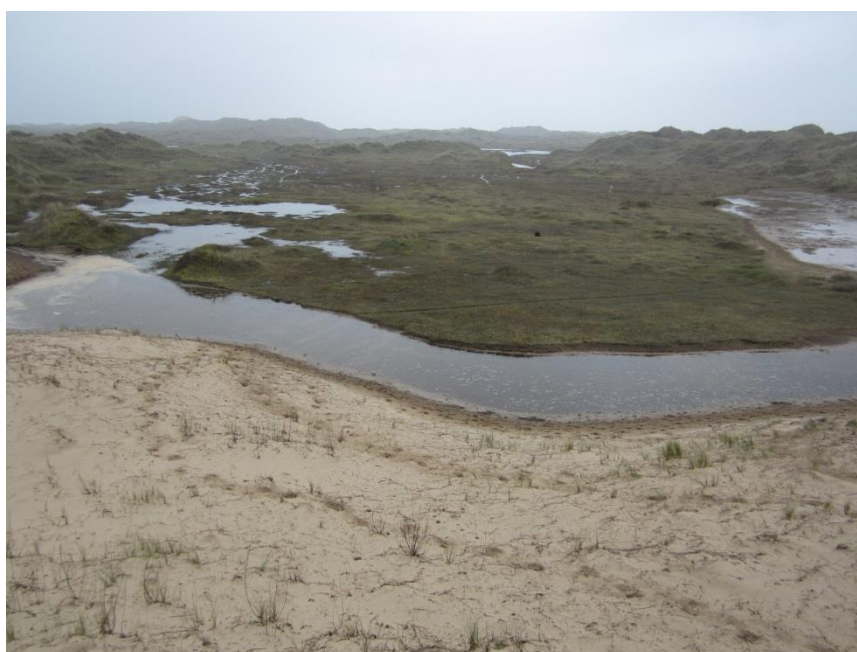
Photograph 8. View seawards along deflation trough of Area 3.

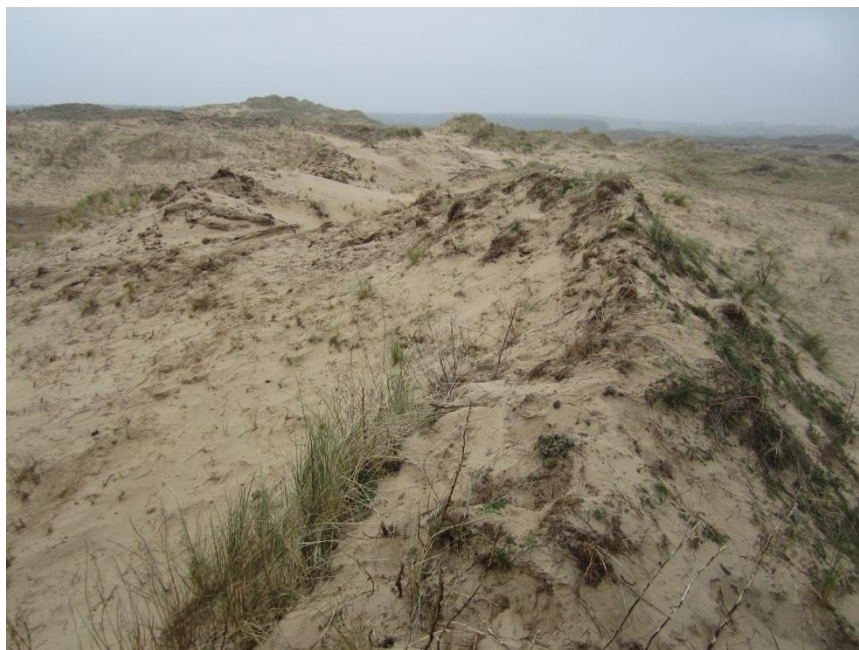
Photograph 9. View north across the dune crest of Area 3.
