Newborough Phase 1 Dune Rejuvenation Works Topographic Survey Report

Kenneth Pye Associates Ltd

Report No: 95

Date: March 2014

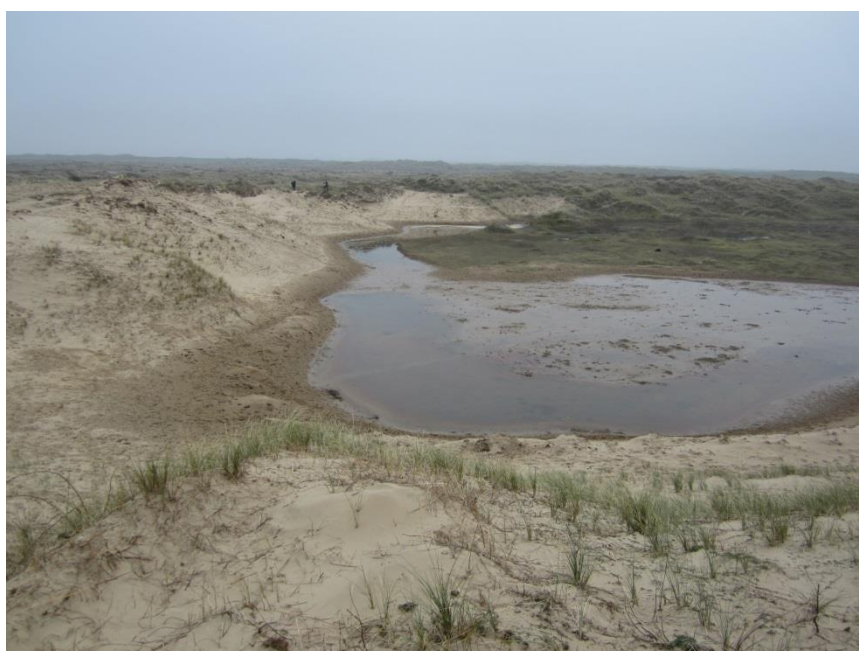
Photograph 10. Oblique view towards the WSW across the deflation trough of Area 3.

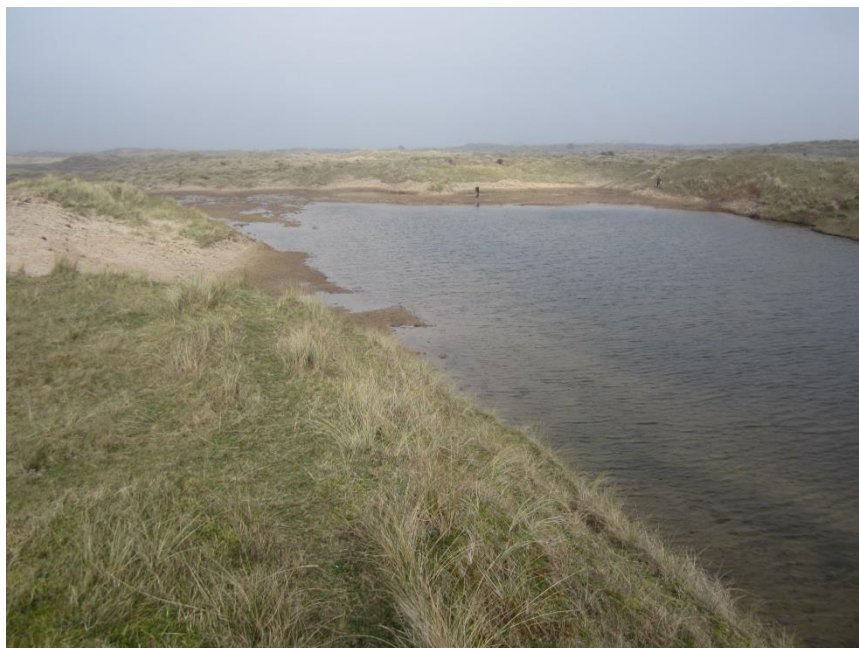
The winter of 2013-14 was relatively wet, with the result that groundwater levels were high at the time of survey and shallow lakes were present in all three areas. At the upwind end of Area 4 the lake was more than 0.8 m deep in places.

Photograph 11. View west across the flooded 'deflation trough' of Area 4.

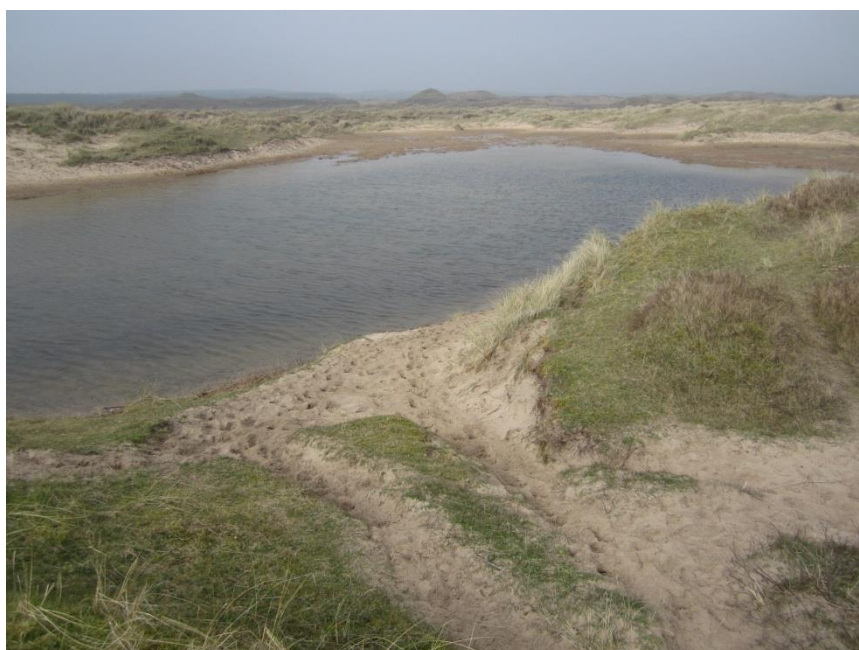
Photograph 12. View NE north across flooded 'deflation trough' of Area 4.

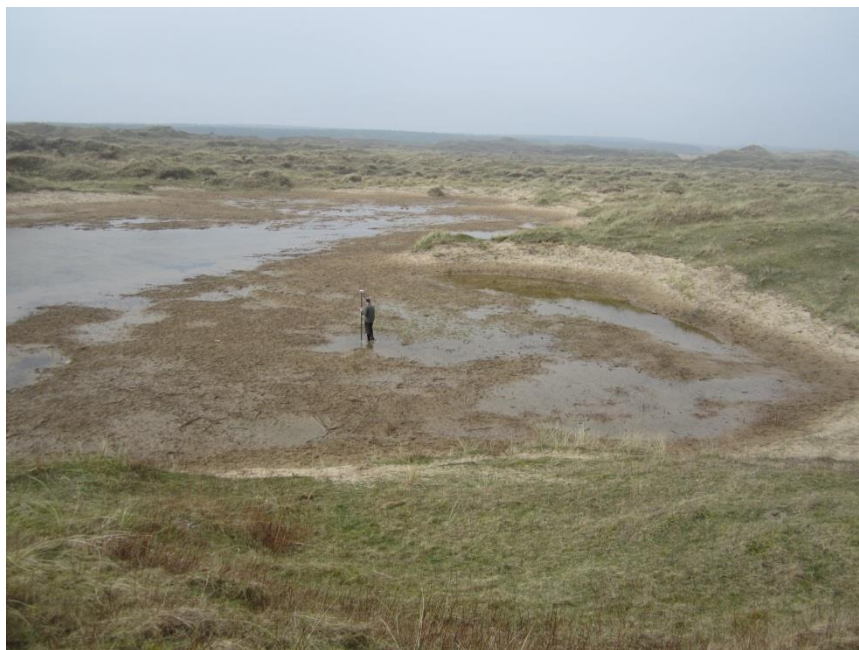
Photograph 13. The NE end of the ‘deflation trough’ of Area 4.

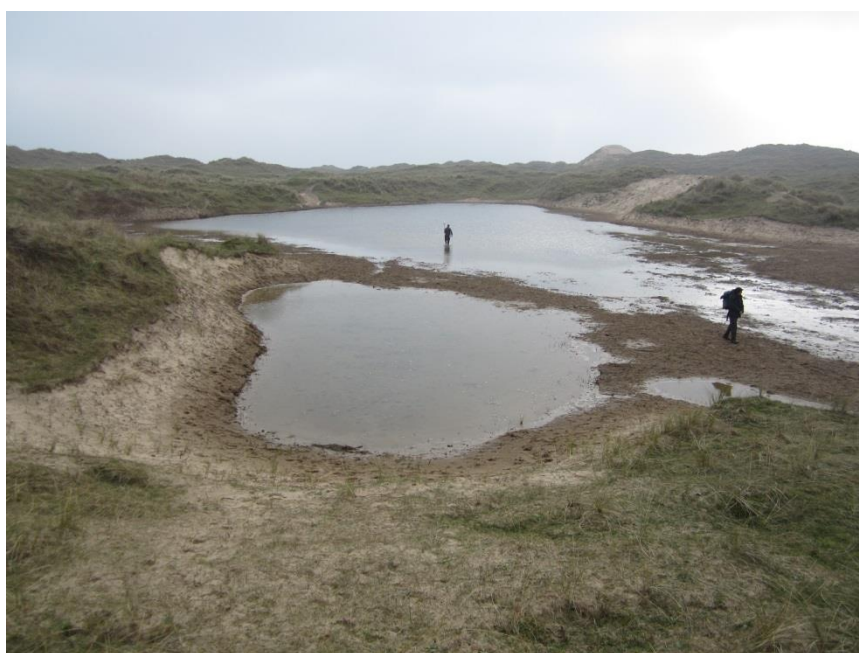
Photograph 14. View east across the inland part of the ‘deflation trough’ of Area 4.
