Newborough Phase 2 Site: Zone 1 West Dune Rejuvenation Works Topographic Survey Report

Kenneth Pye & Simon J. Blott

Kenneth Pye Associates Ltd

Report No: 103

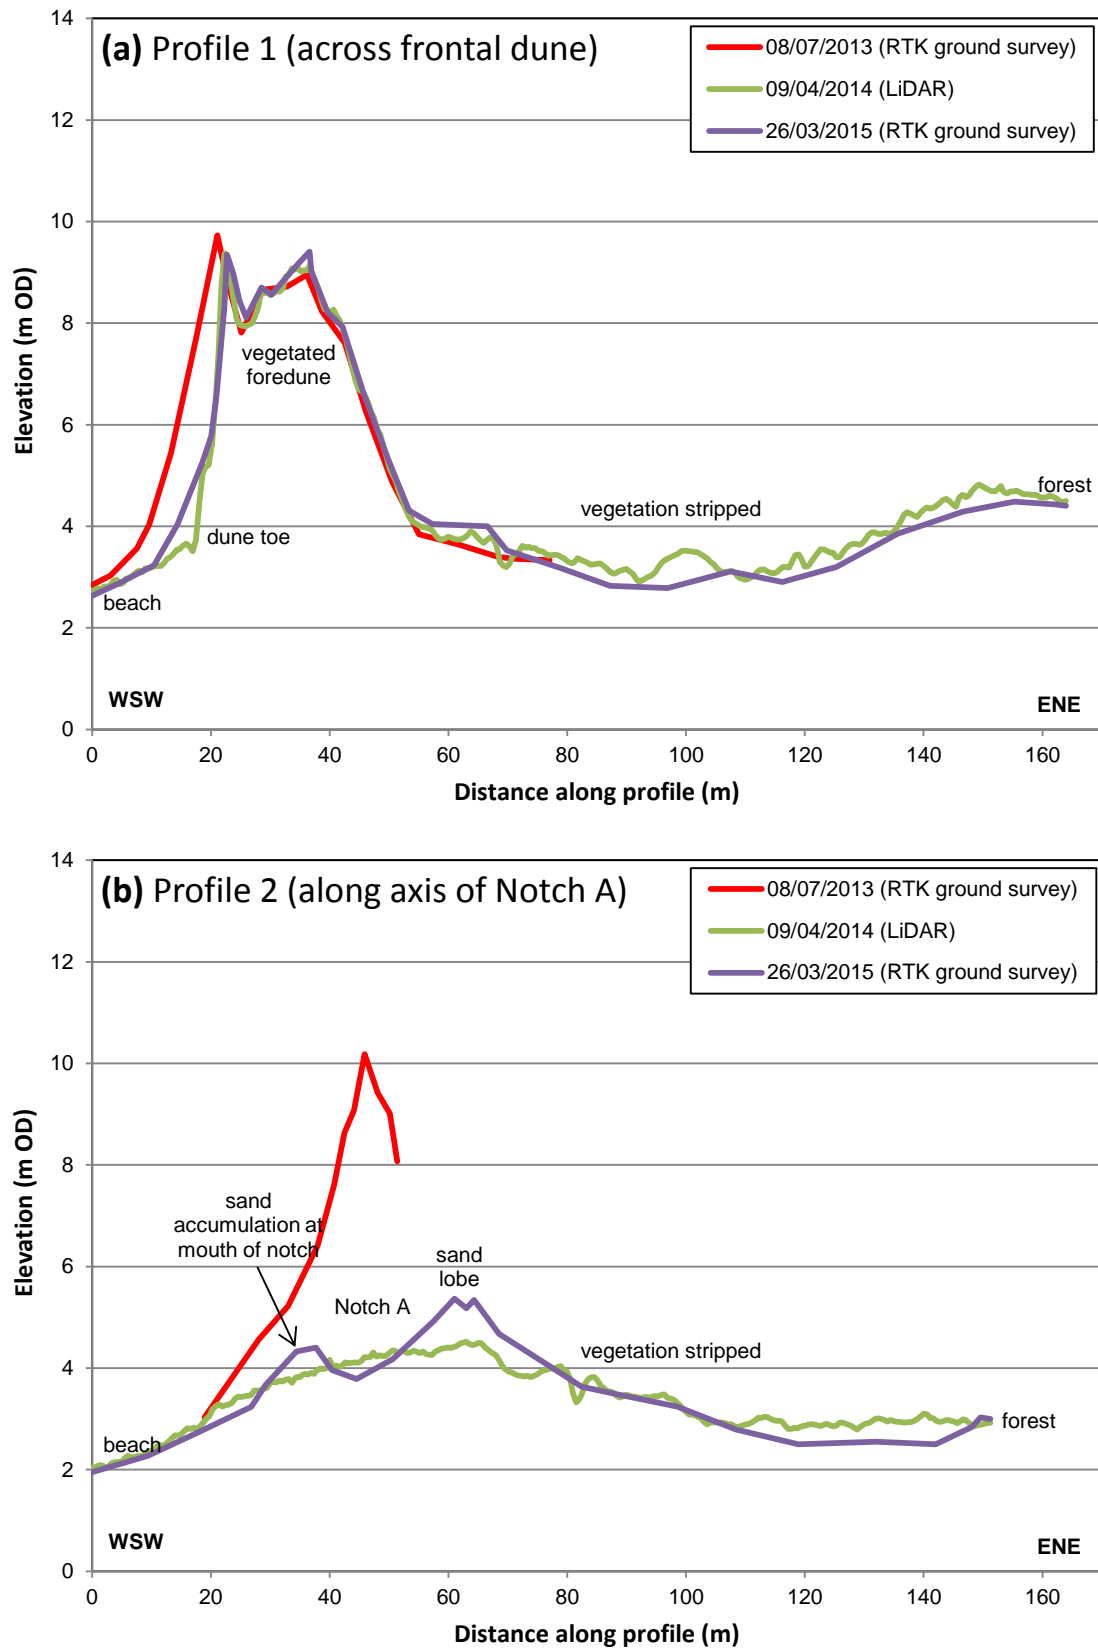
Figure 6a shows recession for the seaward side of the frontal dune ridge which occurred as a result of the storms during the winter of 2013-14.

Figure 6b shows significant change in the long (axial) profile of Notch A between April 2014 and March 2015 due to sand accumulation at the mouth of the notch and formation of a depositional sand lobe on the landward side of the notch.

Figure 6. Comparison of surface levels at profiles 1 and 2, indicated by RTK ground survey on 08/07/2013 (pre-works), LiDAR survey on 9 April 2014 (after the notches had been made), and RTK ground survey on 26 March 2015.

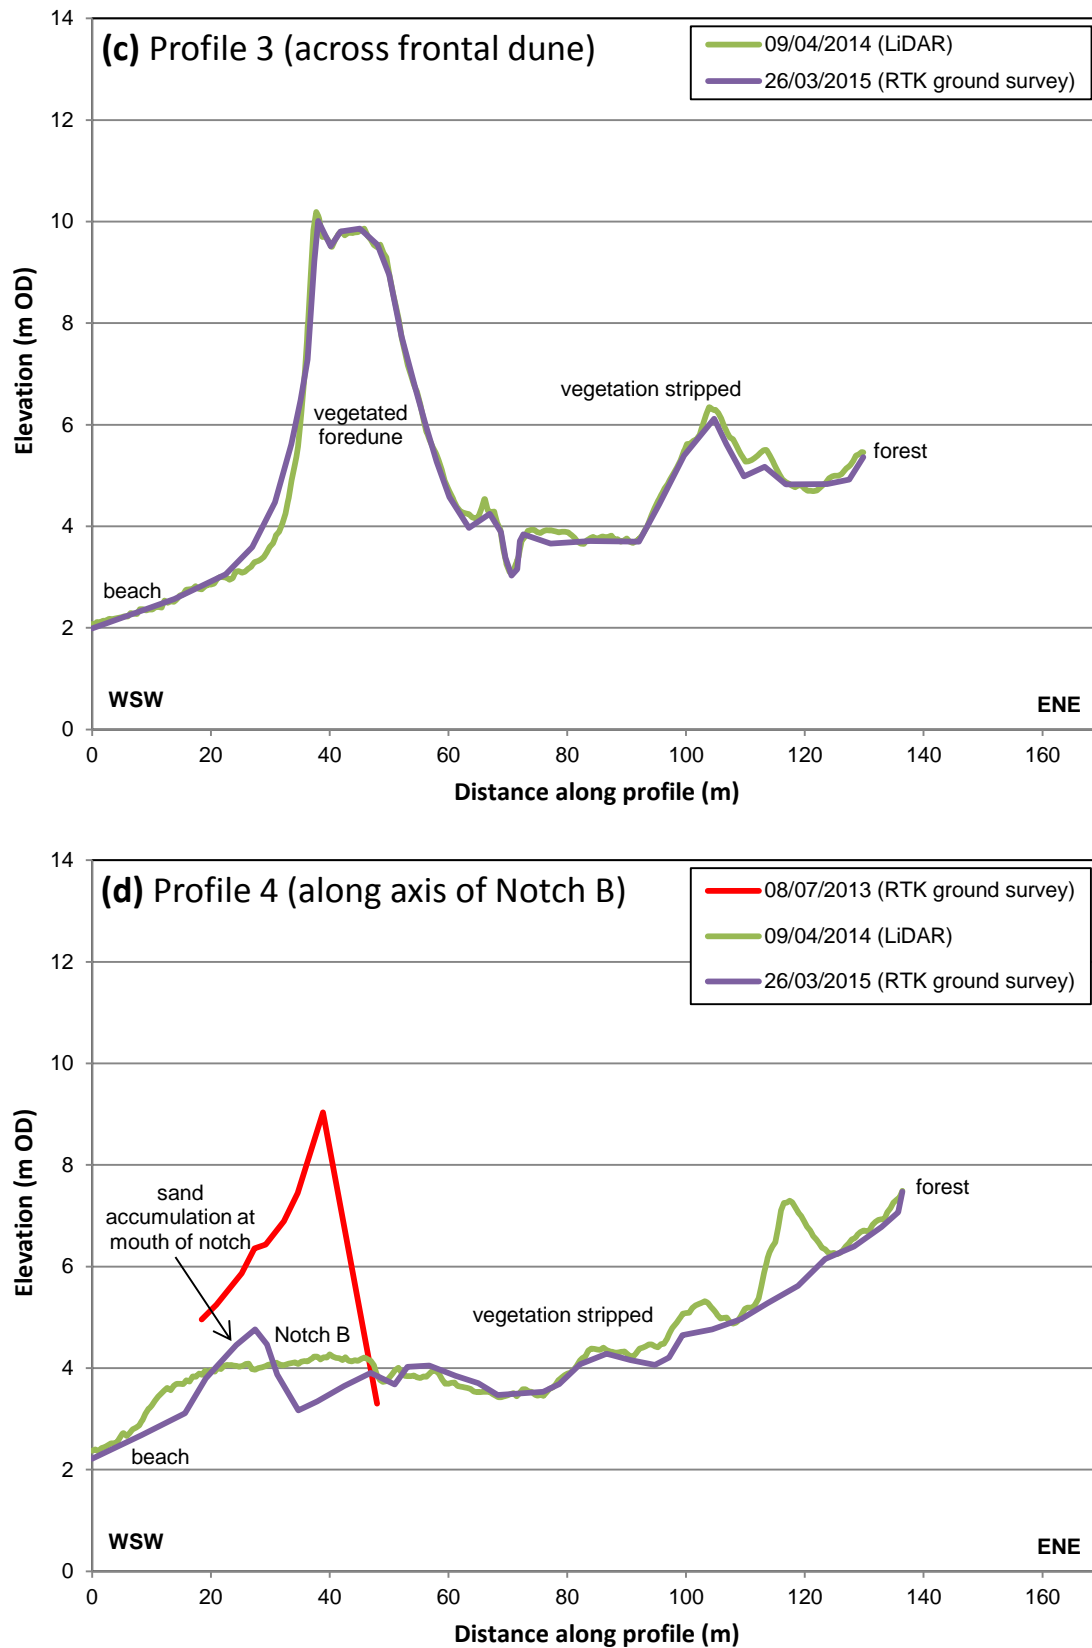
Figure 6c shows that at profile 3 the ground surface behind the frontal dune was locally lowered only by a relatively small amount (up to c. 20 cm) during the de-vegetation process. At the landward end of profile 4 some small dune features were removed during the works (Figure 6d). Within Notch 4 the relatively smooth profile present in April 2014 had changes by March 2015 as a result of sand accumulation at the mouth of the notch, creating a mound, and scour immediately behind.

Figure 6 (continued). Comparison of surface levels at profiles 3 and 4, indicated by LiDAR survey on 9 April 2014 (after the notches had been made), and RTK ground survey on 26 March 2015. Profile 4 was also surveyed before the works during a RTK ground survey on 08/07/2013, and this is also shown.

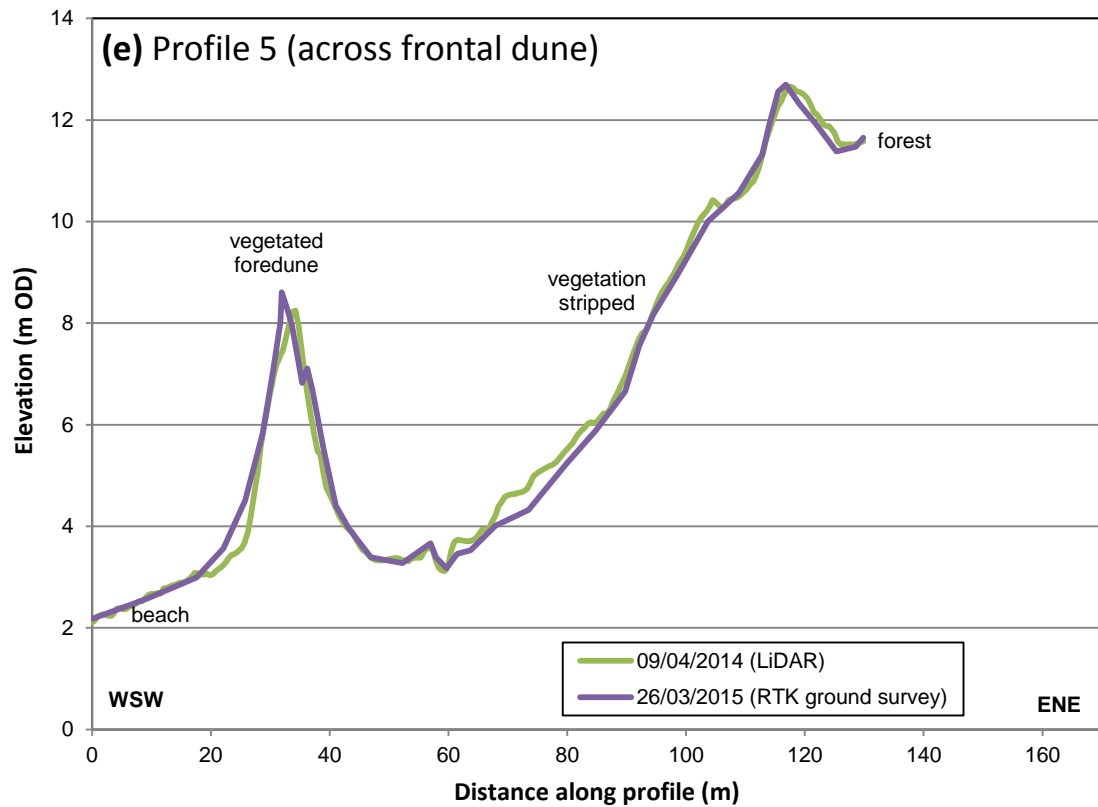
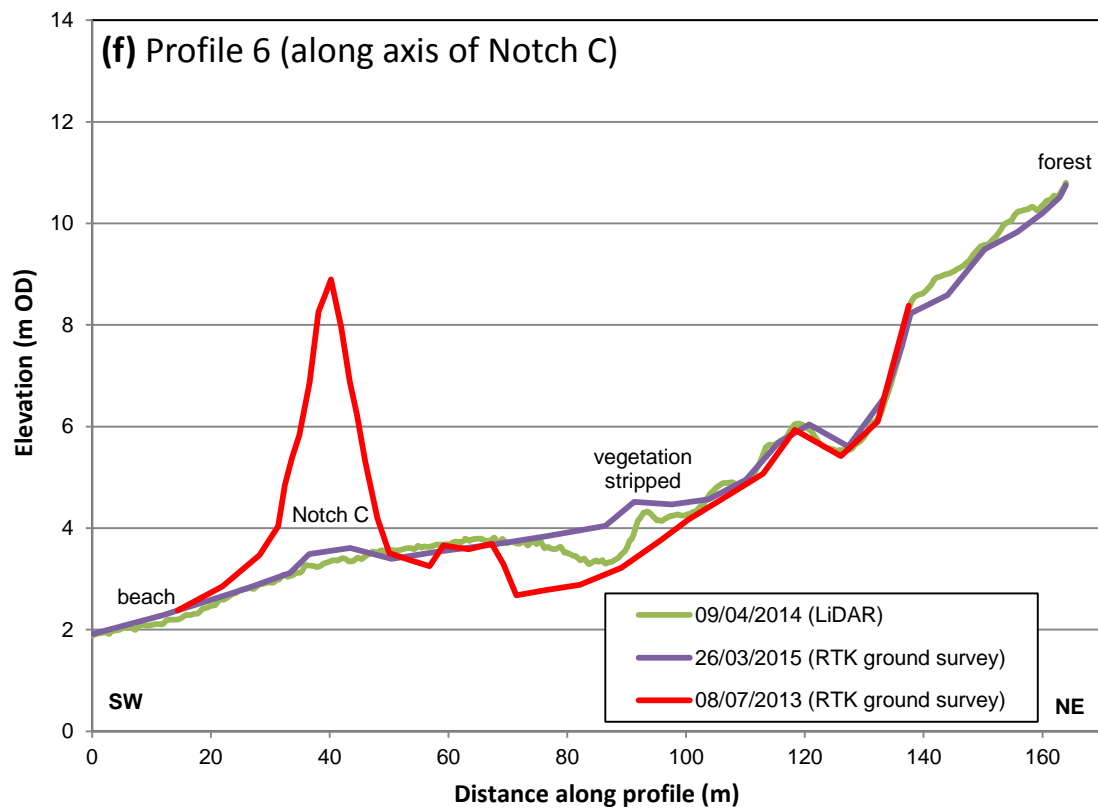
Profile 5 (Figure 6e) shows lowering of the surface by up to 30 cm on the de-vegetated surface.

At profile 6 (Figure 6f) the surface level at the landward side of Notch C showed minor changes between April 2014 and March 2015, but significant sand accretion is indicated in the mid part of the profile; i.e. most sand has not been trapped within the notch but has passed through to infill and cover the ground behind.

Figure 6 (continued). Comparison of surface levels at profiles 5 and 6, indicated by LiDAR survey on 9 April 2014 (after the notches had been made), and RTK ground survey on 26 March 2015. Profile 6 was also surveyed before the works during a RTK ground survey on 08/07/2013, and this is also shown.

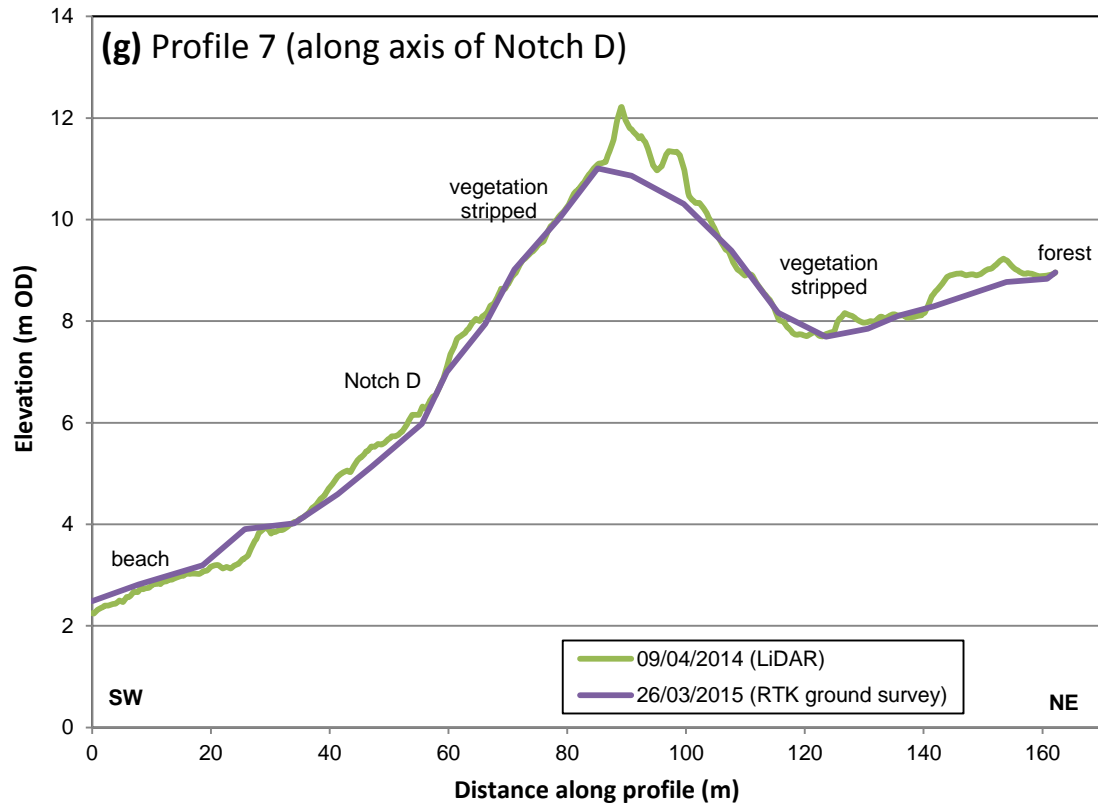
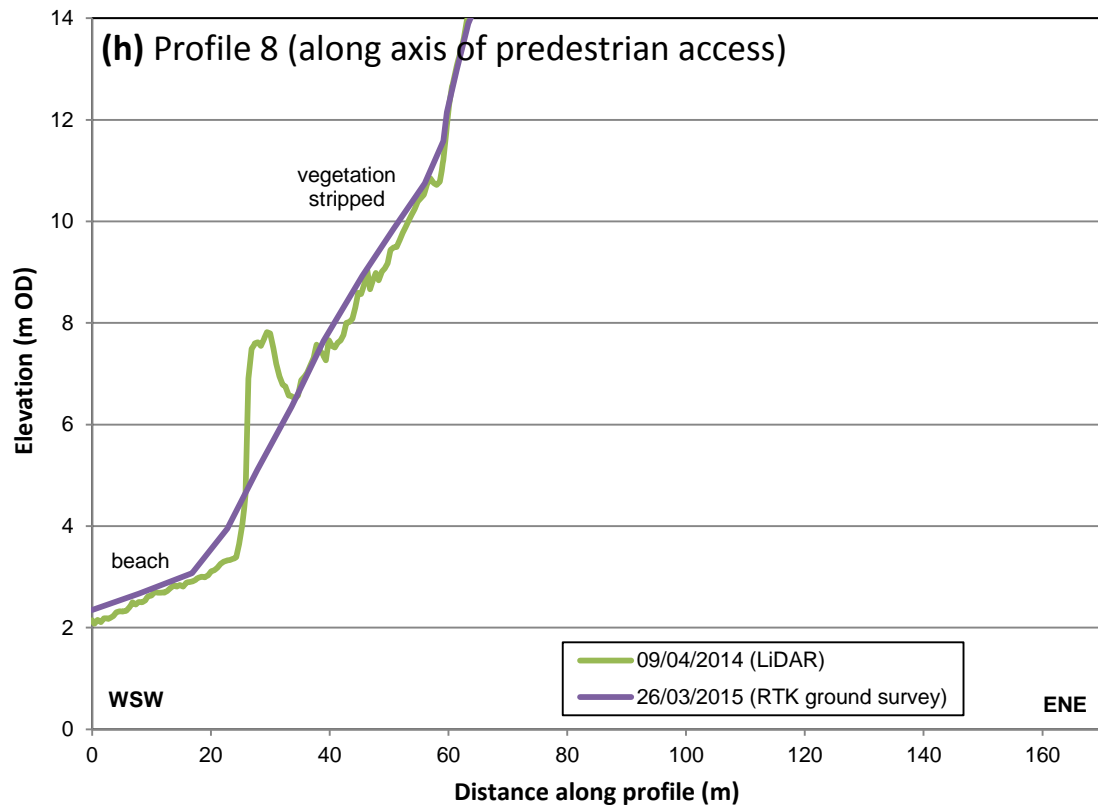
The crest of notch D (profile 7) was lowered by approximately 1.2 m between April 2014 and March 2015, while the surface behind was lowered by up to 30 cm during the de-vegetation works (Figure 6g).

At profile 8 (pre-existing path) the ground level in March 2015 was smoother than in April 2014 due to artificial removal of a small dune behind the beach and deposition of an even sand cover behind (Figure 6h).

Figure 6 (continued). Comparison of surface levels at profiles 7 and 8, indicated by LiDAR survey on 9 April 2014 (after the notches had been made), and RTK ground survey on 26 March 2015.

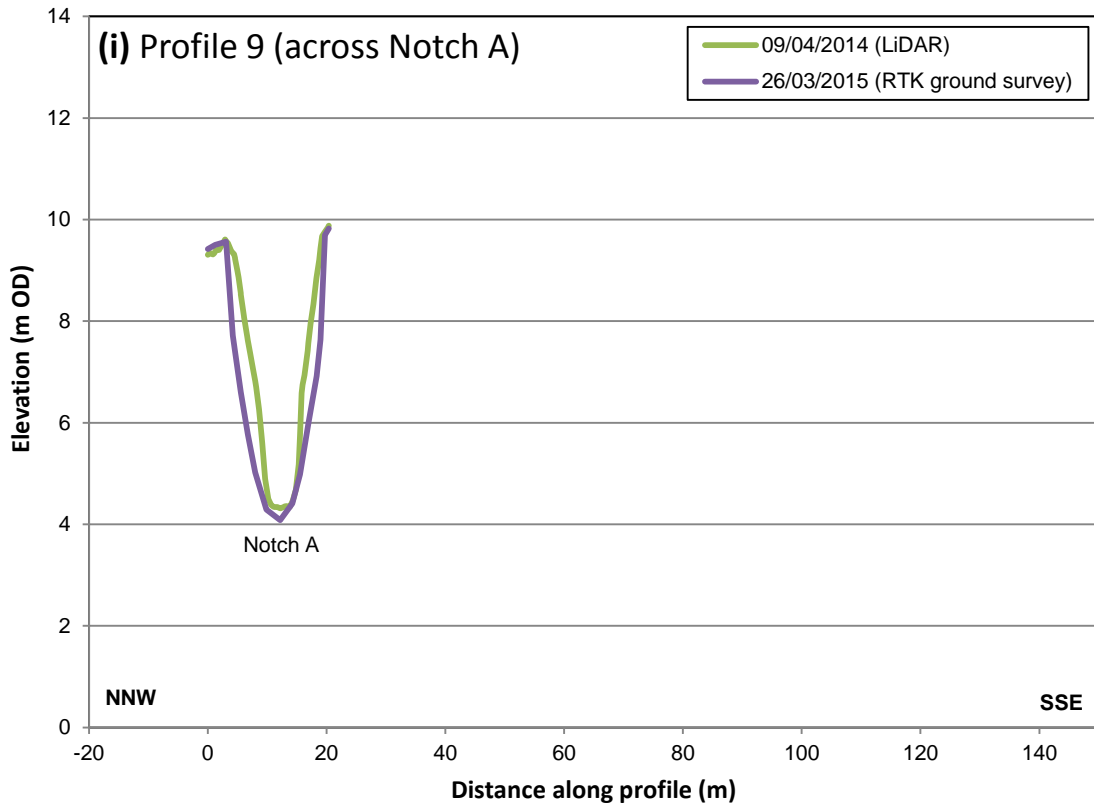
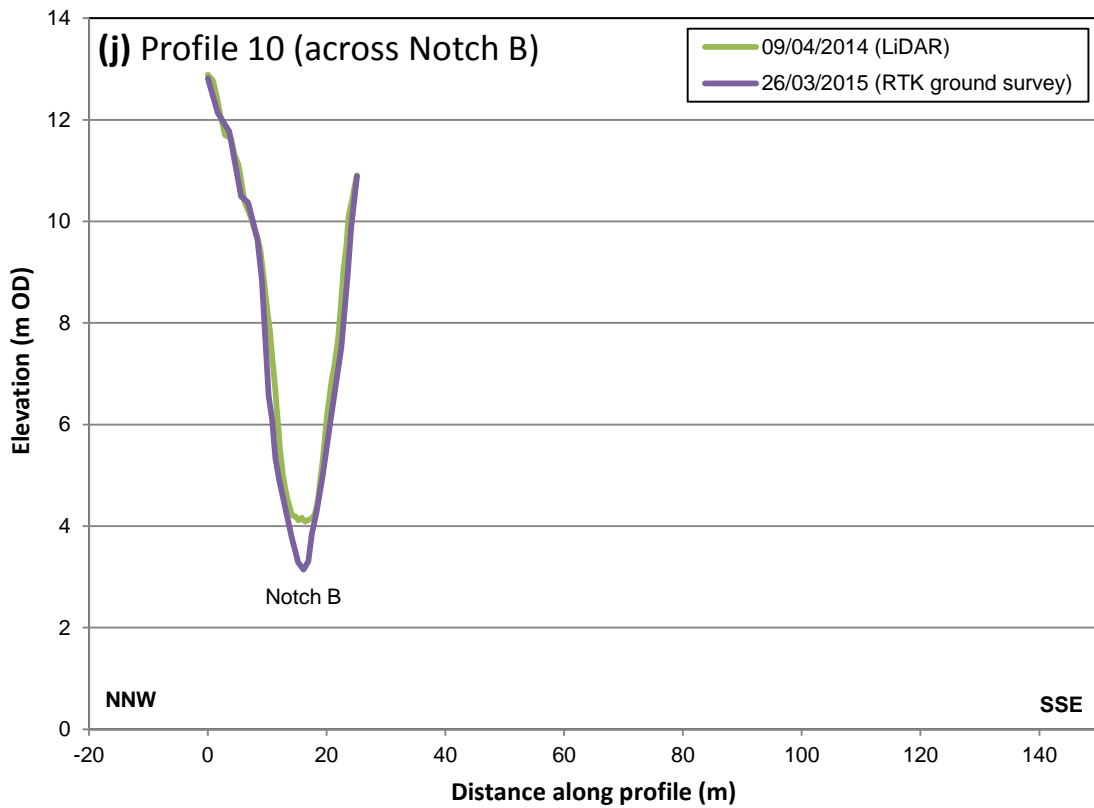
Cross-sectional profile 9 shows widening of the notch due to wind action between April 2014 and March 2015 (Figure 6i). Profile 10 shows slight widening and deepening of Notch B (Figure 6j). Notch C shows some deposition of sand on the lower half of the eastern slope due to slumping and avalanching of sand from higher up the slope, but very little change on

Figure 6 (continued). Comparison of surface levels at profiles 9 and 10, indicated by LiDAR survey on 9 April 2014 (after the notches had been made), and RTK ground survey on 26 March 2015.

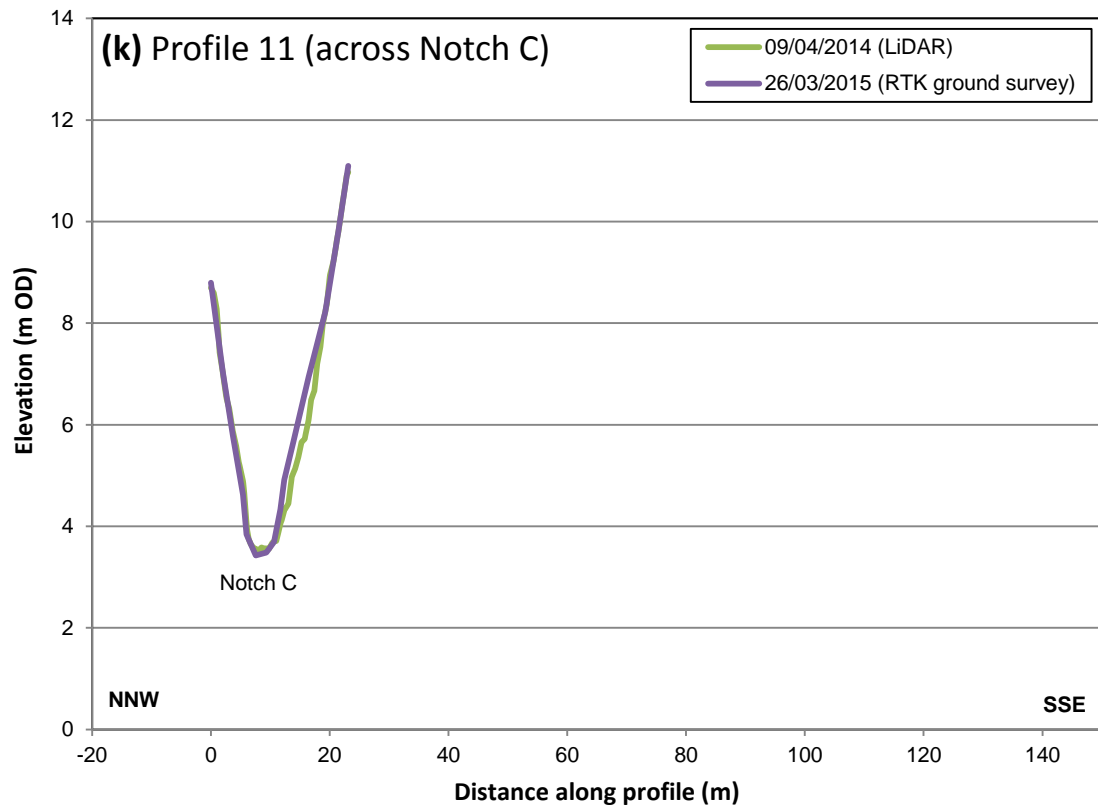
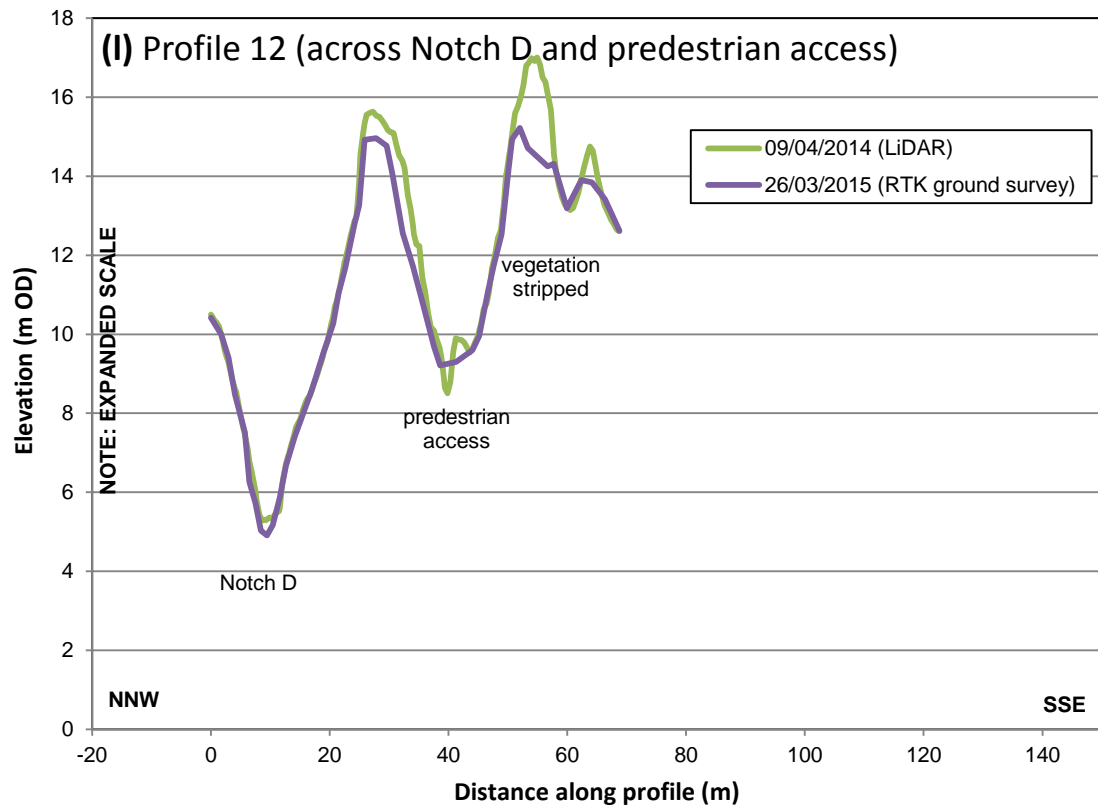
the western slope (Figure 6k). Profile 12 across Notch D and the pre-existing path shows lowering of the dune crests by up to 1.2 m, mainly as a result of the works, with very little change in the cross-sectional profile of Notch D over the period (Figure 6l).

Figure 6 (continued). Comparison of surface levels at profiles 11 and 12, indicated by LiDAR survey on 9 April 2014 (after the notches had been made), and RTK ground survey on 26 March 2015.

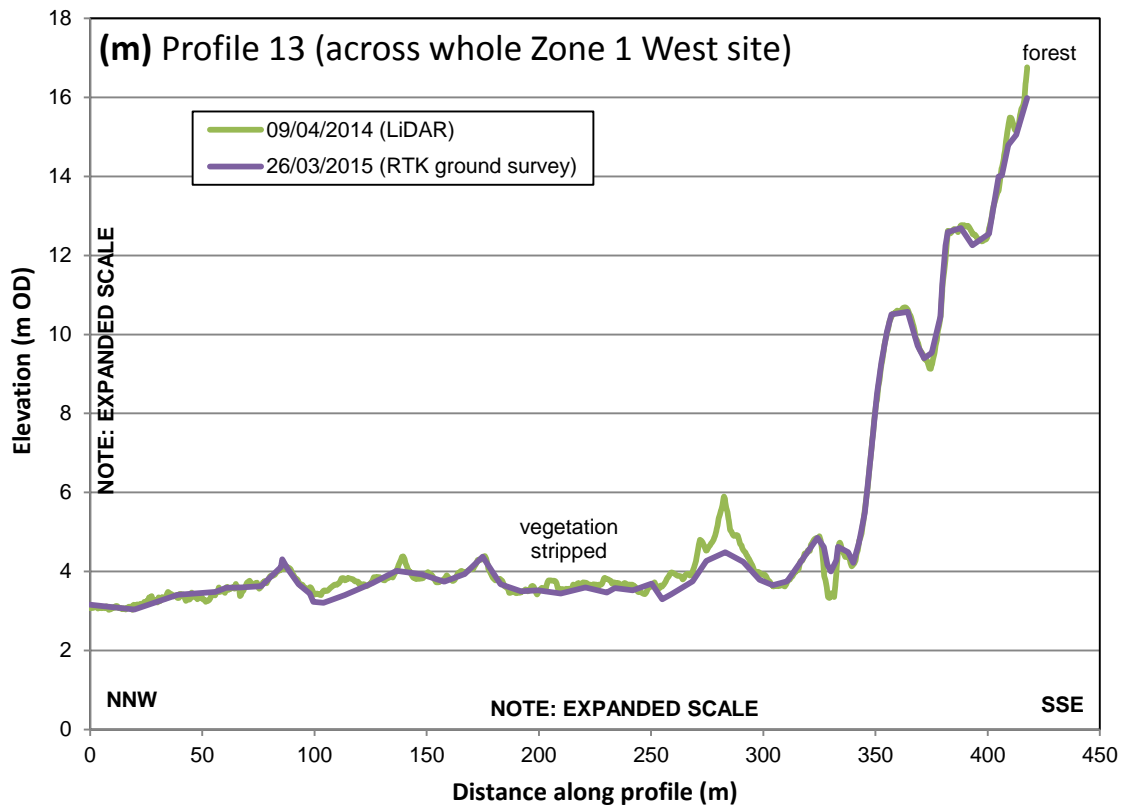
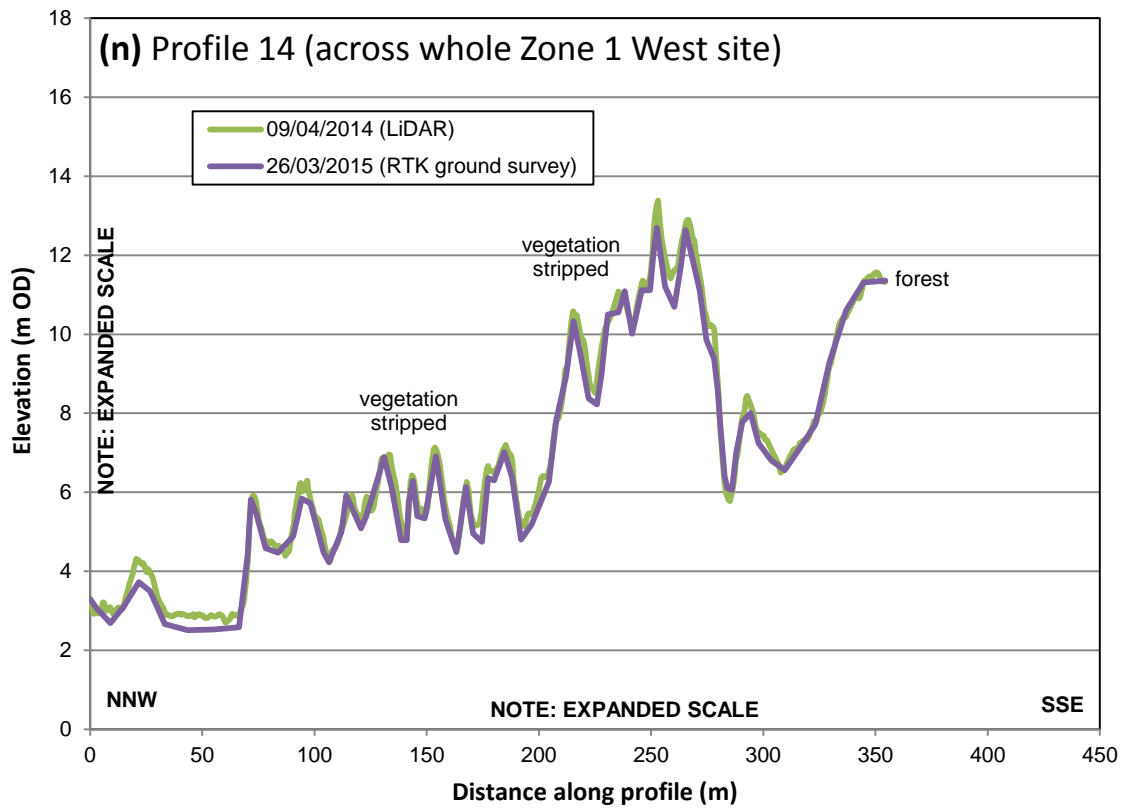
The long profiles 13 and 14 show only relatively small differences between the surface levels in April 2014 and March 2015, indicating that the de-vegetation works did not change the morphology of the site significantly (Figures 6m and 6n).

Figure 6 (continued). Comparison of surface levels at profiles 13 and 14, indicated by LiDAR survey on 9 April 2014 (after the notches had been made), and RTK ground survey on 26 March 2015.

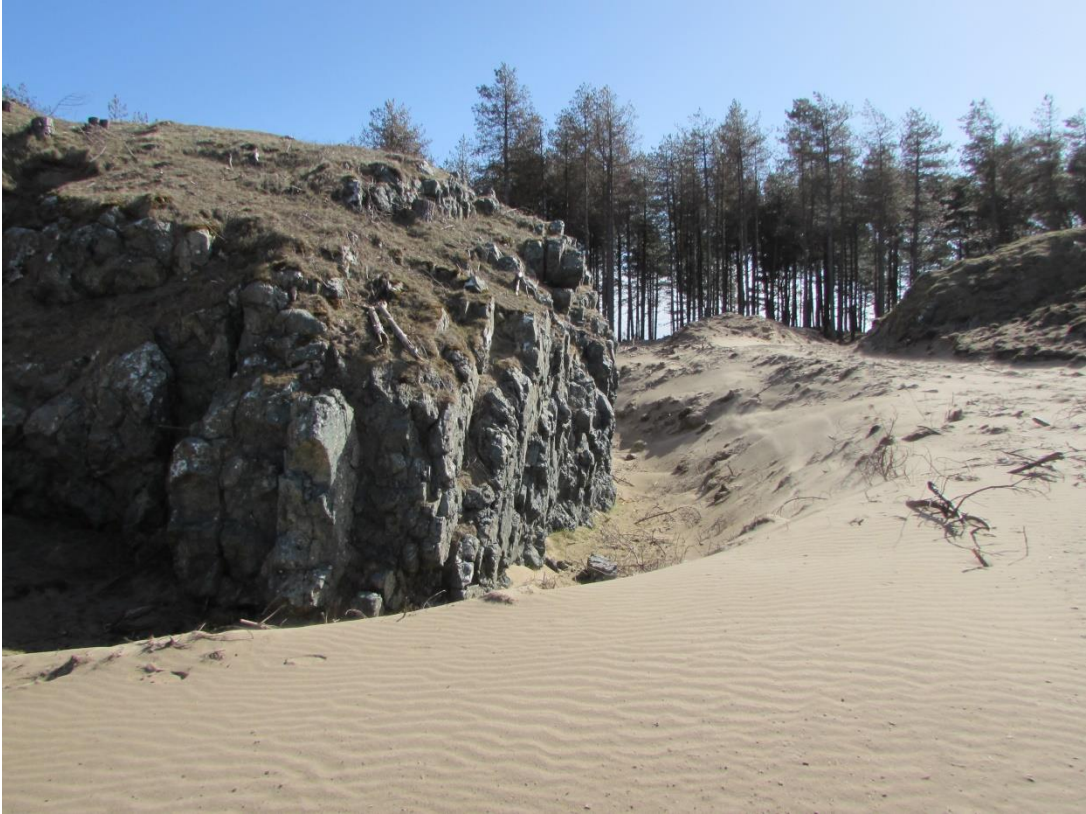
Photograph 6. Sand scour around the base of rock outcrop, looking SE

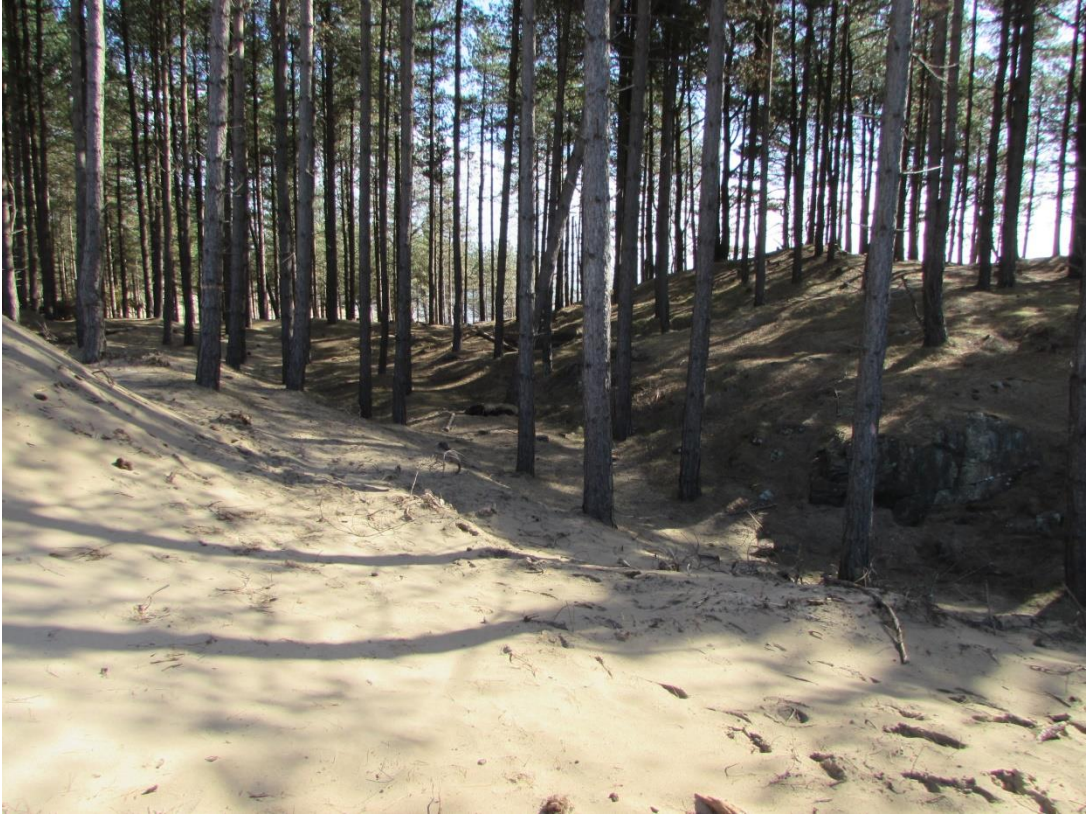
Photograph 7. Sand blowing into the forest, looking E

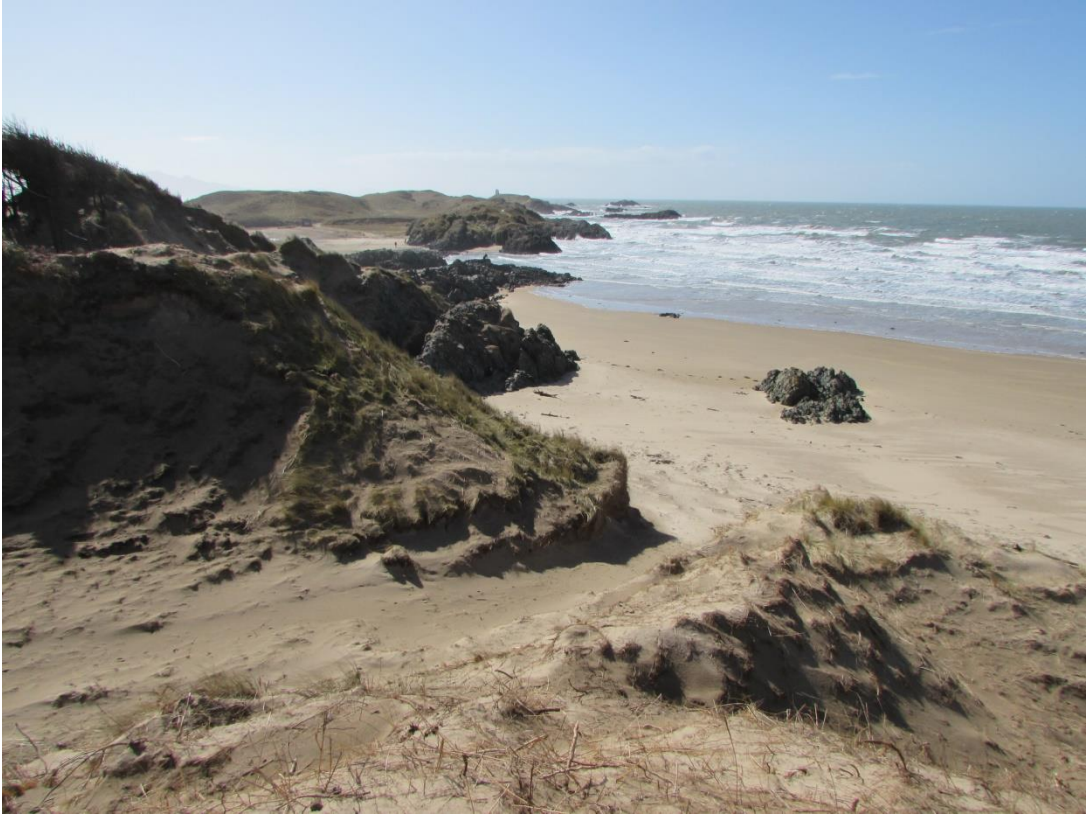
Photograph 9. View across notch caused by pedestrian access, looking SSW

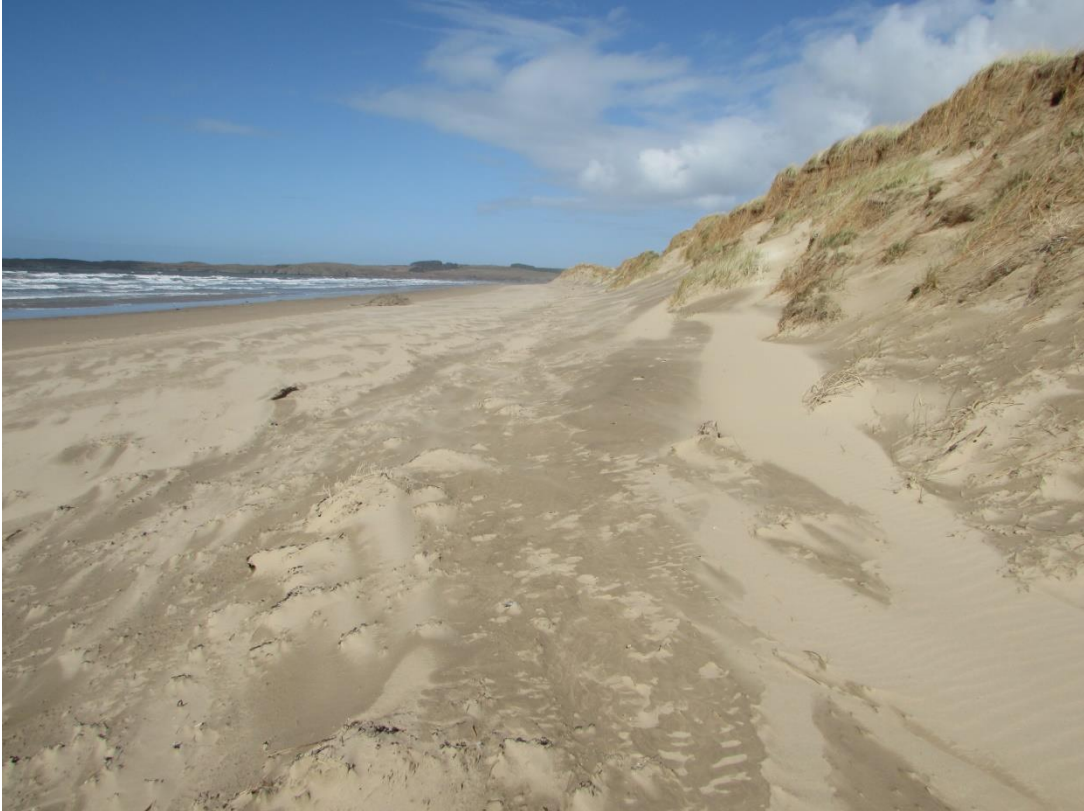
Photograph 21. View along frontal dune toe and sand ramp at the top of the beach, looking NNW

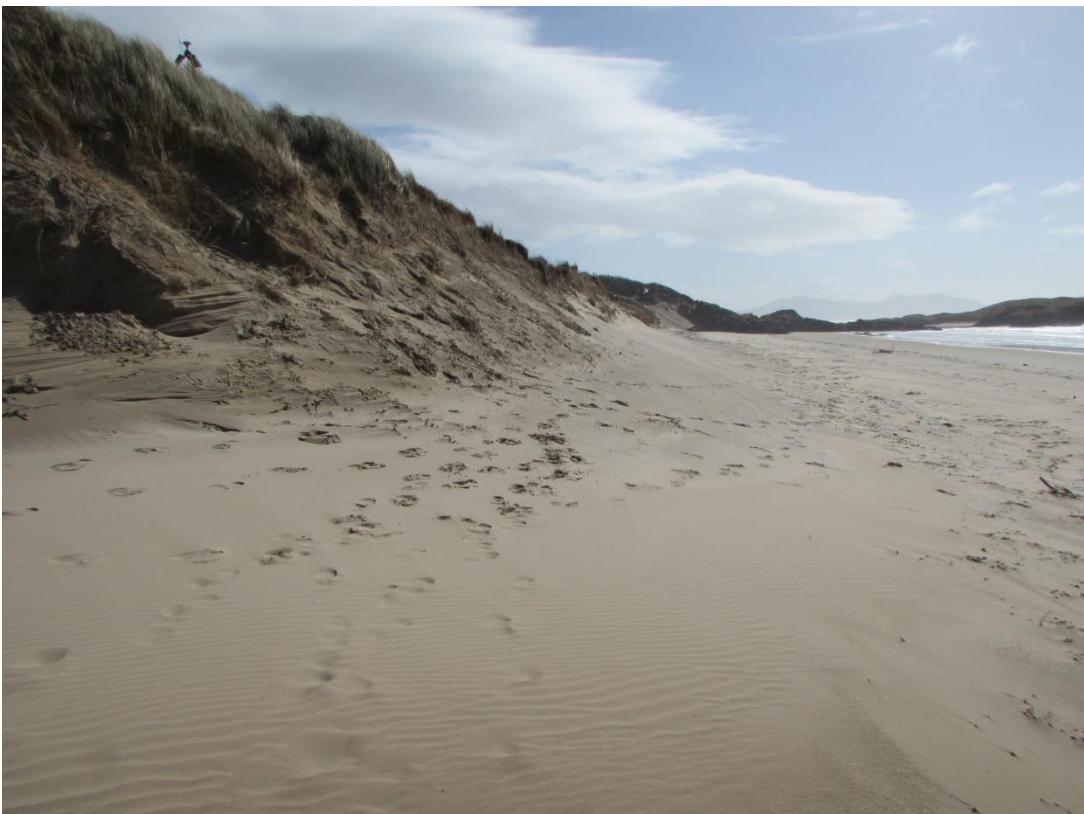
Photograph 22. View along frontal dune toe and sand ramp at the top of the beach, looking SSE
