Ecological Surveys of Welsh Lakes 2017

Shilland EM¹, Goldsmith B¹, Hatton-Ellis TW².

NRW Evidence Report No. 257

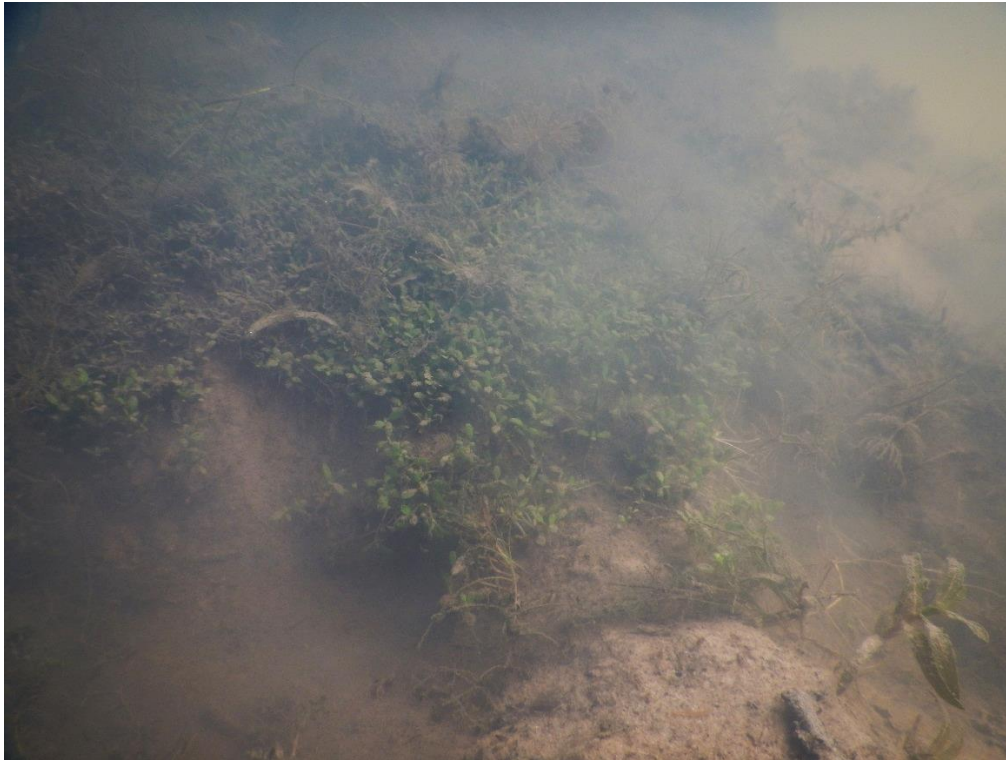
open to cattle grazing, and the poaching activities in the shallows have created more open, sandy conditions in which *Zannichellia palustris* and *Elatine hydropiper* can be found (Figure 4). The maximum depth of colonisation found during the survey was for *P. berchtoldii* and *P. crispus* at 3.4 m on transect three. This is somewhat deeper than that from the surveys of 2003, 2008 and 2011, with 1.8 m, 2.7 m and 2.55 m maxima respectively.

Figure 4 Cattle-poached sandy area with *Elatine hydropiper* (S2 @ 50 cm)

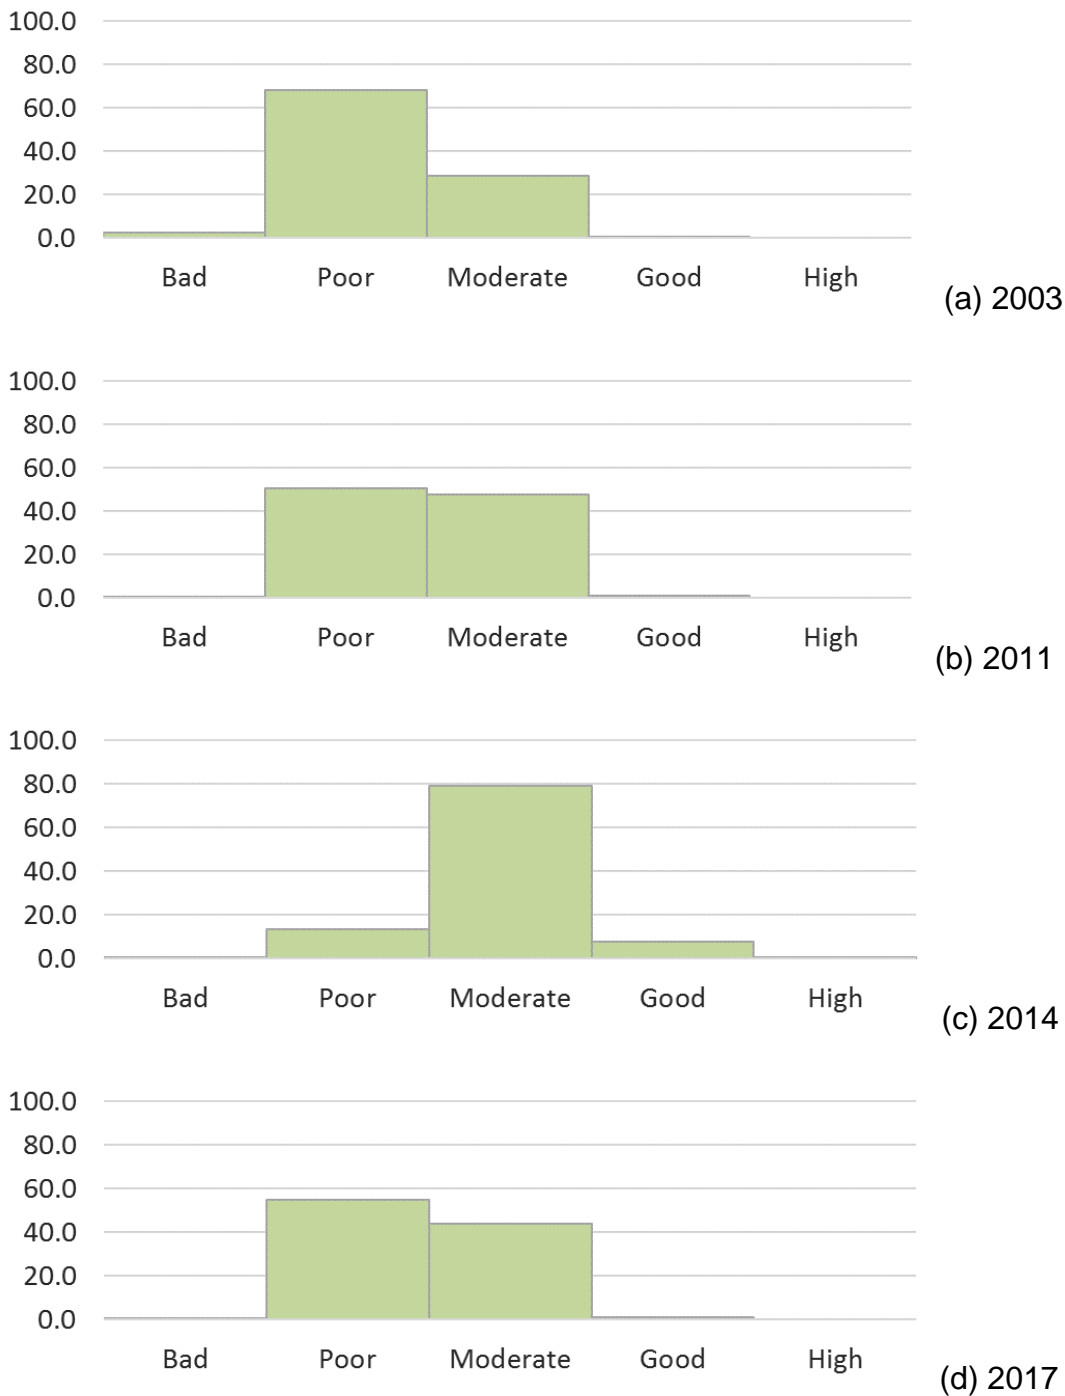
Whilst the Leafpacs tool suggests a deterioration in class since the 2014 survey from Moderate to Poor, this is mainly driven by turnover in relatively rare species in the surveys, especially the occurrence of a small amount of the highly nutrient-tolerant *Zannichellia palustris* in 2017. On the other hand, the COV metric for 2017 is much higher than 2014 (7.18 compared to 2.96) and the maximum depth of colonisation also increased, indicating that Hanmer Mere is more macrophyte dominated than in 2014. This may indicate that the lake is starting to recover, but further data are required to confirm this.

Figure 5. Leafpacs2 Confidence in Class values for Hanmer Mere, 2003-2017.

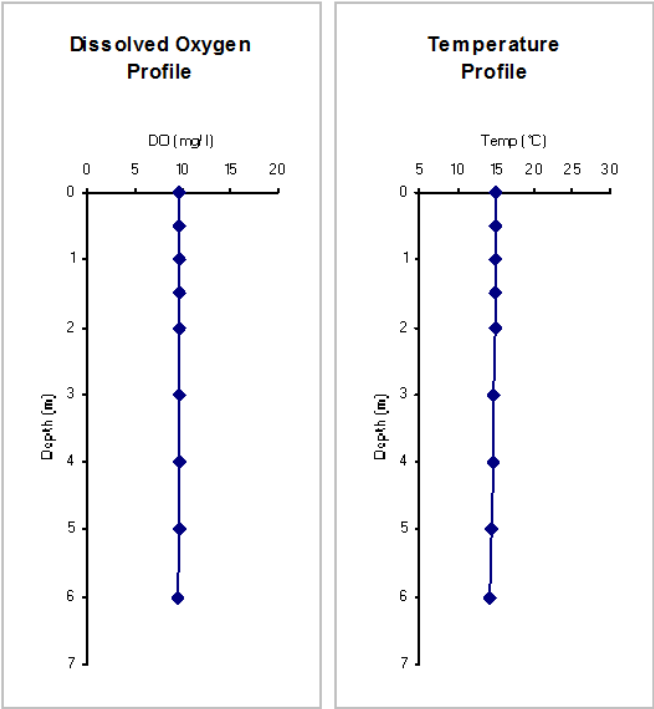
decline in dissolved oxygen towards the bottom of the profile (Figure 9). This is in contrast to Monteith (Ed,1997) who observed thermal stratification at the site on 17/7/1996.

Depth (m)	DO (mg/l)	Temp (°C)
0	9.79	15
0.5	9.7	15
1	9.71	15
1.5	9.71	15
2	9.71	14.9
3	9.71	14.8
4	9.69	14.7
5	9.66	14.5
6	9.59	14.2

Figure 9. Dissolved oxygen and temperature profiles at Llynau Mymbyr (17/08/2017).

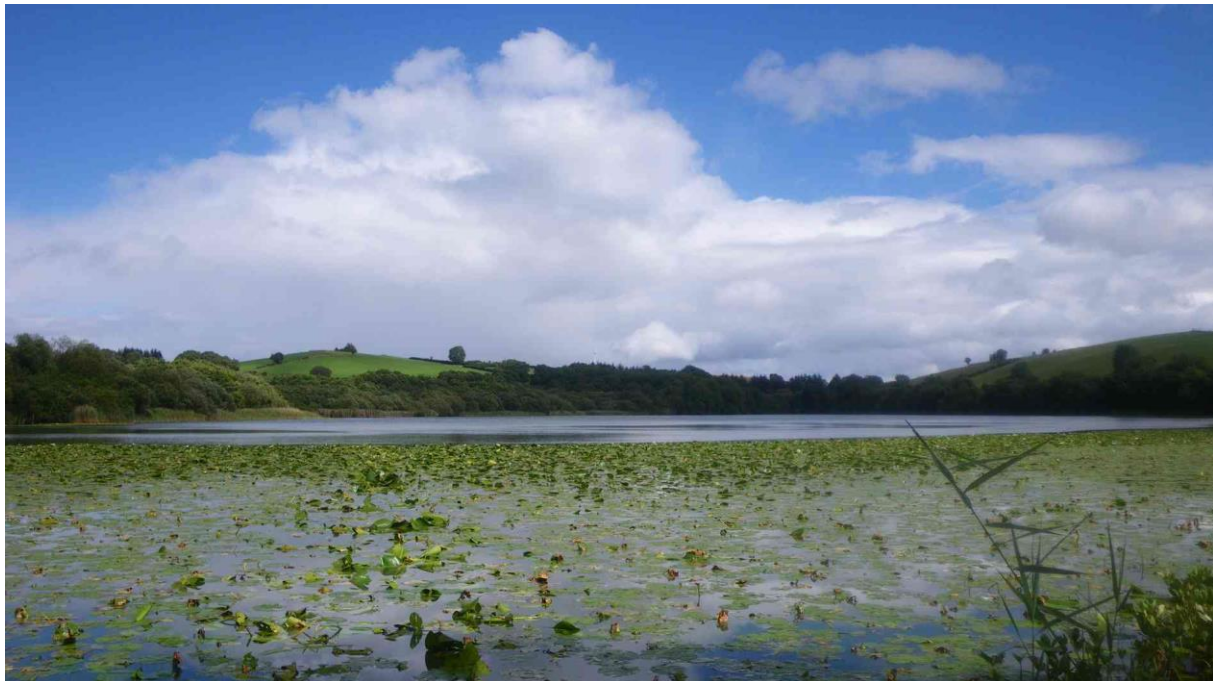
Figure. 18 Llanbwchllyn Lake site photo; from the bird hide at the west end, looking east.

Common species recorded in Llanbwchlllyn Lake were *Potamogeton obtusifolius*, *Lemna trisulca* and *Myriophyllum spicatum*. It is worthy of note that *M. alterniflorum* was also present, albeit less frequent, than *M. spicatum*, two species that are only rarely found growing within the same site (Figure 19a). Throughout the majority of the shoreline, the littoral zone is either dominated by emergent vegetation or over shadowed by *Salix* and *Alnus*, the result being rather sparse submerged flora in shallow water. *Lemna trisulca* was locally abundant within the emergent reeds and present at low density out into open water to a depth of 3.5 m. There are extensive beds of *Nuphar lutea* and *Nymphaea alba* (often mixed, see Figure. 18) around the south and south-west margin to depths of 1.2 m and 1.5 m respectively.

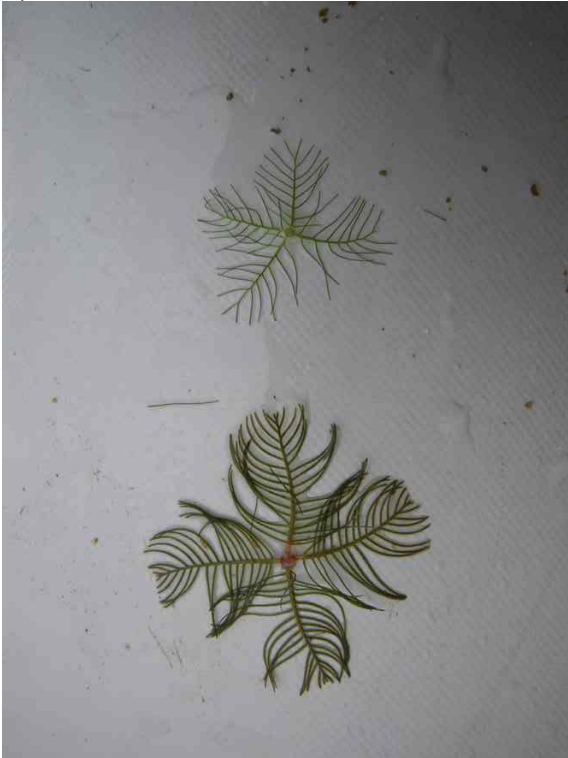
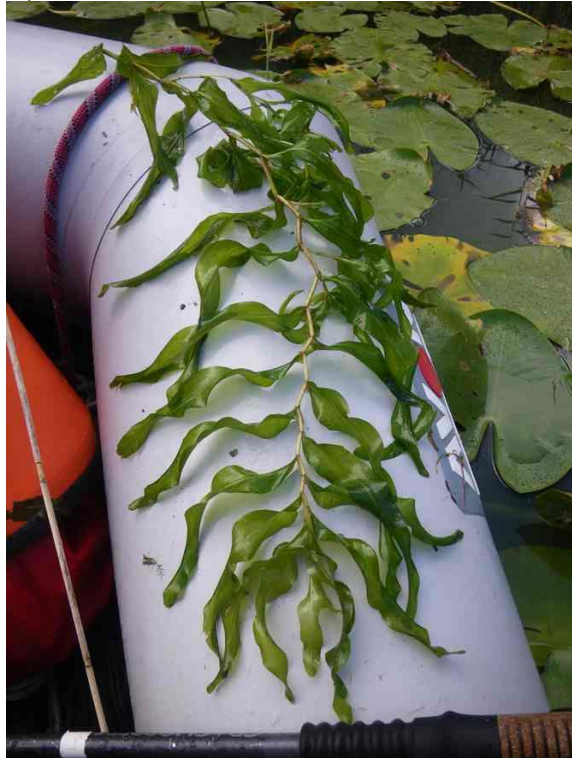
Figure 19. a) Leaf details of *Myriophyllum spicatum* (bottom) and *M. alterniflorum* (top) from Llanbwchllyn and b) *Potamogeton praelongus*

Potamogeton praelongus (Figure 19b) was recorded at two separate locations within the site; at the east end (S2) and beyond the water lilies along the south shore (S2). These beds were relatively dense and in excess of 100 m wide at depths of 50 – 140 cm, with occasional records to 2.9 m. Water levels quoted here are approximately 50 cm below the site maximum. Other submerged species were rare within the survey sections, and it is encouraging to note that no non-native species were recorded.

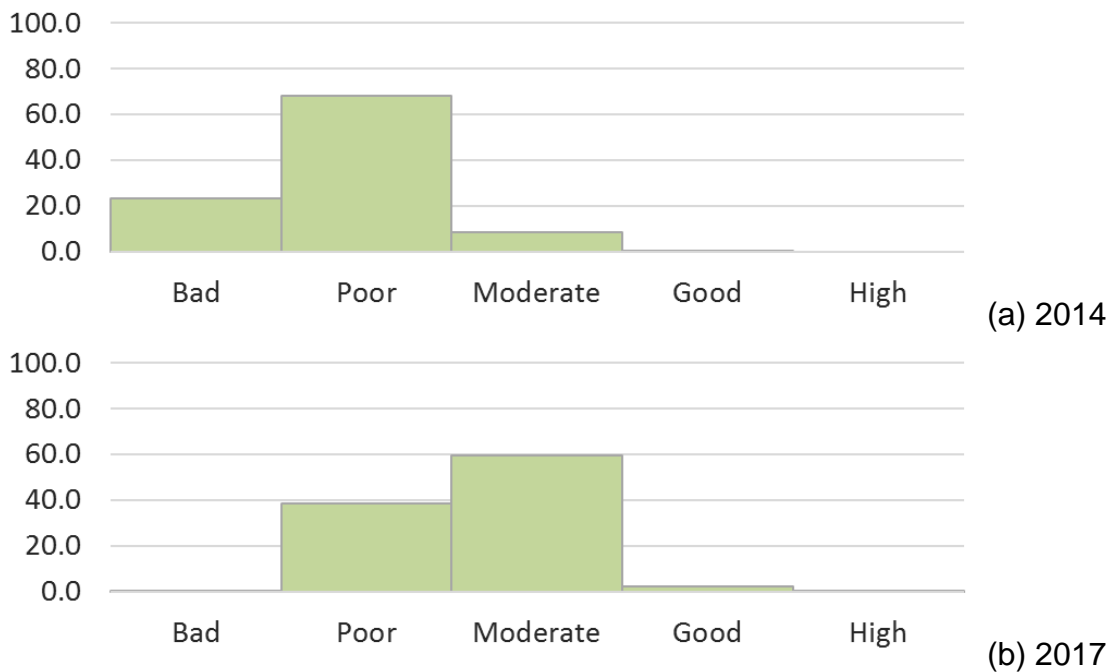
Figure 21. Leafpacs confidence in class results for Llanbwchllyn Lake, 2014 and 2017.

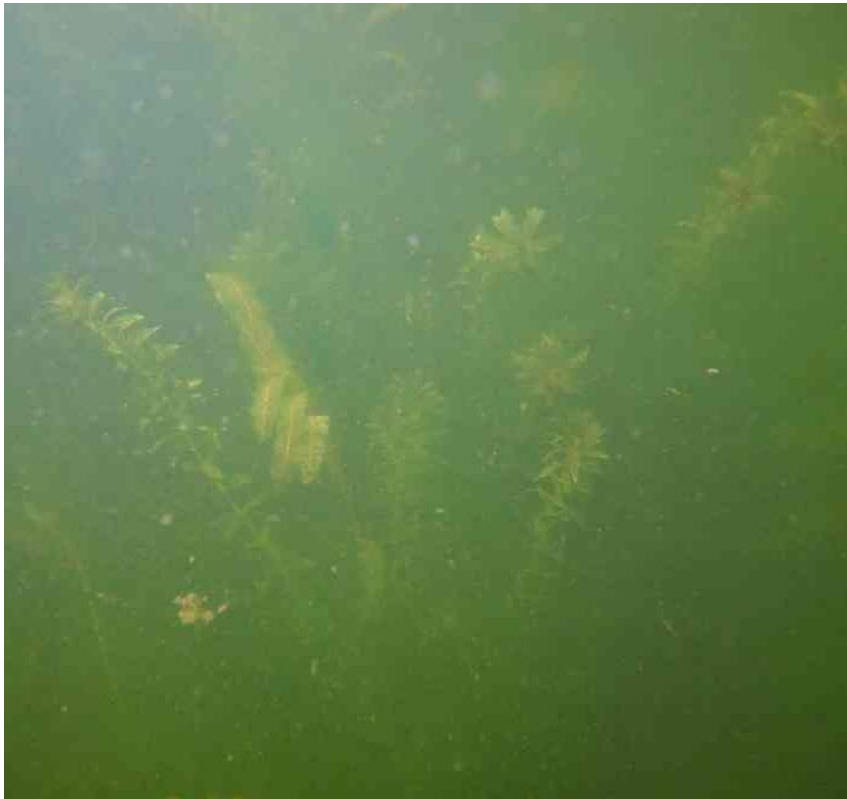
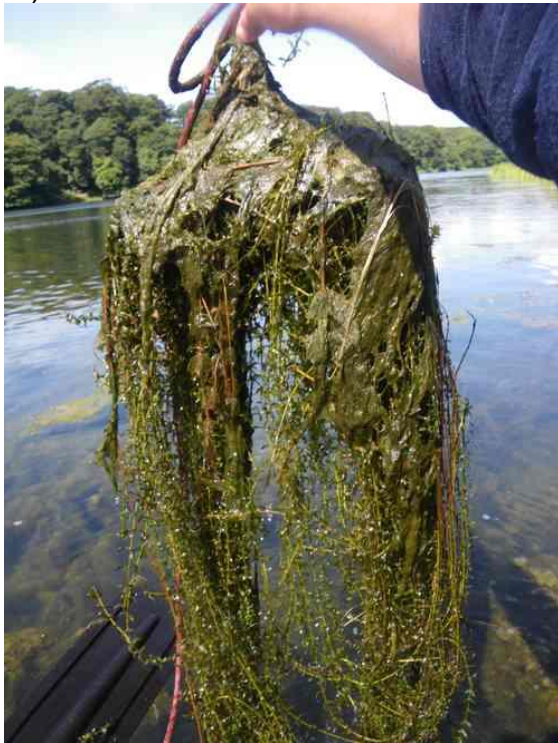
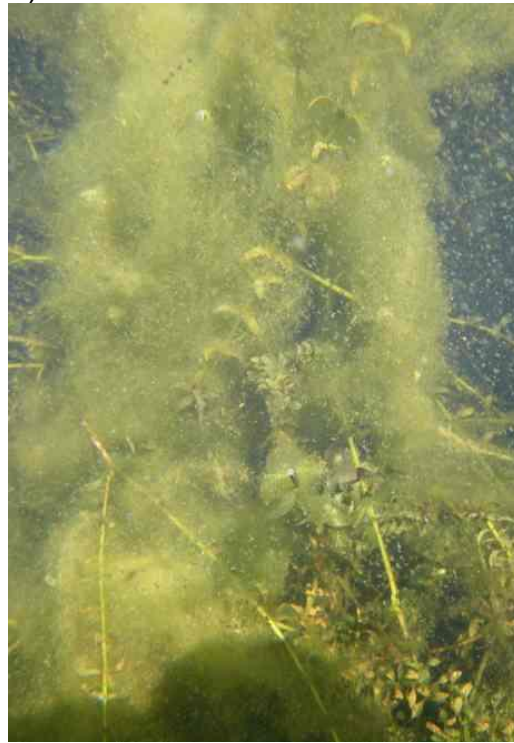
The submerged aquatic macrophyte flora of Bosherston Lily Ponds – Eastern Arm is dominated by only two plant species: *Potamogeton crispus* and *Elodea canadensis* (Table 9). These form dense beds throughout the open water, often with thick growths of filamentous green algae covering them (Figure 30). In the northern half of the site, there was only occasional plants of *Myriophyllum spicatum*, *Potamogeton pectinatus* and *Chara globularis* seen; these species becoming more common at the southern end, particularly *M. spicatum*. *Chara hispida*, which is common in the Central and Western Arm, was not recorded from the Eastern Arm.

Figure 30. a) *Elodea canadensis* and *P. crispus* in turbid water (S2 @ 1.5 m); b) rake trawl with *E. canadensis* and *M. spicatum* showing dense cover of filamentous green algae (S3 @ 1.0 m); c) *E. canadensis* and filamentous green algae (S3 @ 85 cm).

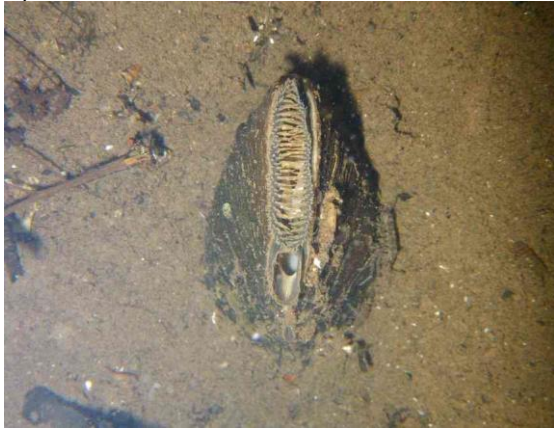
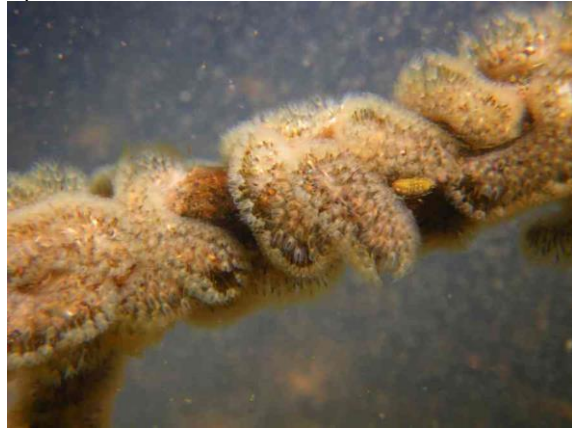
In addition to the flora, a high density of freshwater mussels (*Anodonta* sp.) was noted, particularly in the soft sediments along the northeast shore (Figure 31a), and a colony of the bryozoan *Cristatella mucedo* recorded growing on submerged dead-wood close to the end of Section one at SR9774095713 (Figure 31b).

Figure 31. a) Freshwater mussel (*Anodonta* sp.) filter feeding; b) colony of the freshwater bryozoan *Cristatella mucedo*.

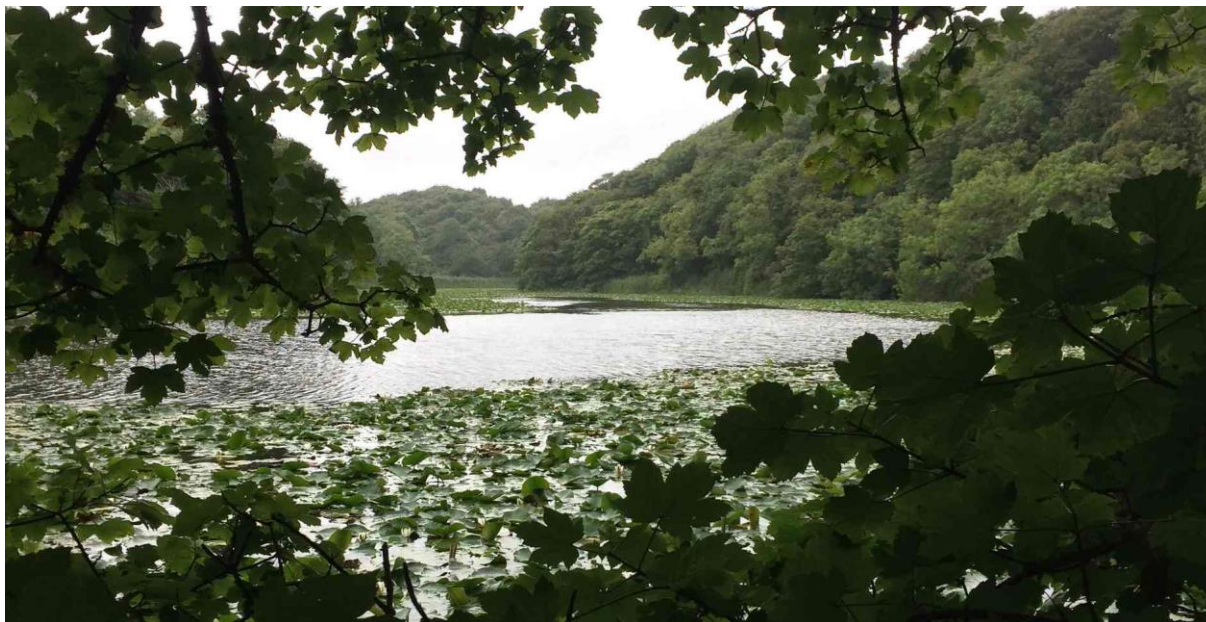
Figure 33. Bosherton Lily Ponds – Central Arm site and catchment photo; from the southeast shore, looking northwest.

The margins are steep-sided and wooded throughout, with many areas having dense overhanging trees including dense canopied sycamore *Acer pseudoplatanus* (e.g. Figure 33). Where shading is less, there exist narrow areas of marginal and emergent plants including; *Sparganium erectum*, *Phragmites australis*, *Bolboschoenus maritimus*, *Lythrum salicaria* and *Epilobium hirsutum* all common.

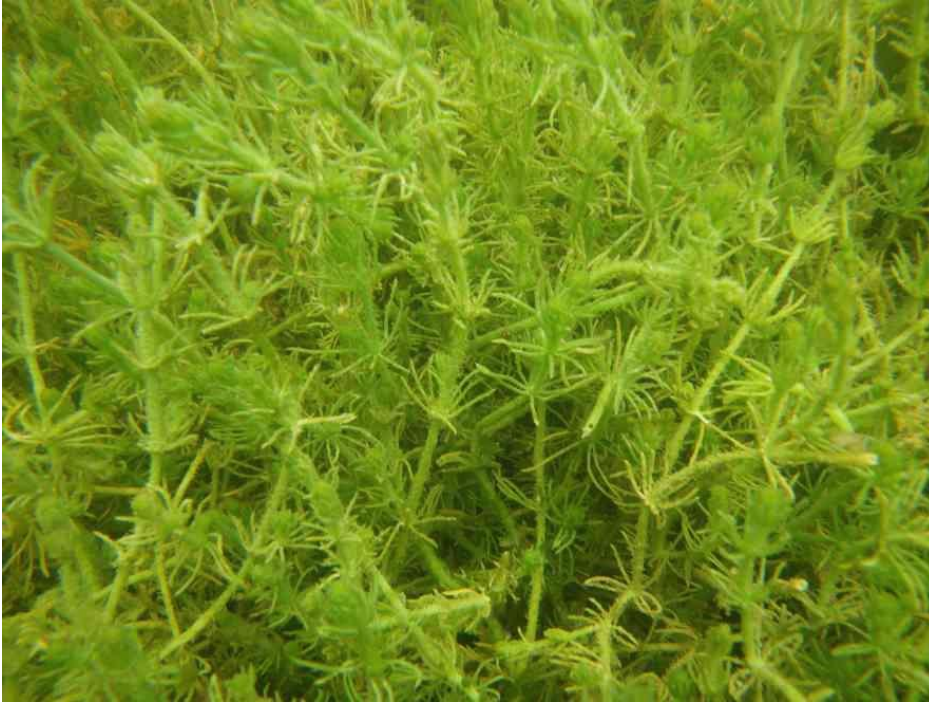
Figure 34. a) mono-specific bed of *Chara hispida* in open water (S2 @ 85 cm); b) *C. hispida* growing within open canopy area of *N. alba* (S1 @ 85 cm).

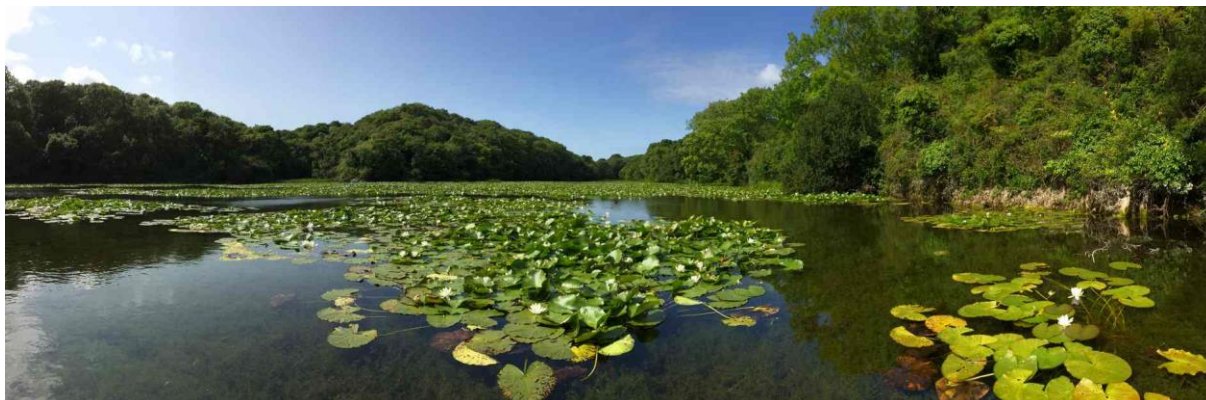
Figure 35. Bosherton Lily Ponds – Western Arm & Central Lake site and catchment photo; from the north looking south.

The aquatic flora is relatively rich, with 15 species recorded (Table 11). There is substantial differences within the site, with a more typically calcareous, *Chara hispida* dominated assemblage, co-occurring with *N. alba* towards the west end and an elodeid assemblage towards the east end. Section one is located on the north side, approximately half way along the arm. Here the littoral zone was species rich, including *Apium inundatum* (Figure 36a), *Nitella flexillis* agg., *Chara hispida* (Figure 36b), *C. virgata*, *N. alba*, *Persicaria amphibia*, *Elodea canadensis*, *Potamogeton berchtoldii*, *P. crispus*, *P. pectinatus*, *Fontinalis antipyretica*, and *Lemna trisulca*. The open water in this region was a mosaic of *C. hispida* and *N. alba* (Figure 35) dominating, with most of the above-named species occurring occasionally within. In

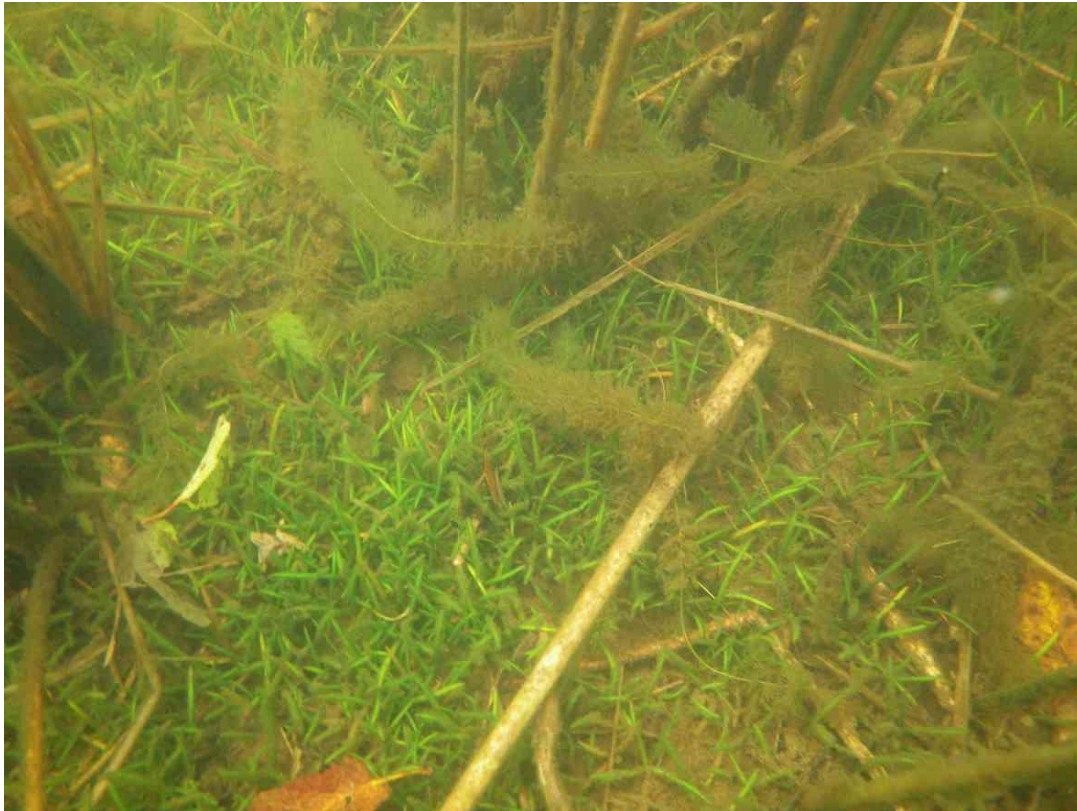
Figure 65. *Littorella uniflora* and *Myriophyllum alterniflorum* growing on soft sediments (S3 @ 50 cm)
