# LLYN TEGID EMBANKMENTS, BALA,

## GWYNEDD:

# PRELIMINARY ECOLOGICAL APPRAISAL

### A REPORT ON BEHALF OF NATURAL RESOURCES WALES

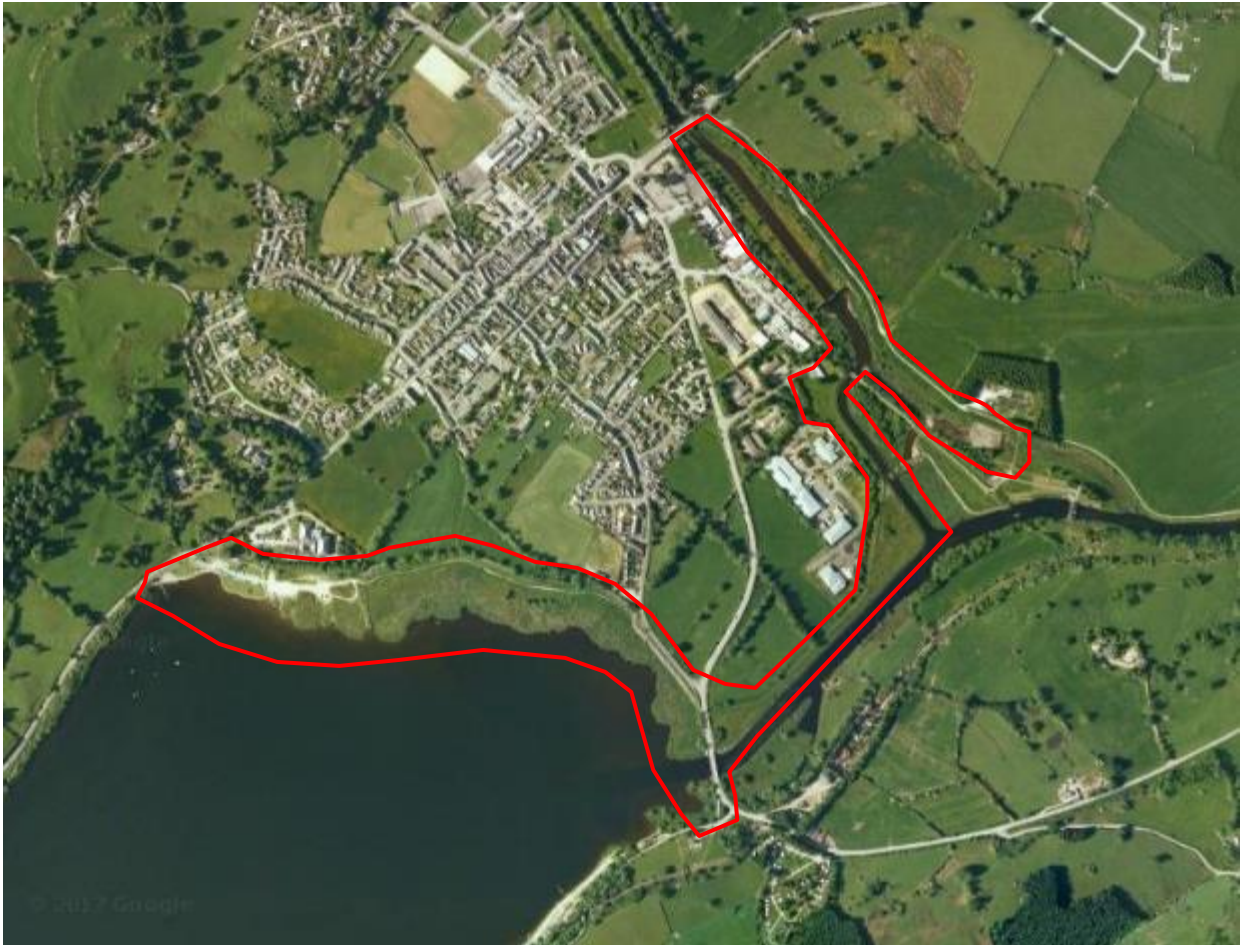
**FIGURE 1. THE APPROXIMATE SURVEY AREA IS OUTLINED IN RED.**  
IMAGE © GOOGLE 2017.

2.2 The approximate survey boundary used is shown on figure 1, above. This area was confirmed with NRW at the Bala office immediately prior to the survey, but was also slightly constrained by land access (this primarily means that we were unable to enter the fields/properties behind the embankments (on the landward side)), but these were viewed from the embankments as much as possible. The location of the embankments which are the focus of the ongoing project are shown on figure 2, overleaf. The River Dee is the larger river which flows out of the lake at its eastern end, the Tryweryn is the (slightly) smaller river which joins the Dee from the north of the image.

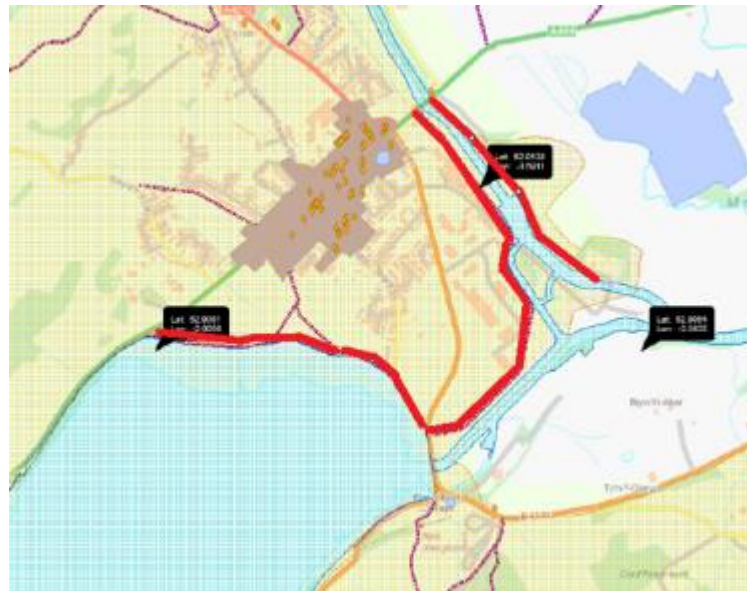
**FIGURE 2. EMBANKMENT LOCATIONS. –**  
*THIS IMAGE IS EXCERPTED FROM A PLAN PROVIDED BY NRW*

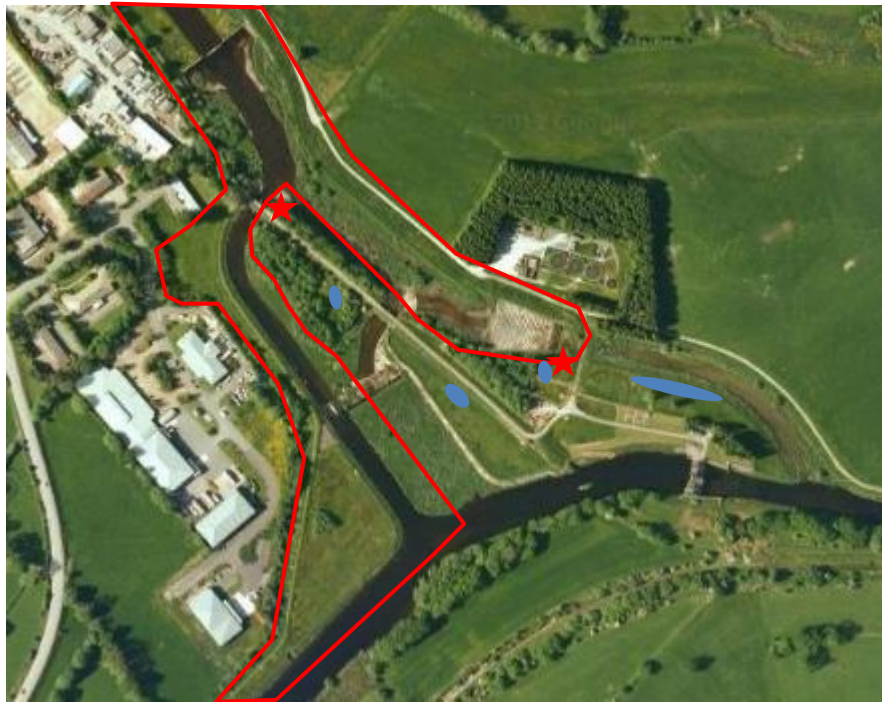
**FIGURE 5. DETAIL PLAN OF THE LOCATIONS OF SCRAPES AND HOLTS CREATED BY NRW AT BALA.**  
**HOLTS ARE SHOWN BY RED STARS, SCRAPES IN BLUE.**  
**THE SURVEY AREA AGAIN OUTLINED IN RED**  
**IMAGE ©GOOGLE 2017**

4.6.1 NRW staff responsible for maintenance of the flood defences in Bala report that four scrapes (hollows in the ground intended to enhance the area for amphibians) were created in the eastern part of the flood defences, just outside the surveyed area. These are intended to hold water, but be separate to the river system (except in flood times) allowing amphibians to breed free from predation by river fish, and other potential disturbances. Additionally, two artificial otter holts were also created nearby, also in the eastern part of the flood defence scheme. Management of both holts and scrapes has varied and the present status of these features are unknown, as all are outside the area of the present

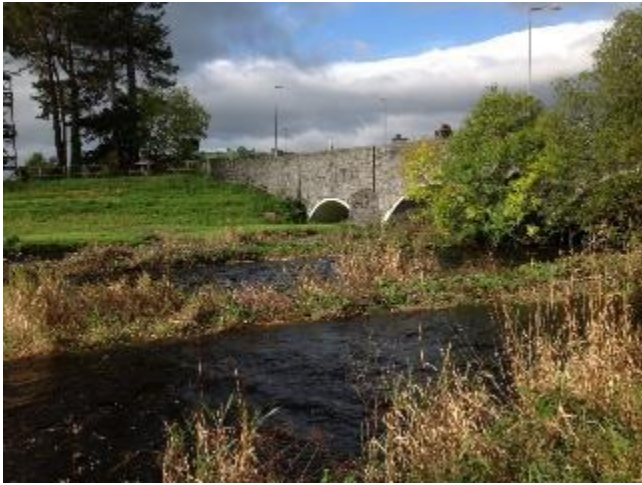
**PICTURE 1. ISLANDS WITH BALSAM. TN1.**

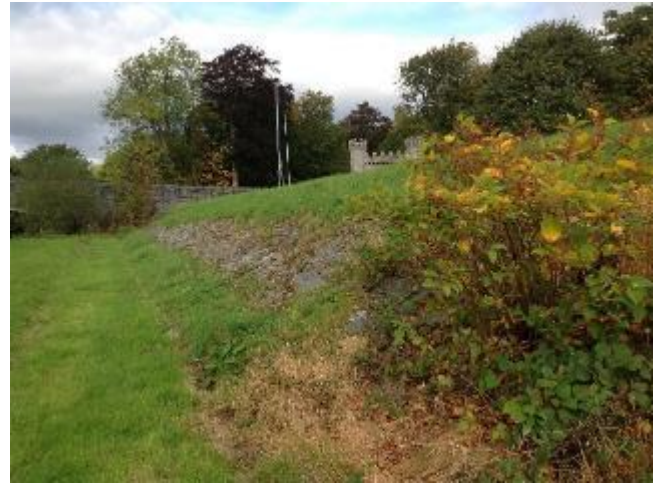
**PICTURE 2. JAPANESE KNOTWEED TN2.**

6.4.2 It is recommended that appropriately qualified and experienced specialist consultants (or NRW staff if appropriate personnel are available) are engaged to remove the knotweed on the embankment. Various methods are possible:

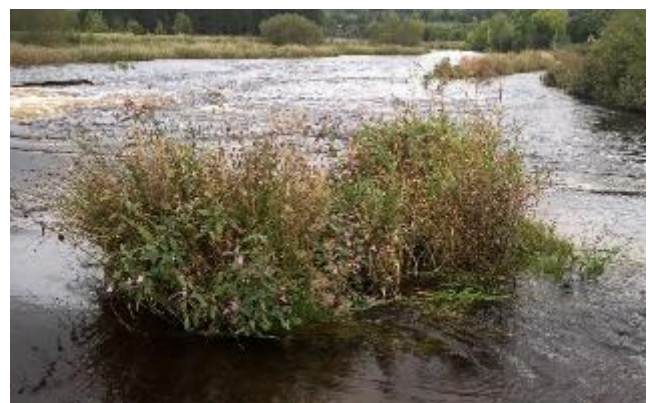
**PICTURE 6. HIMALAYAN BALSAM, TN6.**

6.4.3 Removal of Himalayan balsam is easier in terms of the individual plant, however the issue here is the sheer number of the plants in the catchment. The seeds are spread by the watercourse and so any course of eradication which only takes place on this site without considering the wider catchment is likely to fail in the long term, as the plant will reintroduce from upstream. Therefore ideally, the balsam will be removed as part of a comprehensive project over the whole catchment, - but this is probably unlikely to be feasible.

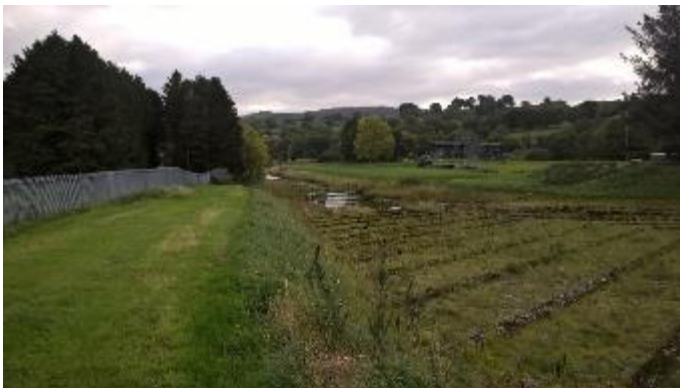
PICTURE 11. SPILLWAY AND SOUTHERN END OF THE SITE. TN12.

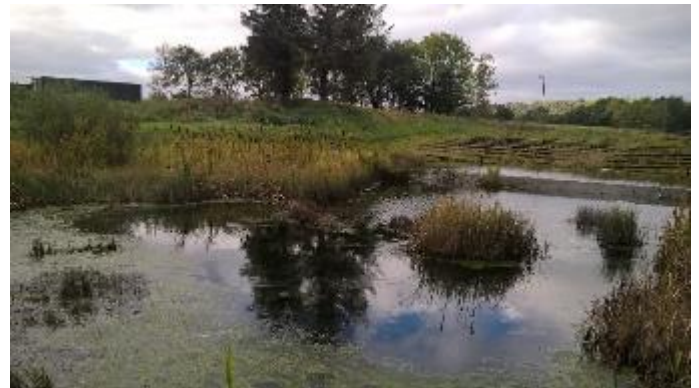
PICTURE 12. BELOW SPILLWAY. TN12.

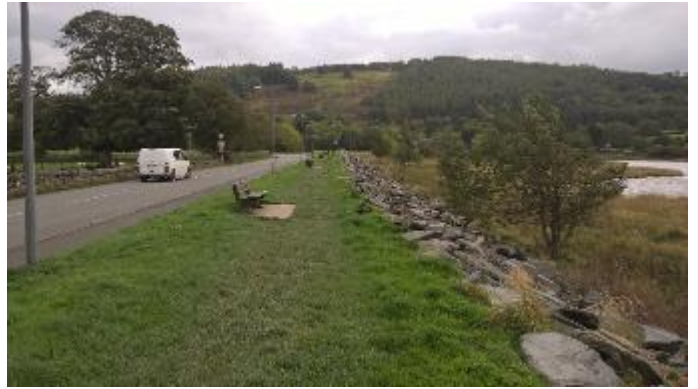
**PICTURE 14. STONE FACED FLOOD BANK. TN16.**

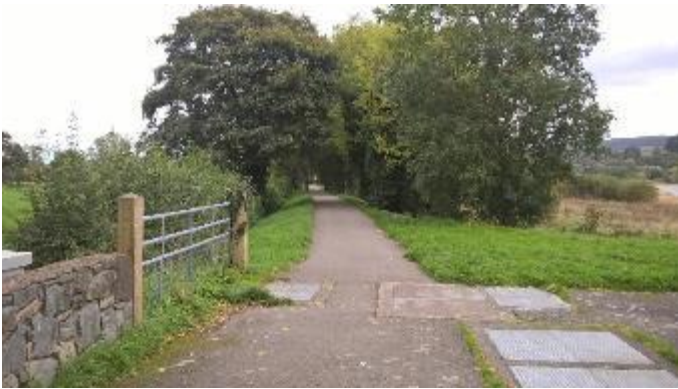
**PICTURE 15. MATURE TREES ON EMBANKMENT. TN16.**

6.2.3 The mature trees should be protected as much as possible. It is recommended that an arboricultural survey (to BS5837 standard) is carried out of the affected area, which is used to design a comprehensive plan to protect the trees within the work area. This will identify root protect in zones for all trees to be retained, which will be fenced off from site workers using Heras fencing.

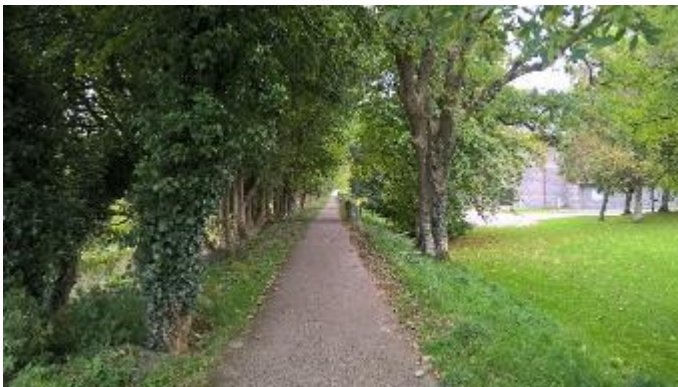
Behind the mixed scrub, grassland and tall ruderal was an earth embankment, which was faced with stone in places, and topped with short, mown amenity grassland. This was species poor and managed to be very short with a similar composition to the car park area, with frequent common daisy. There were some longer grassy areas forming the ground flora beneath the trees (seen in picture 25 below), dominated by ivy, but with thistles, docks, groundsel, common ragwort, herb Robert, red campion, clovers, nettles, greater stitchwort mullein and nettles. The banks were topped with many large mature trees (TN16), including oak, ash, horse chestnut, birch, and cherry. Behind the embankment was a loosely managed (and tall) hedgerow including hawthorn (dominant), rowan, hazel and ash. The trees were often covered in dense ivy.

**PICTURE 25. TREE TOPPED EMBANKMENT**

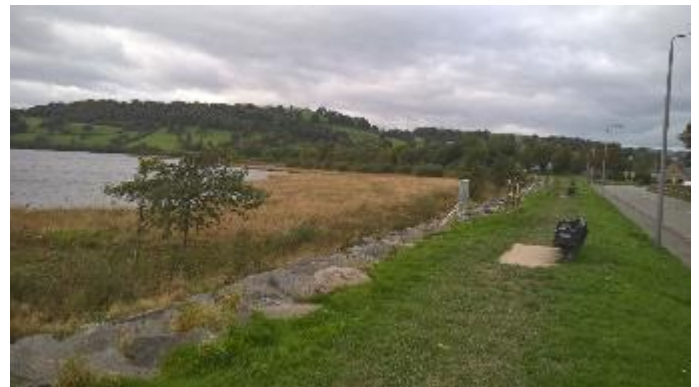
**PICTURE 26. TREELESS EMBANKMENT IN THE SOUTH.**

5.3.7 In the south near the Dee the embankment opens out, with only short mown amenity grassland between the bank and the road (Picture 26). Behind the embankment hedgerows were pasture fields, which were not accessed, but appeared species poor improved grassland.

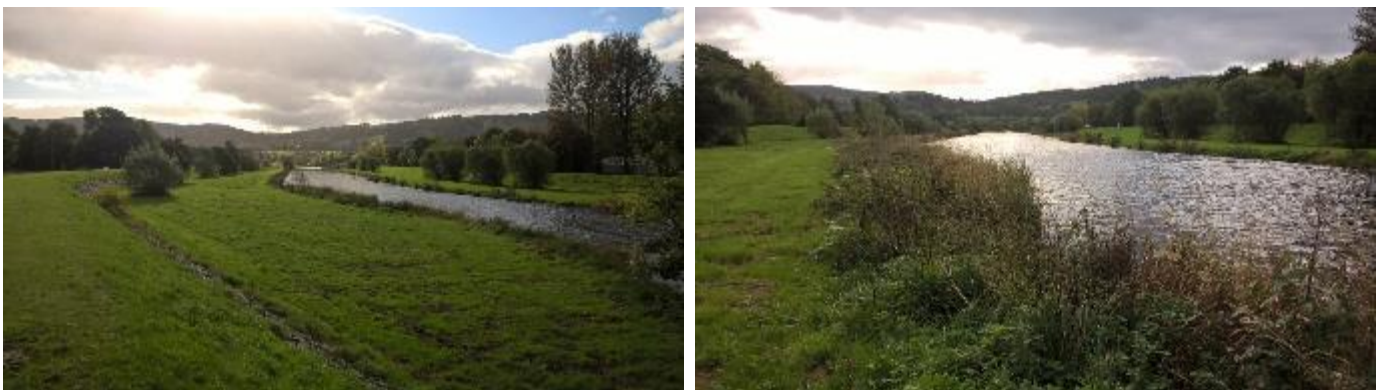
In the northernmost part of the survey area the river Tryweryn flows south in a broad channel between two large raised embankments, topped with short mown amenity grassland. Between these was a broad area of less intensively managed grassland forming a flood containment channel, and then a narrow strip of marginal vegetation (wider to the

**PICTURES 29 AND 30. THE RIVER TRYWERYN CORRIDOR LOOKING SOUTH.**
