Condition Assessment using 2016 River Habitat Survey data and Common Standards Monitoring guidance for the Afon Teifi and Afon Eden – Cors Goch Trawsfynydd SACs

NRW Evidence Report No. 192

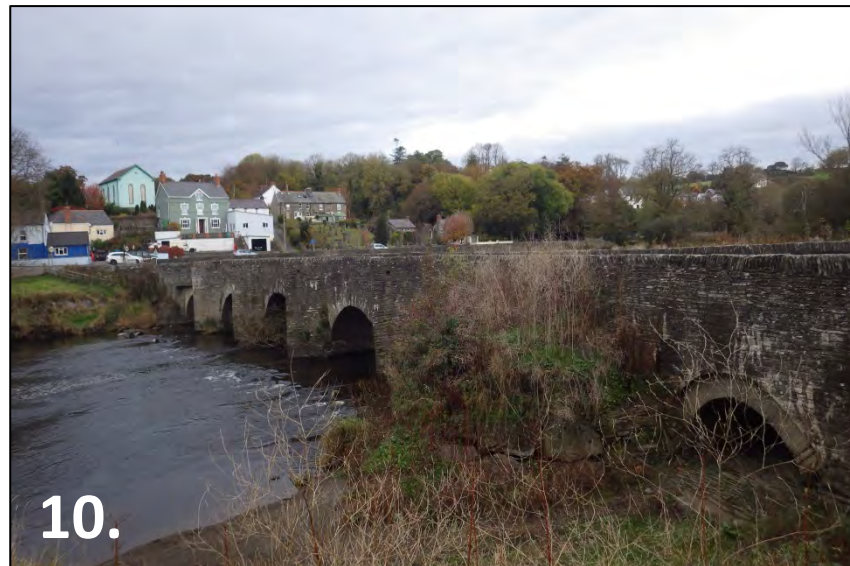
Image 10: An example of a major in-channel structure (Site ID 25334)

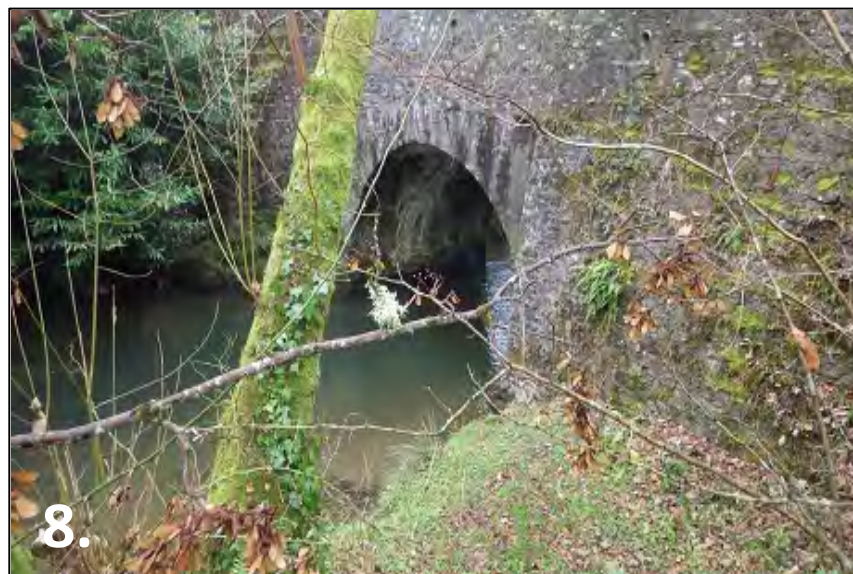
Image 8: Example of an intermediate bridge (Site ID 10573)

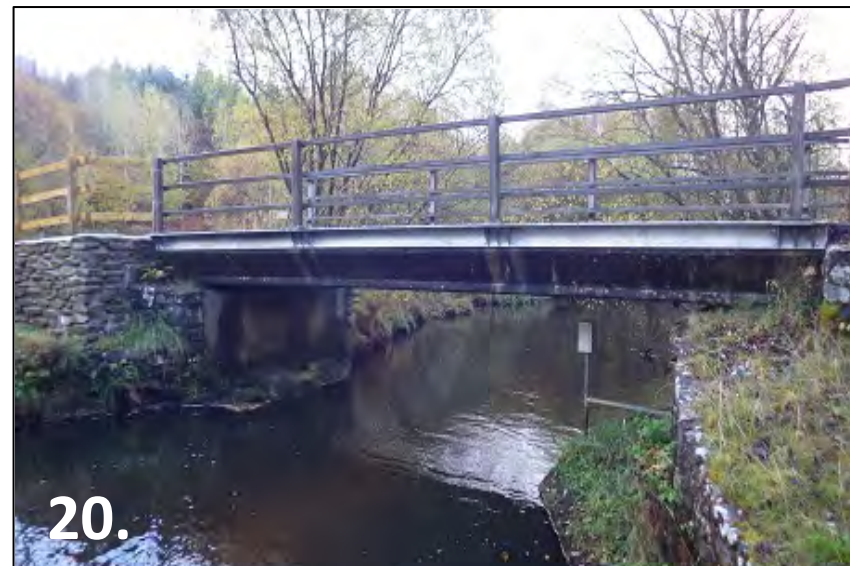
Bryn Eden also lies within SAC Unit 15 and contains only one minor in-channel structure (bridge), which has no in-channel structures (Appendix B: Afon Eden SAC, Image 20).

Image 20: An example of a minor bridge over the Afon Eden, with a reinforced bank (Bryn Eden)
