# Llyn Tegid Reservoir Safety Project

## Access Audit

Version: 3.0

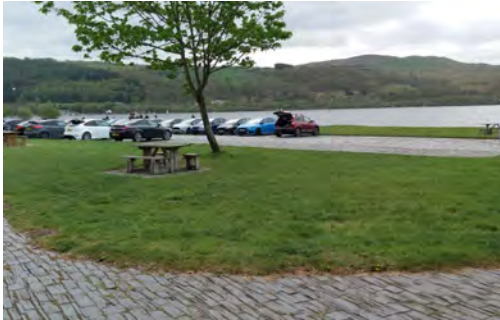
<p>Foreshore car park seating</p> <p>Nine benches noted in total, two are connected to the footpaths via small stone paved paths. Two dropped kerbs noted. Ramped access to both seating areas (c. 1:30 and &gt;1:60), width c. 1.8m.</p> <p>Grass between stone pavers and uneven slabs mean the surface isn't 'level' in parts, paving joints don't appear to comply with recommendations set out in guidance.</p>	<p>Access to seating is not compliant with BS 8300, 'where joints are filled but recessed below the surface, the difference in level between adjacent units should not be greater than 2mm, with joints not wider than 10mm and recess not deeper than 5mm'. BARM recommends path surfaces be 'hard and firm with very few loose stones' and that 'the ideal is non-slip, well-drained, level path'.</p>	<p>Opportunities to improve surfacing considered outside the scope of the Llyn Tegid Reservoir Safety project.</p>

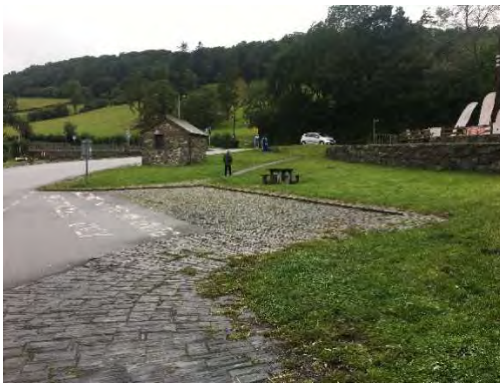
<p>Foreshore car park (formal)</p> <p>Surface materials: Tarmac and paved stone. All car parking spaces are stone paved, tarmac used purely for road surfacing.</p> <p>Access: Two dropped kerbs noted connecting the car park to surrounding raised, both at the west side (one connects motorcycle bay to footpath, another to a small area, possibly a loading bay or coach parking for 2 coaches). No tactile paving noted.</p> <p>No designated disabled car parking spaces noted.</p> <p>No bicycle parking noted.</p>	<p>Access is not compliant with BS 8300, 'where joints are filled but recessed below the surface, the difference in level between adjacent units should not be greater than 2mm, with joints not wider than 10mm and recess not deeper than 5mm'. BARM recommends path surfaces be 'hard and firm with very few loose stones' and that 'the ideal is non-slip, well-drained, level path'.</p> <p>There is an opportunity to provide cycle parking in the area, in accordance with recommendations for cycle parking set out in BS 8300, to improve overall parking provision in the area. Consider provision of accessible litter bins for people using picnic benches.</p>	<p>Opportunities to improve surfacing considered outside the scope of the Llyn Tegid Reservoir Safety project.</p>

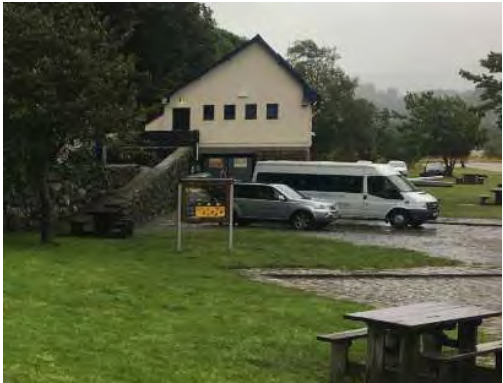
<p>Seating: as described above.</p> <p>No litter bins provided here.</p> <p>Podium signage not accessible.</p>	<p>BS 8300 recommends 'appropriate tactile paving should be used, where necessary, on access routes to provide warning, guidance or information to people who are blind or partially sighted'.</p> <p>BS 8300 also recommends that designated accessible parking spaces be provided (a minimum of 6% of total parking spaces for recreation and leisure facilities).</p> <p>BS 8300 'Information and signage should be located where it is clearly identifiable and visible from all directions' and 'maps should incorporate tactile embossing'.</p>	<p>Opportunities to improve surfacing considered outside the scope of the Llyn Tegid Reservoir Safety project.</p> <p>For many visitors to Bala this will be the first stopping point in the area, therefore addition of signage clearly showing the location of the car park in relation to other amenities, and identifying accessible and step-free routes (including tactile embossing for those who are blind or partially sighted) would improve legibility of the area and compliance with BS 8300.</p> <p>NRW to discuss further with SNPA to agree details, but suggest there is scope for Llyn Tegid Reservoir Safety project to deliver these improvements.</p>

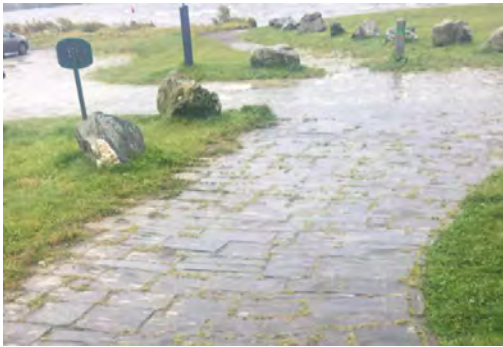
CP/03

<p>Foreshore car park (informal)</p> <p>Access control: Boulders restrict access width of car park to c. 6m, bollard restricts footpath access to c. 1.8m.</p> <p>Surface materials: Bare earth and unbound stone. Boulders used to line footpath (which are also bare earth).</p>	<p>BARM recommends path surfaces be 'hard and firm with very few loose stones' and that 'the ideal is non-slip, well-drained, level path'. BS 8300 recommends 'an access route should have a firm, slip-resistant and reasonably smooth surface. Cobbles, bare earth, sand and unbonded gravel should not be used'.</p>	<p>Opportunities to improve surfacing considered outside the scope of the Llyn Tegid Reservoir Safety project.</p>

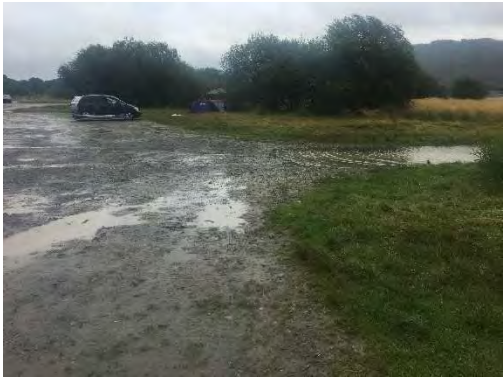
<p>No seating provided.</p> <p>Dog waste bin provided.</p> <p>Signage provided.</p>	<p>BS 8300 recommends 'appropriate tactile paving should be used, where necessary, on access routes to provide warning, guidance or information to people who are blind or partially sighted'. BS 8300 also recommends that designated accessible parking spaces be provided (a minimum of 6% of total parking spaces for recreation and leisure facilities)</p>	<p>Consider addition of accessible car parking spaces if formalising this car park. Consider use of tactile paving to increase safety for those who are blind or partially sighted that may use this space.</p> <p>It is likely that boulders are being used to demarcate boundaries rather than restrict access, if formal surfacing is used there is an opportunity to remove these / reuse them elsewhere on site as hard surfacing for vehicular access should be clear without them.</p>

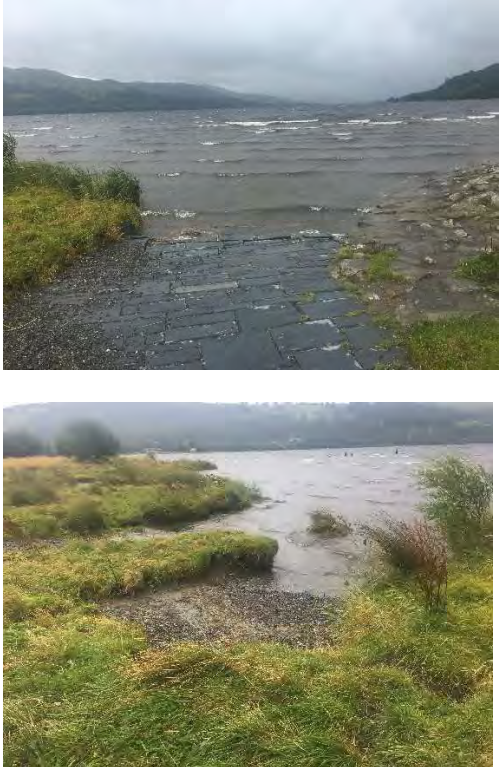
CP/04

<p>Water sports launch area</p> <p>Series of four egress points off lakeshore car park (one stone paved, three unsurfaced cut out points in the foreshore bank)</p> <p>Path gradients: Varies. c.1:15 – 1:20 (no topographical information for this area)</p> <p>Path widths: Varies. c. 2m - 6m</p> <p>Surface materials: Stone paving and exposed bare earth.</p> <p>Car parking and amenities: Car park directly behind. Public toilets and showers (at watersports centre) located c. 100m away. Café c. 150m away.</p> <p>No seating or resting places at the canoe launch</p> <p>No signage noted.</p>	<p>No guidance for canoe access points is given in BS 8300 or BARM. EA publication 'Access for all' recommends inclusive canoe access, but also acknowledges that this is not always possible (particularly creating a fully accessible launch point).</p> <p>The route is not accessible down to the launch point or between the launch point and nearby amenities to the standard recommended in available guidance.</p>	<p>Opportunity to improve this area through car park enhancement proposals, as part of the Reservoir Safety Scheme. However scope is limited– e.g. improving surfacing (unbound) at normal lake level, not building long concrete ramps.</p>

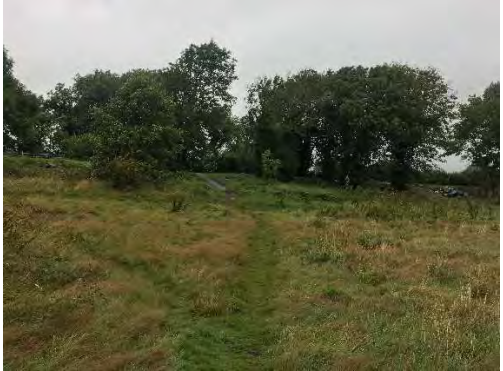
CP/05

<p>Informal footpaths and spaces along the foreshore</p> <p>Mostly unsurfaced; one footpath reinforced with unbound stone (see R4/13) that is well used. Others are a network of desire lines leading to lake.</p> <p>Gaps in vegetation on the foreshore use for barbecues, picnics during the summer. No surfaced areas here, just grass cover.</p>	<p>BARM recommends path surfaces be 'hard and firm with very few loose stones' and that 'the ideal is non-slip, well-drained, level path'. BS 8300 recommends 'an access route should have a firm, slip-resistant and reasonably smooth surface. Cobbles, bare earth, sand and unbonded gravel should not be used'.</p>	<p>Llyn Tegid Reservoir Safety project to rationalise some of this access through proposed car park enhancements. This would also include designating some of these areas as 'habitat restoration areas', for which access would be restricted using fencing, and pedestrians would be encouraged to use other areas of the lake foreshore for recreation.</p>
