Condition Assessment using 2016 River Habitat Survey data and Common Standards Monitoring guidance for the Afon Teifi and Afon Eden – Cors Goch Trawsfynydd SACs

NRW Evidence Report No. 192

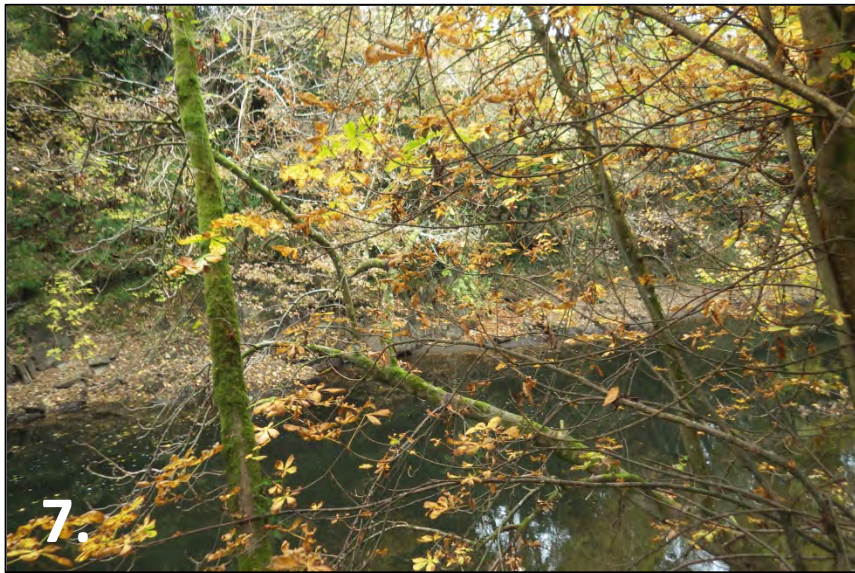
Image 7: An example of exposed bedrock (Site ID 3296)

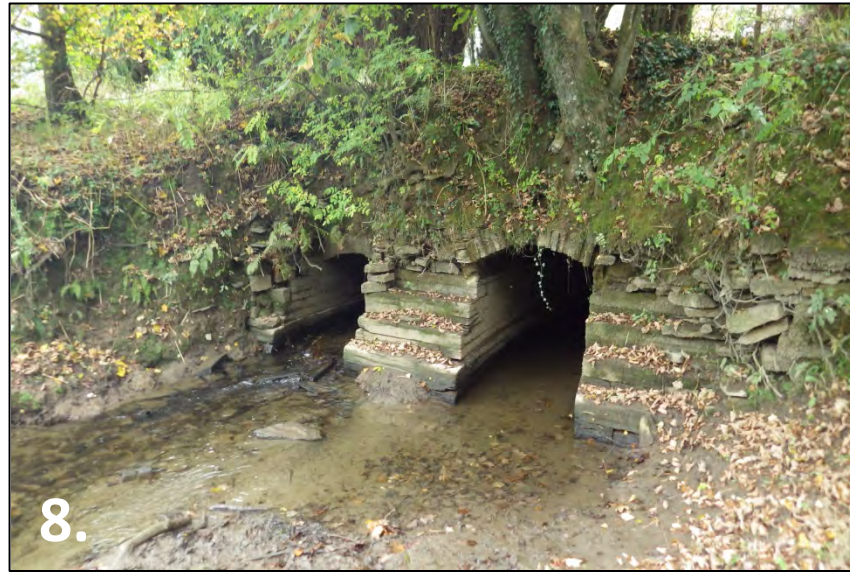
Image 8: An example of a minor outfall (Site ID 3296)

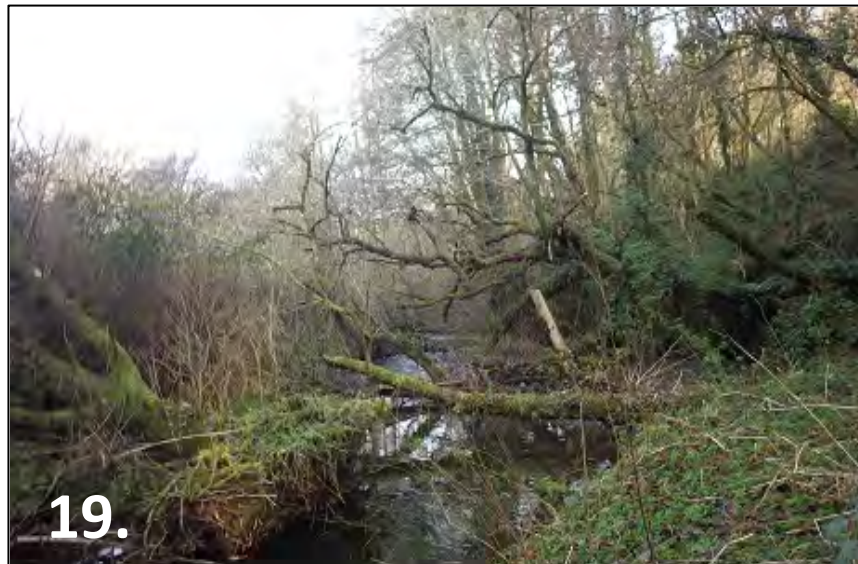
Image 19: Example of in-channel woody debris (Site ID 10582).

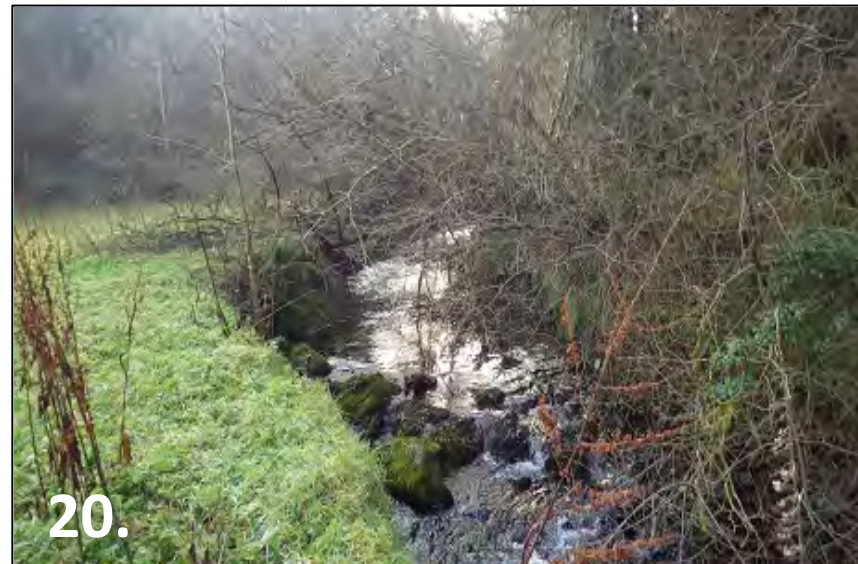
Image 20: Example of vegetated boulders (Site ID 10582).

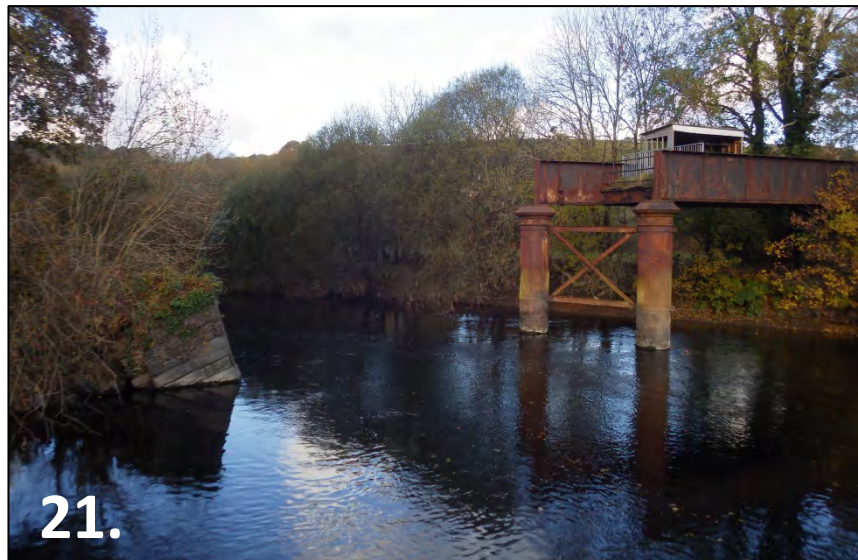
Image 21: Example of a major in-channel structure (redundant rail bridge) (Site ID 22380).

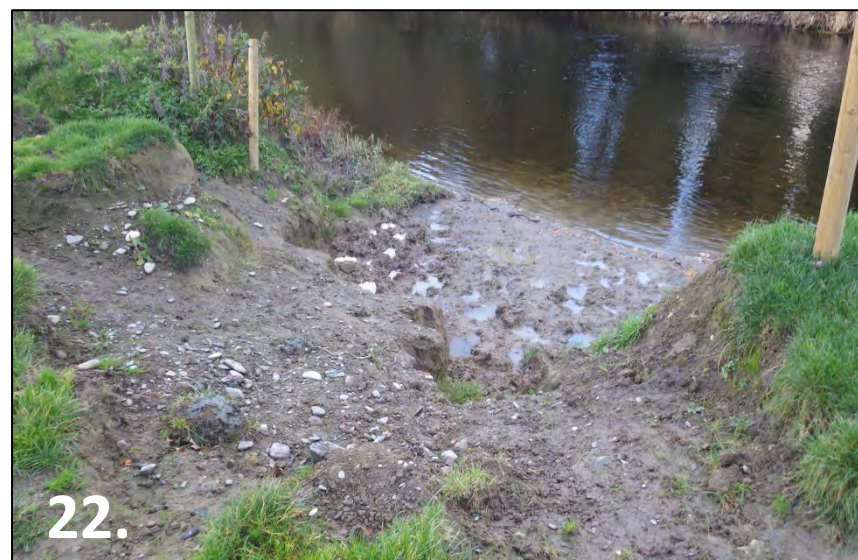
Image 22: Example of a poached area of river bank (Site ID 22380).

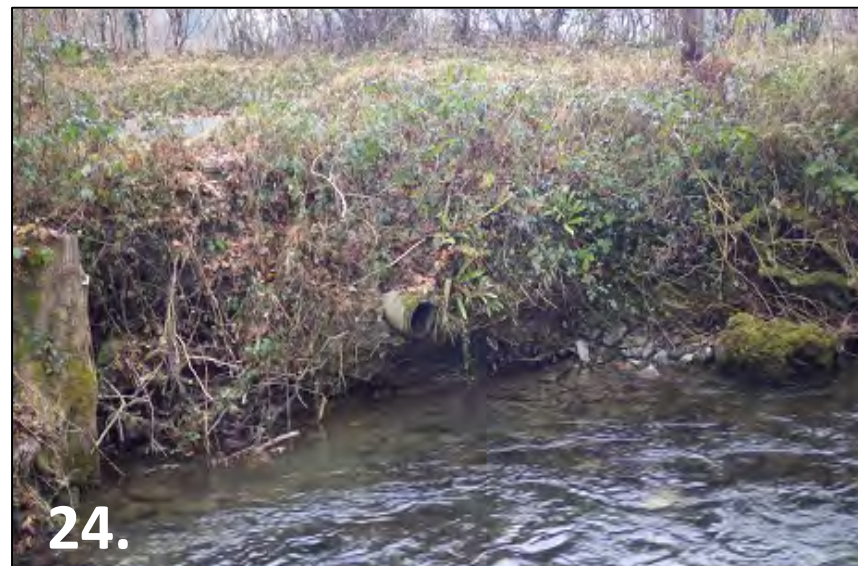
Image 24: Example of a minor outfall (Site ID: 10583).

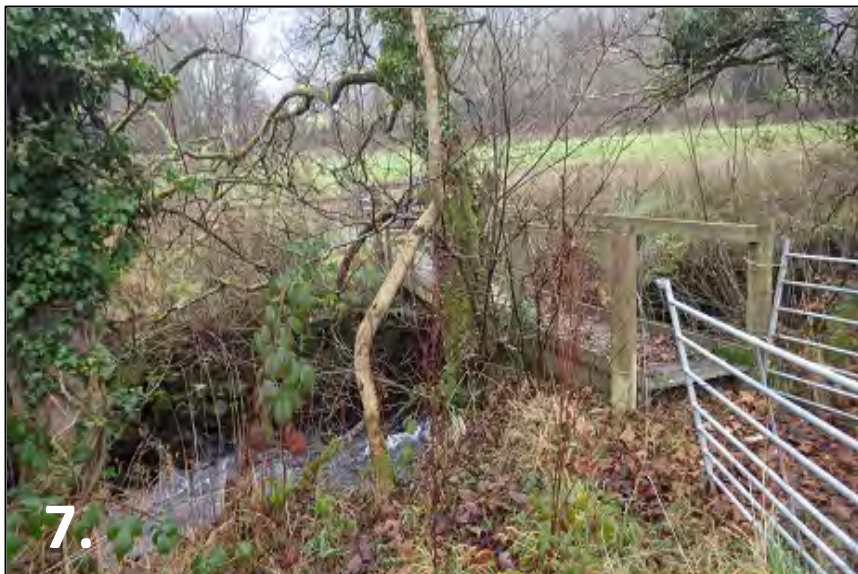
Image 7: Example of a minor bridge (Site ID 10573)

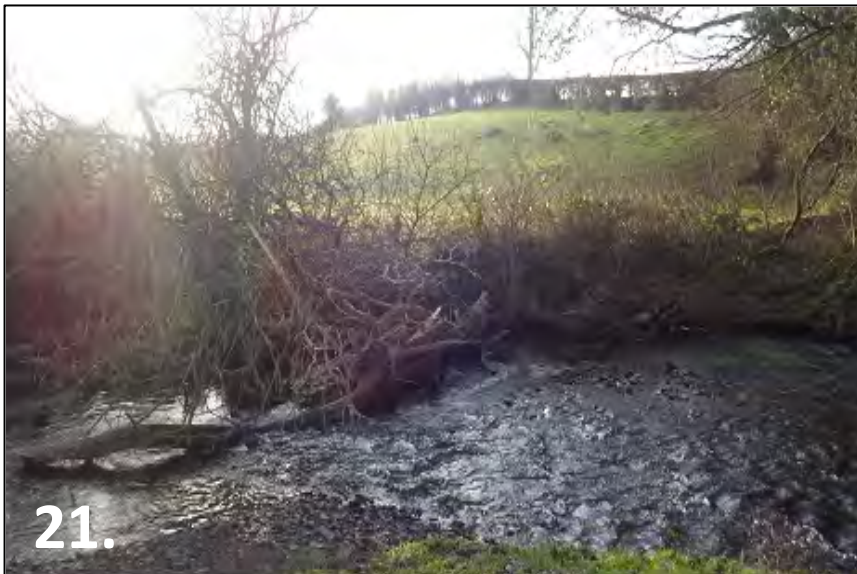
Image 21: Example of woody debris on the Afon Grannell (Site ID 10553)

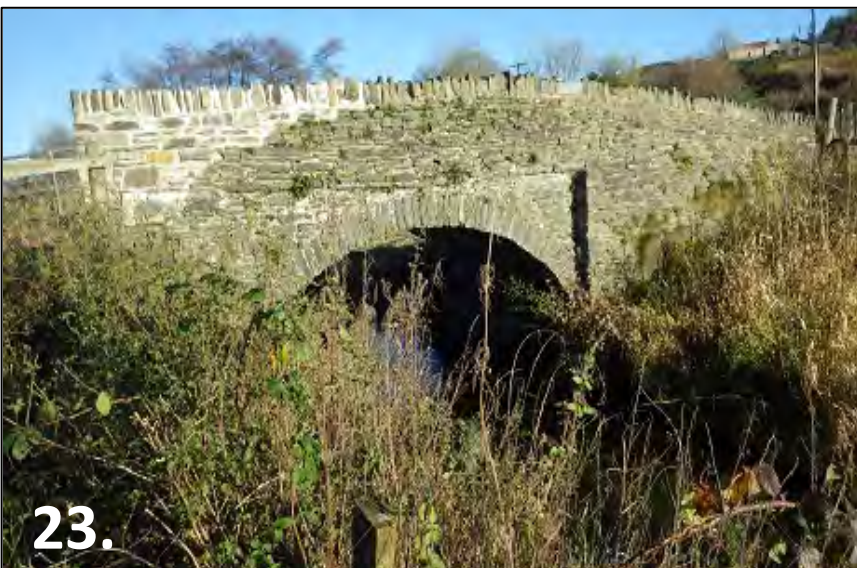
Image 23: An example of a minor bridge on the Afon Dulas (Site ID 10555)

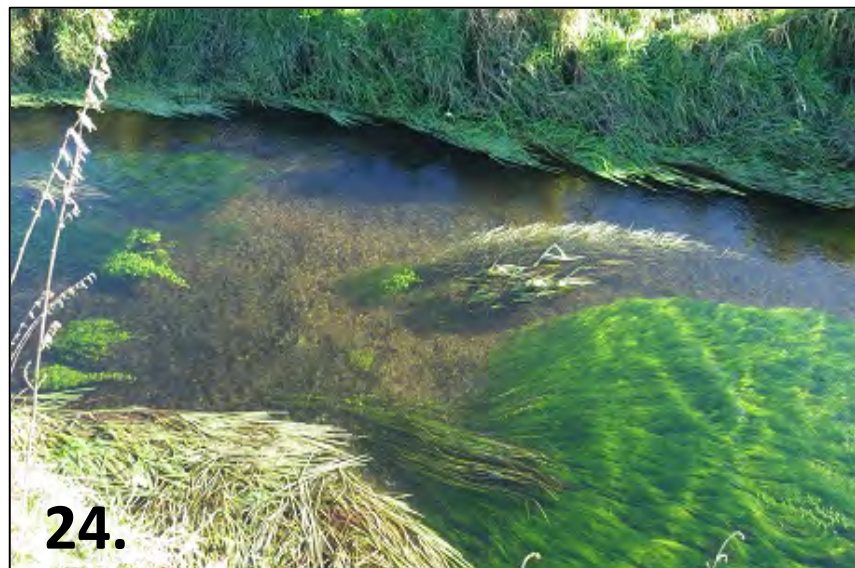
Image 24: An example of submerged vegetation (Site ID 10555).

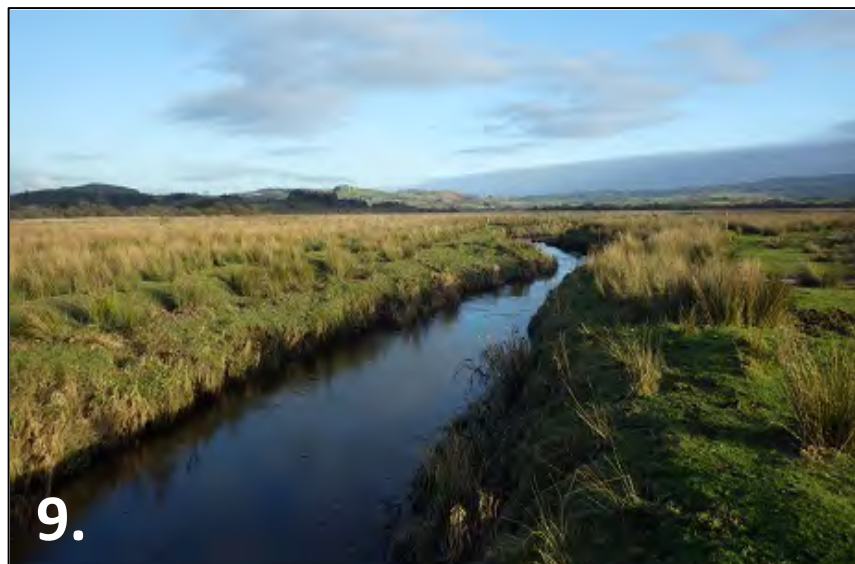
Image 9: Historically deepened channel on the Teifi (Site ID 3214).

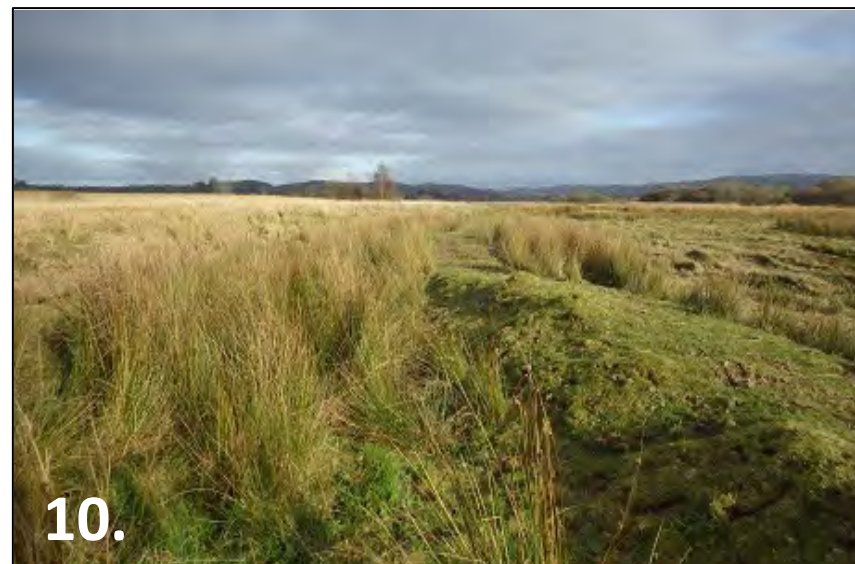
Image 10: Remnant of historic off-set embankment (Site ID 10566).

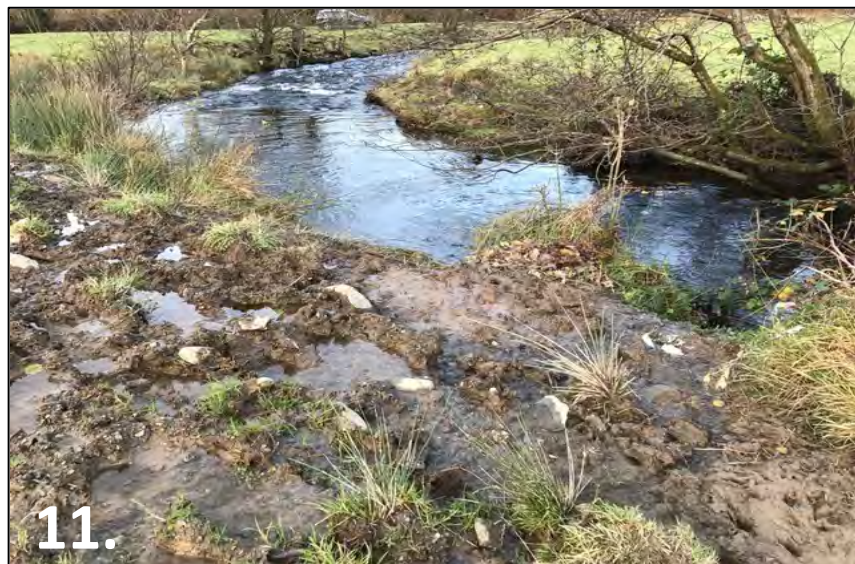
Image 11: An example of poached riverbank (Site ID 797).

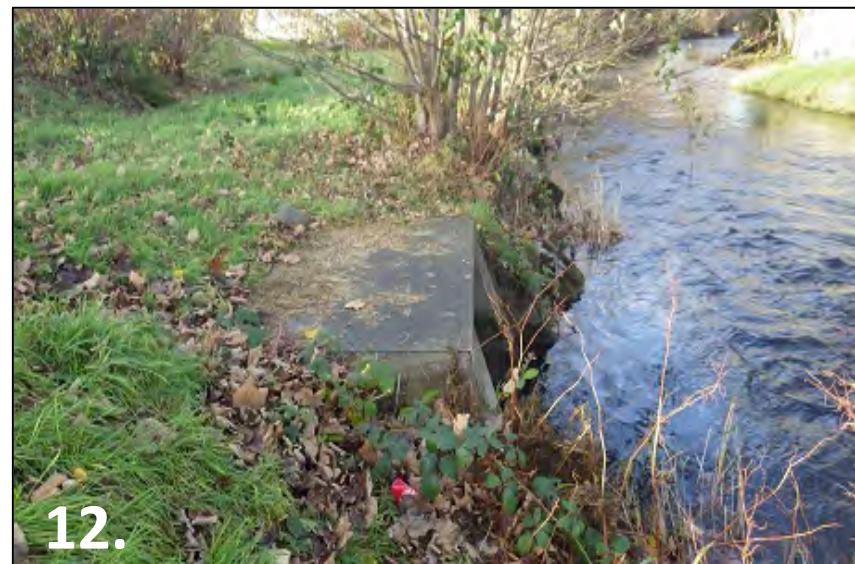
Image 12: An example of a minor outfall into the Afon Teifi (Site ID 22340).

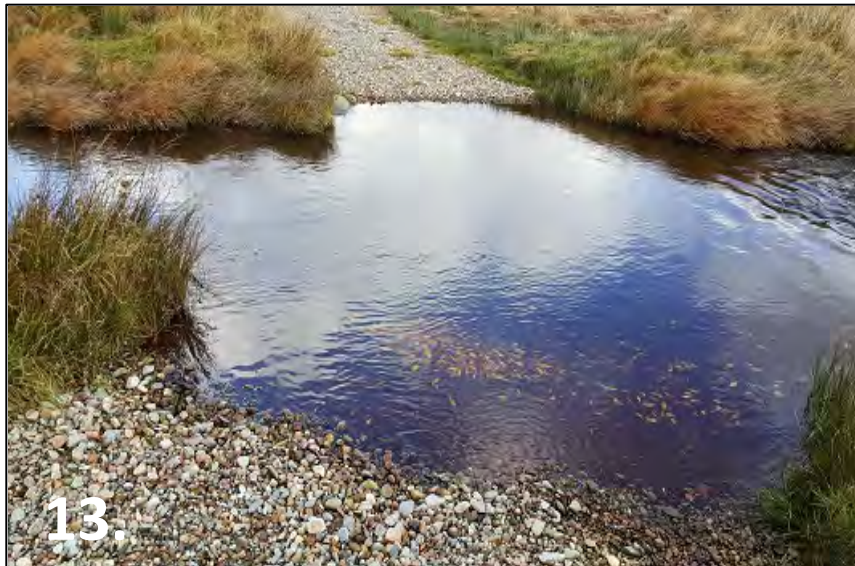
SAC Management Unit 8 of the Afon Eden is represented by the BrynRe survey site. Fourteen in-channel structures were recorded in this section. These included two intermediate structures consisting of a weir and a ford (Appendix B1: Afon Eden SAC, Image 13), along with five minor bridges (Appendix B1: Afon Eden SAC, Image 1), one minor outfall/intake and six flow deflectors. One of the minor bridges had a hay bale underneath the bridge (Appendix B1: Afon Eden SAC, Image 14); it is not known whether this was intentionally placed in the river, but the result was that the flow was scouring the earth bank behind the two block stones, locally eroding the channel. This section had undergone recent management and river rehabilitation measures aimed at increasing flow diversity and increasing the suitability of the site for salmonids and freshwater pearl mussel, as part of the Pearls in Peril initiative. One such restoration method was the addition of boulder deflectors; these have been recorded as in-channel structures during the survey.

Image 13: An example of an intermediate ford (BrynRe).

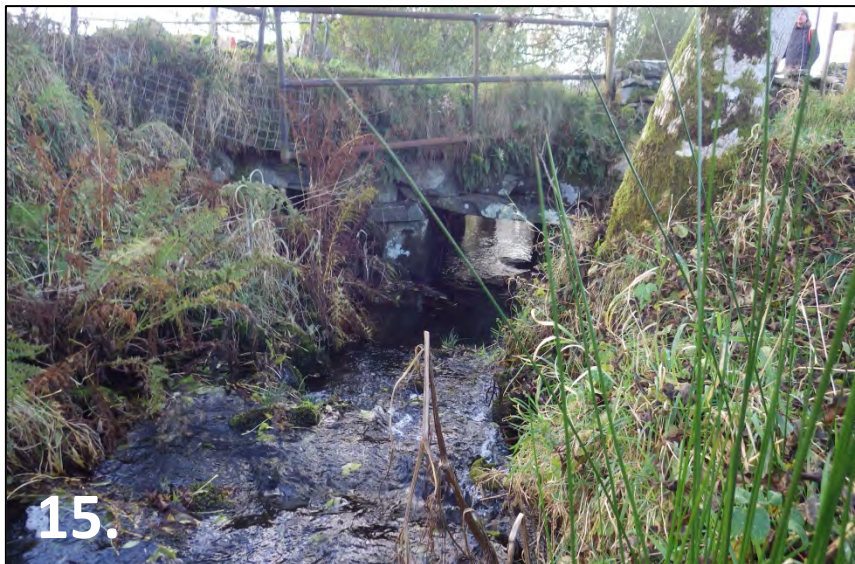
The Aber survey site falls within SAC Unit 11 and three major deflectors are recorded as present in the upper stretch of the reach (Appendix B: Afon Eden SAC, Image 16). One minor farm access bridge was recorded (Appendix B: Afon Eden SAC, Image 15), along with two watergates.

Image 15: A minor bridge present on the Afon Bronaber (Aber).

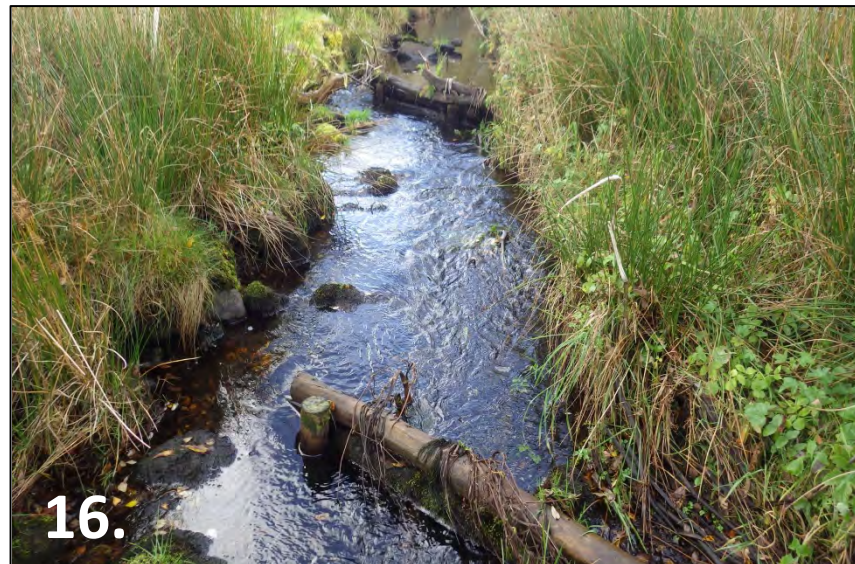
Image 16: Deflectors present in the upper reach of the Afon Bronaber (Aber).

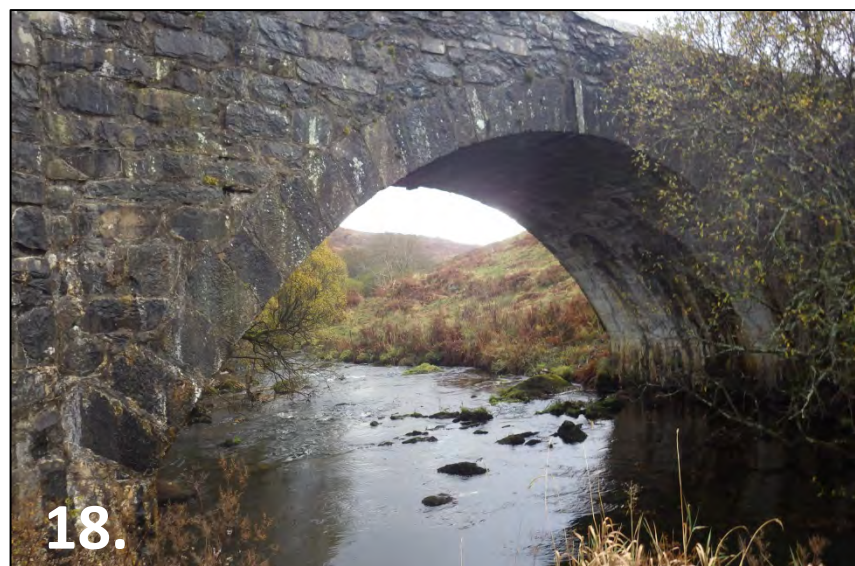
The Pont-y-Grible site within SAC Units 12 and 36 contained one example of an intermediate weir/slucice and a minor bridge (Appendix B: Afon Eden SAC, Image 18) that acted as the boundary between the two SAC units. Byrdir also falls within SAC Unit 36 and contained one minor Watergate (Appendix B: Afon Eden SAC, Image 21). Continuing further downstream and falling within SAC Units 36 and 15 was the Ty'n-llwyn survey site, which contained a major footbridge (Appendix B: Afon Eden SAC, Image 22) and a major ford (Appendix B: Afon Eden SAC, Image 23); the ford bed level was high within the channel, which led to an intermediate weir. Also present in the section was a minor cattle drinking bay (Appendix B: Afon Eden SAC, Image 24).

Image 18: An example of a minor bridge on the Afon Eden (Pont-y-Grible).

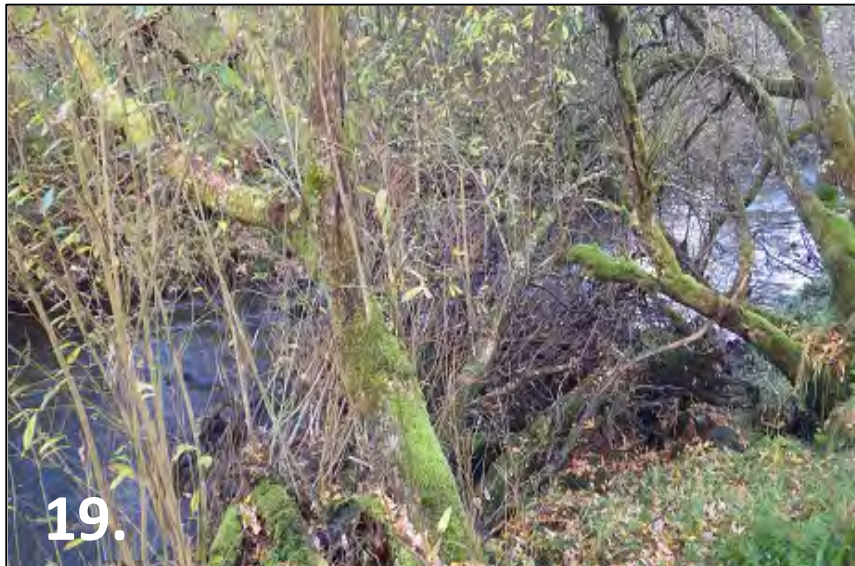
Image 19: An example of woody debris present on the Afon Eden (Bryn Eden).

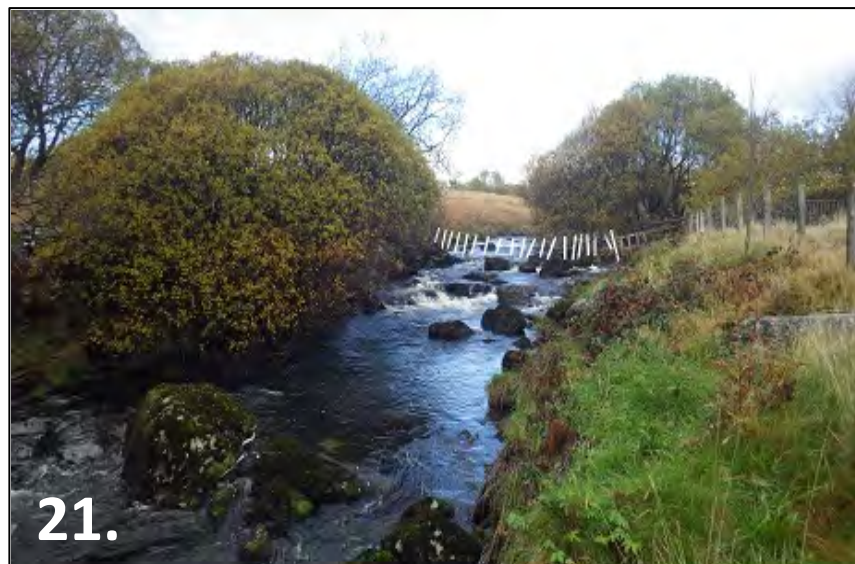
Image 21: An example of a watergate present on the Afon Eden (Brydir).

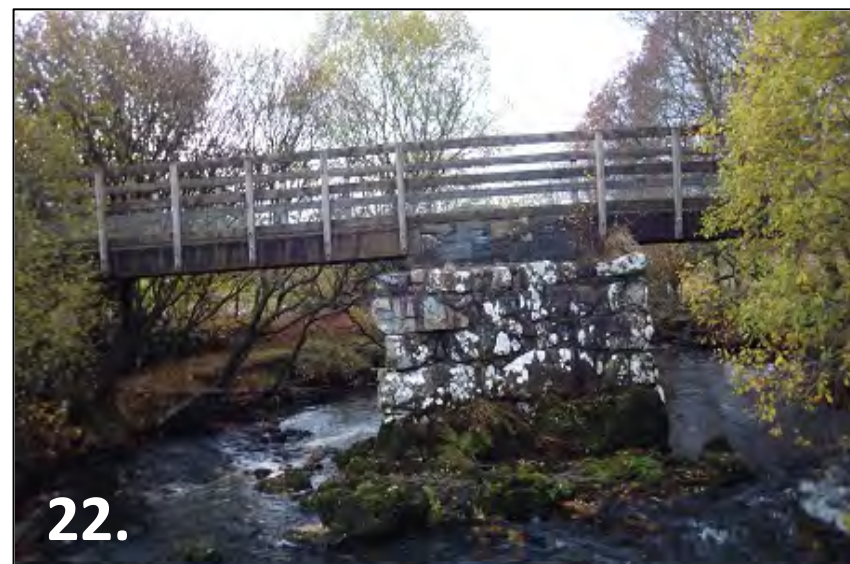
Image 22: An example of a major footbridge present on the Afon Eden (Ty'n-Ilwyn).

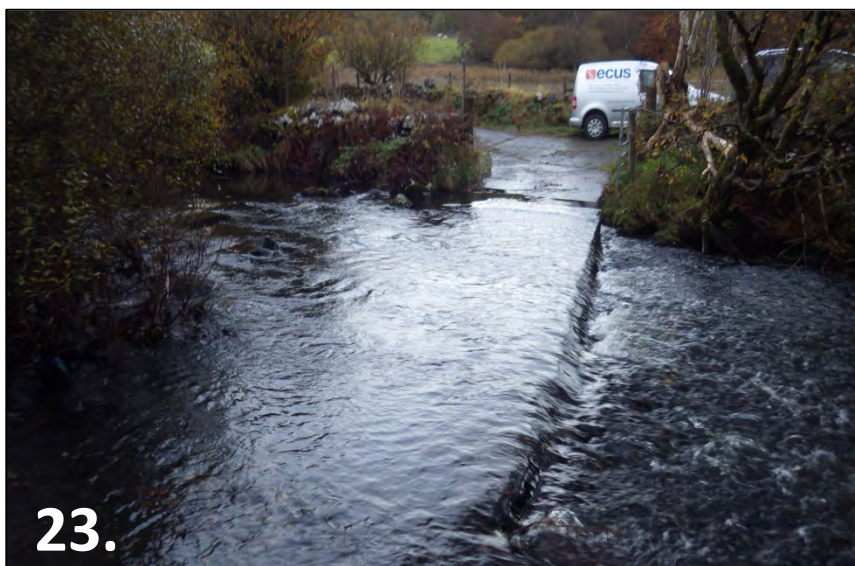
Image 23: An example of a major ford present across the Afon Eden (Ty'n-Ilwyn).

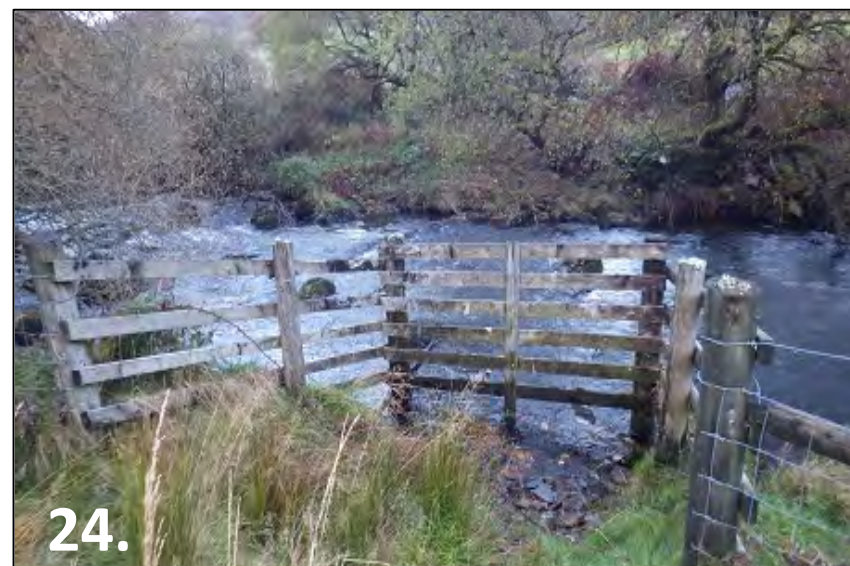
Image 24: An example of a drinking bay on the Afon Eden (Ty'n-Ilwyn).
